**Wisconsin & Southern Railroad Co. March 2010**  
**Recently Emerged Critical Structure Condition Photos/Synopsis**  
**Prairie Subdivision & Fox Lake Subdivision**

**Bridge B-260 MP 183.8 Prairie Subdivision, Wisconsin River, Lone Rock, WI- March 2010 Critical Concrete Conditions**

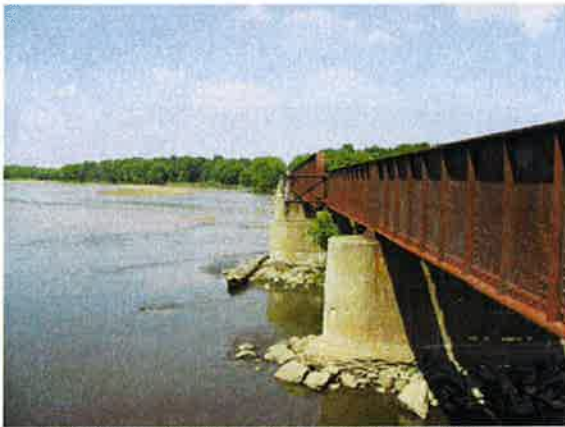
B-260 Concrete Conditions Pier 2 - 6/12/07 View West

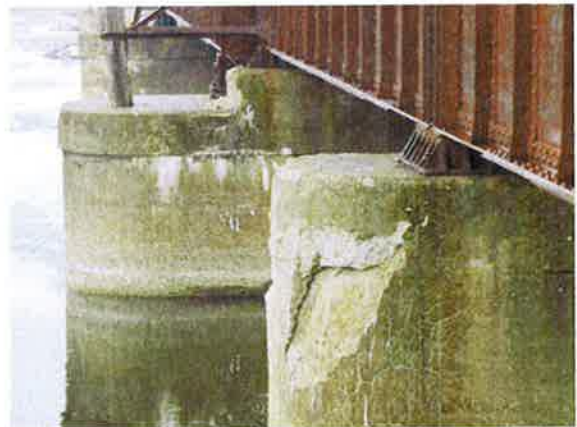
Inspection revealed severe critical shear cracked, spalling and displaced concrete condition in load bearing areas of substructure unit pier 2 and pier 3 that was unobserved in previous site visit in fall of 2009.

The shear cracks have created a slip plane compromising the integrity of the pier shaft to safely transfer and distribute the live load (train loading) to the substructure footing, necessitating twice weekly inspections for changes and or settlement as degradation could advance rapidly and cannot be predicted. Any further degradation or detectible settlement will warrant structure removal from service immediately and follow up inspection by a structural engineer to determine if train operations can resume and under what circumstances.

B-260 Concrete Shear Crack, Pier 2 -3/9/10 View West

Contractor effected repairs would consist of removal of degraded concrete, installation of steel bearing grillage to allow structure to remain in service during repairs, and replacement of degraded areas with steel reinforced cast in place concrete. Costs to perform the B-260 concrete repairs are estimated at \$173,000.00.

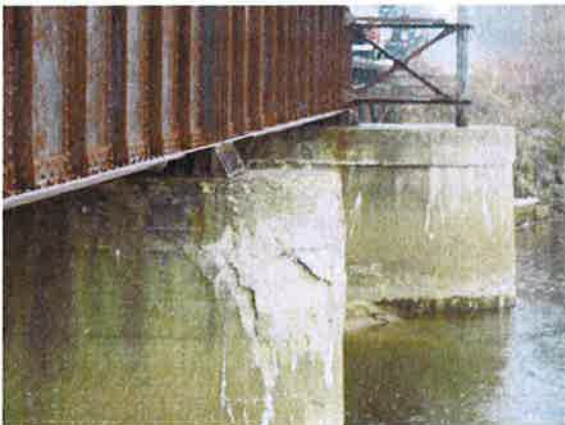
B-260 Concrete Shear Crack, Pier 2 -3/9/10 View East

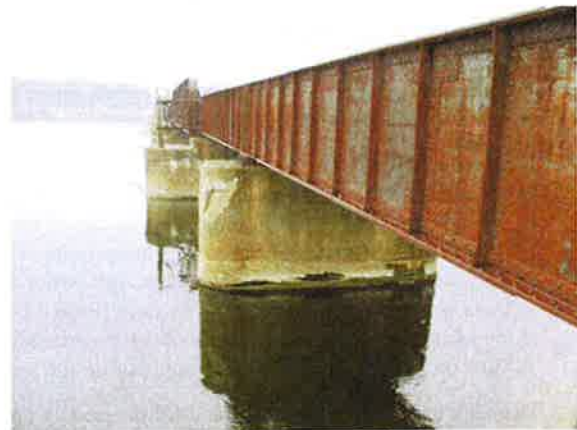
B-260 Concrete Shear Crack, & Concrete Erosion/ Pop outs at Cold Joint at Waterline Pier 2 -3/9/10 View West

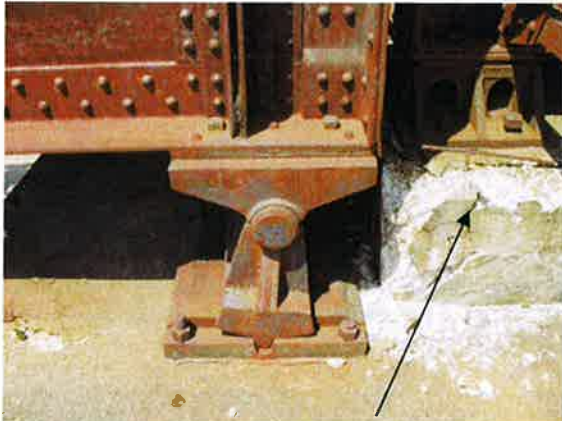
B-260 Surface Spalled Concrete Bearing 5 Riser, Pier 3, Span 8 -6/12/07

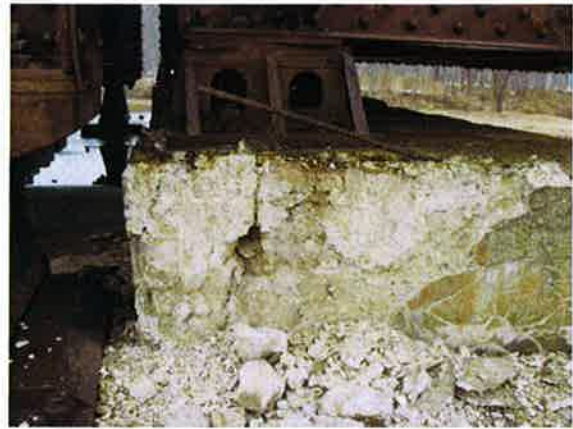
B-260 Shear Fractured Concrete -25% of Load Bearing Area, Bearing 5 Riser, North Face, Pier 3, Span 8 -3/9/10

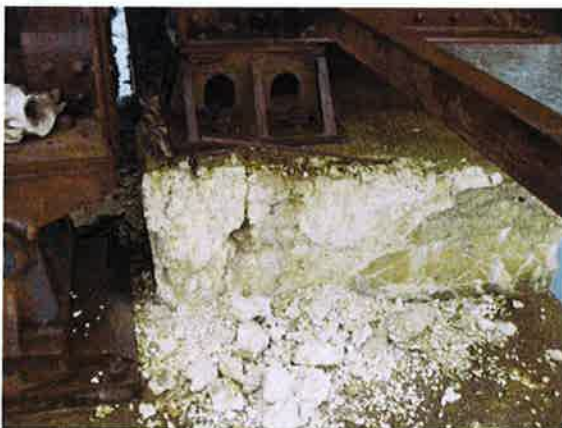
Fracture Detail Depth Bearing 5 Riser, North Face, Pier 3 -3/9/10

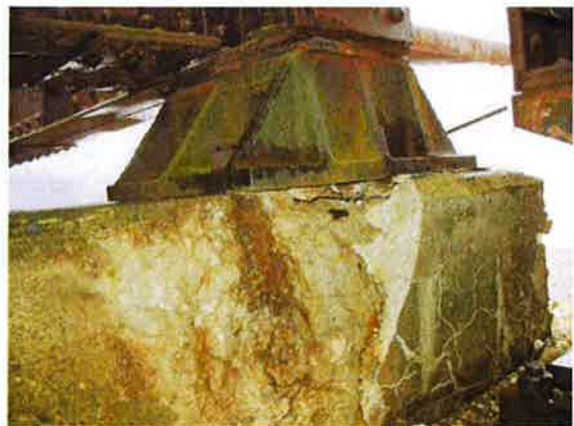
Fractured/Displaced Concrete Load Bearing 5 Riser, West Face, Pier 3 -3/9/10

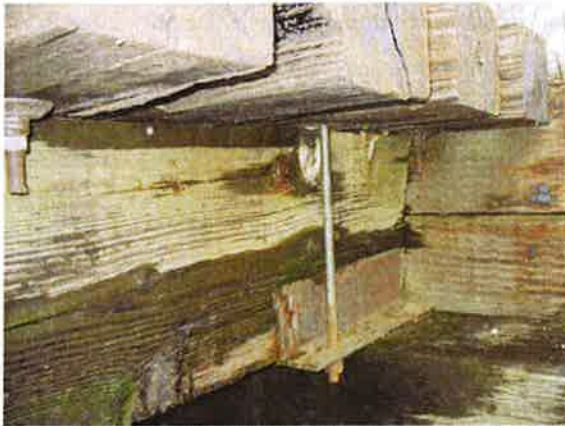
Stinger 1, span 1 was found to be splintered at the east bearing end as well as decay voided behind the connection angle. Pile caps in bents 3 and 5 exhibited moderate vertical cracks throughout length and shear cracks emanating from the primary pile load bearing points. Additionally the sub cap of frame bent 6 was found to be shear cracked and displaced at the seat. The timber conditions exhibited warrant prompt remedial action to preclude an out of service condition from arising. Additionally, tie condition on steel through girder spans 14 and 15 has degraded sufficiently that 60% of the rail holding spikes were found to be missing, in some areas 12 consecutive ties in a row. These areas were re-spiked then double spiked at time of inspection to allow the structure to remain in service but tie decay is sufficiently advanced that complete replacement of ties on spans 14 & 15 is warranted within the very near future if structure is to remain in service.

B-260 Splayed Cracking/Crushing Stringer 1, Span 1

Repairs to stringers, pile caps and frame sub cap are planned by WSOR forces with inventoried materials within the next few weeks. Cost for WSOR performed repairs (labor and materials) are estimated at \$9,516.60.

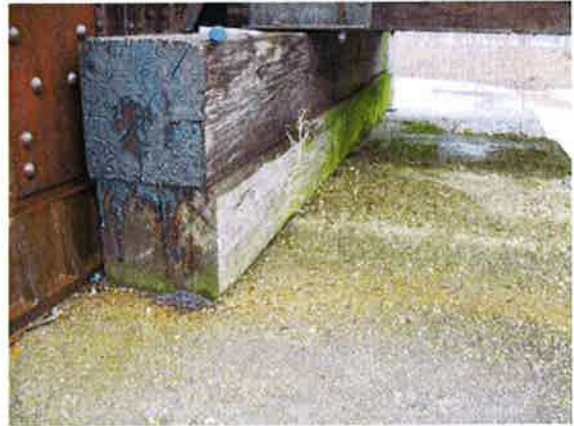
B-260 Sub Cap(lower) Frame Bent 6 Cracking/Crushing (pier 1)

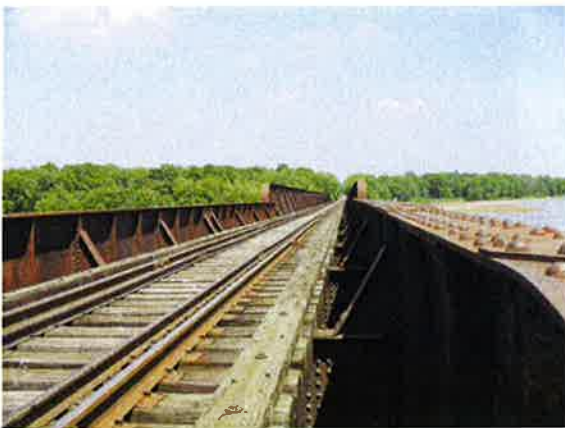
B-260 Tie Deck Span s 14 & 15 June 2007 View East

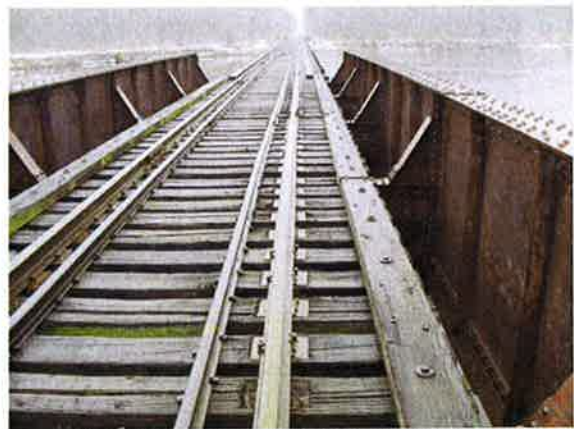
B-260 Tie Deck Span s 14 & 15 March 2010 View East  
(Note 12 Consecutive Ties Missing Spikes in Foreground)

Contractor effected complete timber tie deck replacement of spans 14 & 15 repairs bridge B-260 repairs are estimated at \$76,641.00.

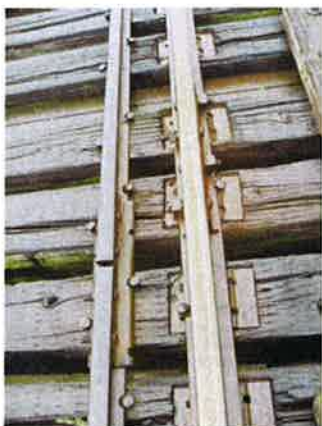
B-260 Typical Tie Deck Condition Spans 14 & 15 March 2010

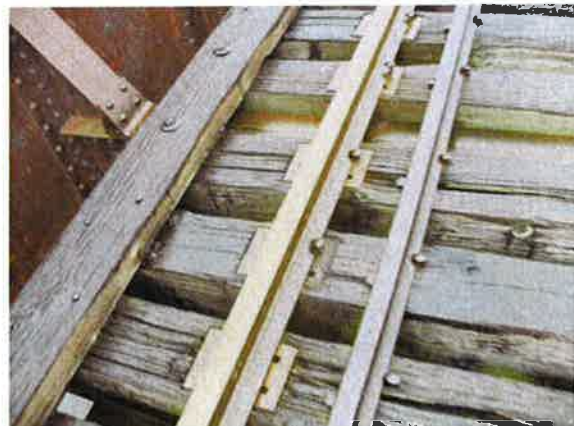
B-260 Typical Tie Deck Condition Spans 14 & 15 March 2010

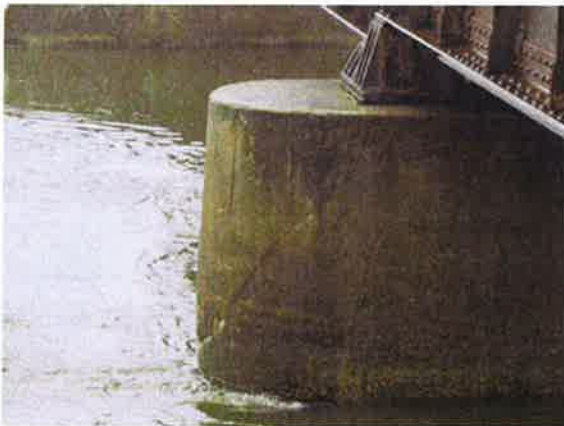
March 2010 cursory inspection revealed serious diagonal shear crack in the concrete load bearing area of pier 2, emanating from bearing 1, and extending to sides and exiting the south pier nose, which did not exist in previous inspections. Additionally the structure exhibits additional alignment rotation in draw span due to field fitted and insufficiently secured wedge bearing keepers at rest pier3 and 5 bearings when structure was secured from opening by the Milwaukee Road.

The shear crack in pier 2 has compromised the integrity load bearing concrete immediately adjacent to the bearing seat which will lead to further extensive, increasingly rapid, concrete degradation and eventual loss of serviceability. Rotation of the draw span is causing uneven load distribution across the bearing shoe system and displacing the wedge bearings, which if allowed to continue will allow the beams to become unsupported creating an out of service condition with an expensive repair.

B-310 Concrete Shear Crack Pier 2 - 3/11/10 View West

Contractor effected repairs would consist of removal of degraded concrete, installation of steel bearing grillage to allow structure to remain in service during repairs, and replacement of degraded area with steel reinforced cast in place concrete, and realignment of draw span and permanent bearing fixation to prevent further rotation. Costs to perform the B-310 concrete repairs and draw span alignment are estimated at \$148,000.00.

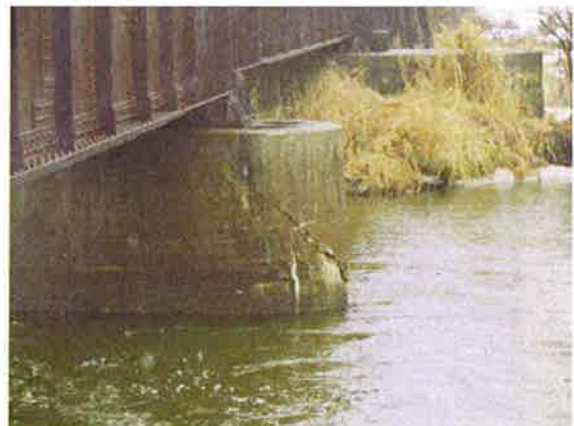
B-310 Concrete Shear Crack, Pier 2 -3/11/10 View East

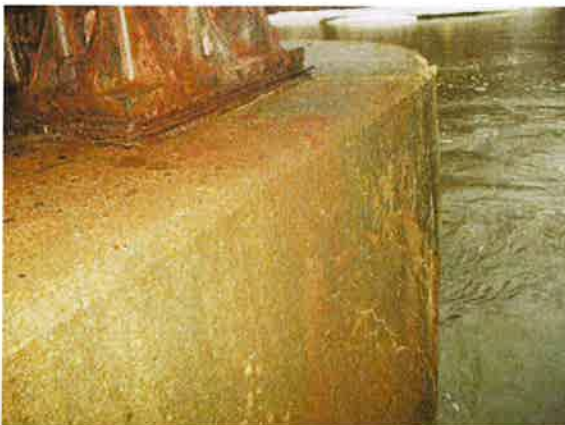
B-310 Concrete Bulging Shear Crack, Pier 2 -3/11/10 View South

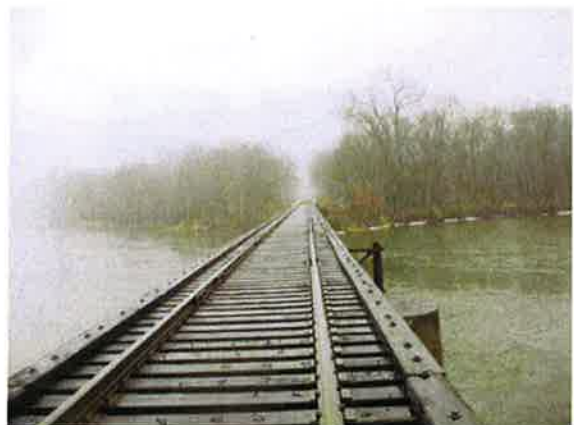
B-310 Misalignment of Draw Span View West

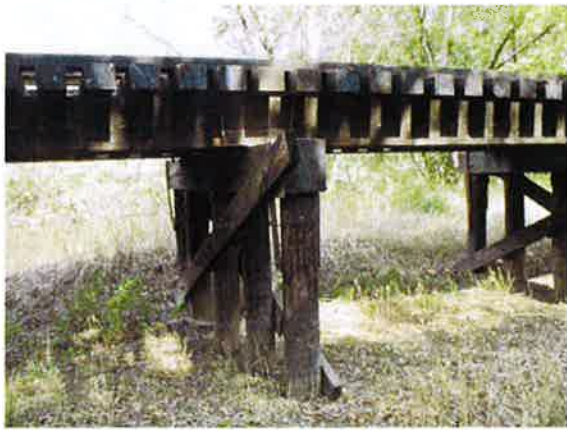
B-318 Bent 6, Typical Condition September 2007

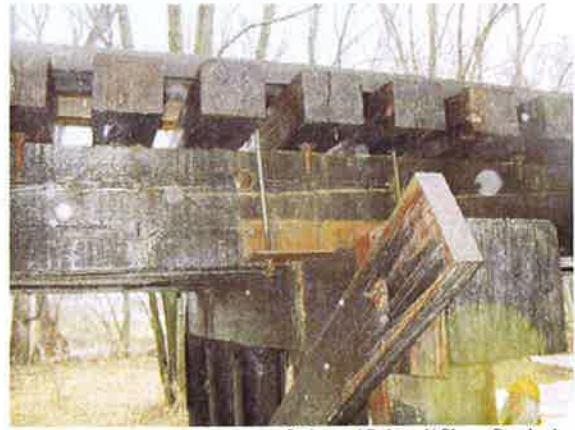
Inspection revealed severe splayed cracked, shear cracked and decayed timber stringers, pile cap bent 6, and frame bent 12 in the 11 span east timber approach trestle. The general stringer condition exhibited in this structure is fair to poor as the stringers are nearing the end of their life span (age) and coupled with the low capacity (overloaded) settling bent conditions contributing to greater flexural strain, rapid stringer degradation failure is occurring and will be ongoing until complete replacement of the timber approach is effected.

B-318 Bent 6 Pile Cap Fracture Stringer 1 Splayed/ Shear Cracked

Replacement of stringer 1 spans 1 & 2 and stringers 1 & 2 spans 4, 5 & 6, pile cap bent 6 and total replacement of frame bent 12 are planned by WSOR forces with inventoried materials within the next few weeks. Cost for WSOR performed repairs (labor and materials) are estimated at \$21,874.76.

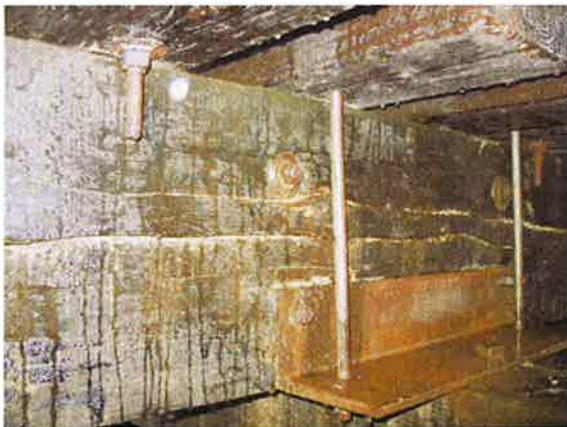
B-318 Bent 2, Span 1 & 2 Splayed Cracking/Crushing Stringer 1

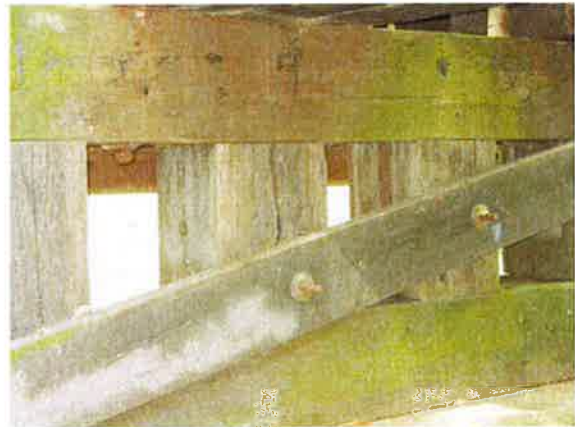
B-318 Frame Bent 6 Cracking/Crushing Cap, Posts, & Sub Cap.

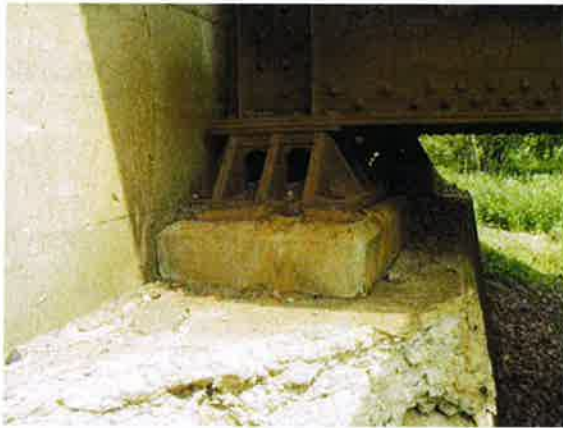
Inspection revealed severe shear cracked, spalling and displaced concrete condition in load bearing areas of east abutment, substructure unit pier 1 and pier 2 and west abutment that are compromising the integrity of all substructure units. This condition is critical to the stability of the structure since the two main beam design is a non-redundant and degradation failure of the load bearing concrete could cause span displacement and derailment under train loading.

A-440 Concrete Conditions East Abutment Bearing 2

A contract with E-80 Plus Constructors has been approved and signed for repairs consisting of installation of jacking beams, removal of degraded concrete in bearing areas, installation of precast concrete bearing blocks to allow structure to remain in service during repairs, and replacement of remaining degraded areas with steel reinforced cast in place concrete. Costs to perform the A-440 concrete repairs are based at a not to exceed quote of \$165,480.00.

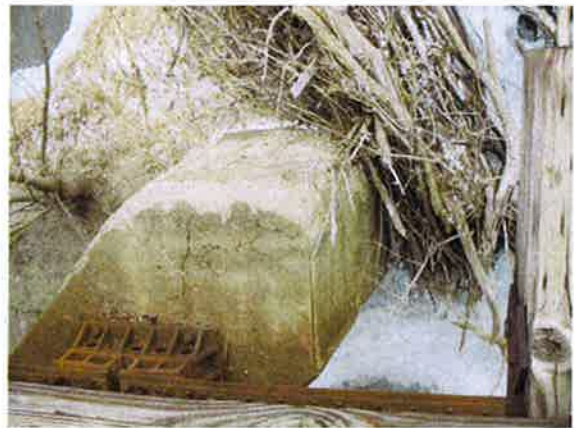
A-440 Concrete Shear Cracks, Bearing 1, Pier 2

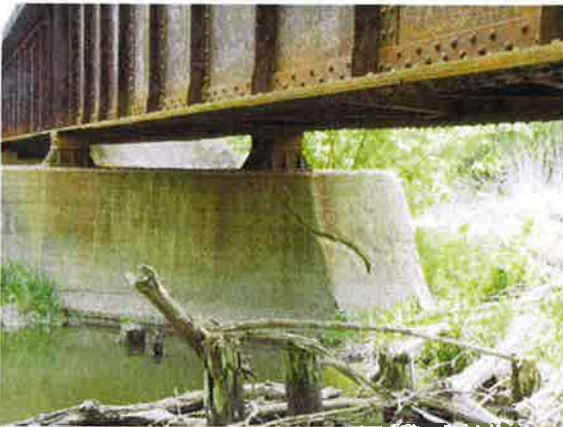
A-440 Concrete Shear Crack Under and Past Bearing 1, Pier 1

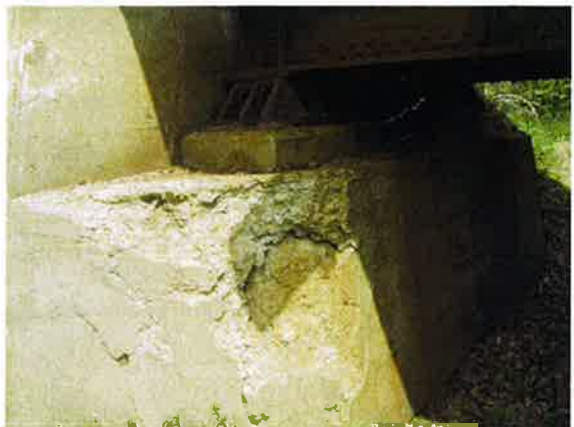
A-440 Concrete Conditions East Abutment Bearing 1

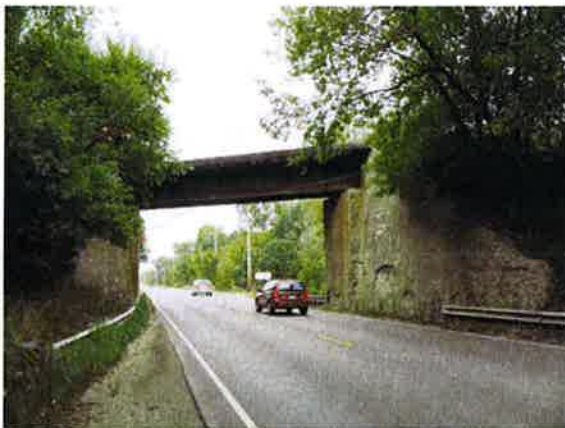
Inspections over the last 15 years reported continued deterioration of the concrete bearing shafts and wingwalls in the east and west abutments, which has now progressed substantially, with structure exhibiting shear cracks under bearings, and heavy spalling and pop-outs occasionally displacing concrete into the roadway prompting calls from the Richmond Ill. Police Department.

A-444 Concrete Conditions East Abutment Sept. 2009 View North

Contractor effected repairs would consist of removal of degraded concrete, installation of steel bearing grillages to allow structure to remain in service during repairs, and replacement of degraded areas with steel reinforced cast in place concrete. Costs to perform the A-444 concrete repairs are estimated at \$295,000.00.

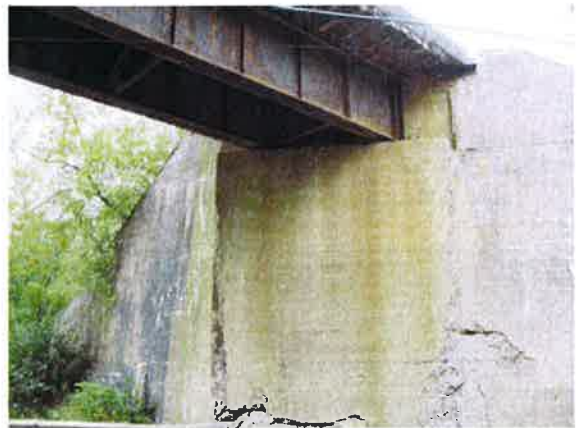
A-444 East Abutment Shear Cracks, Bearing Shaft & Bearings 1 & 2

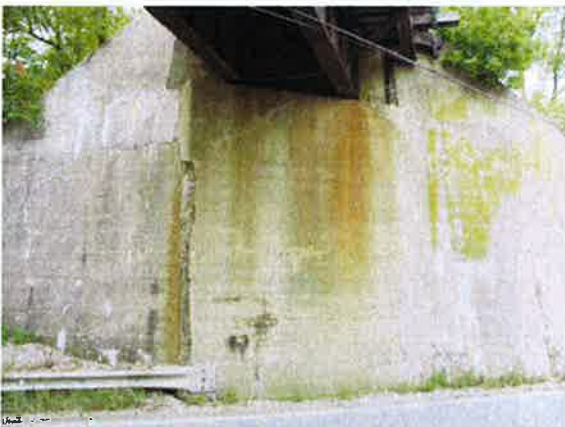
A-444 West Abutment Shear Cracks, Under Bearings 1 & 2 and Bearing Shaft

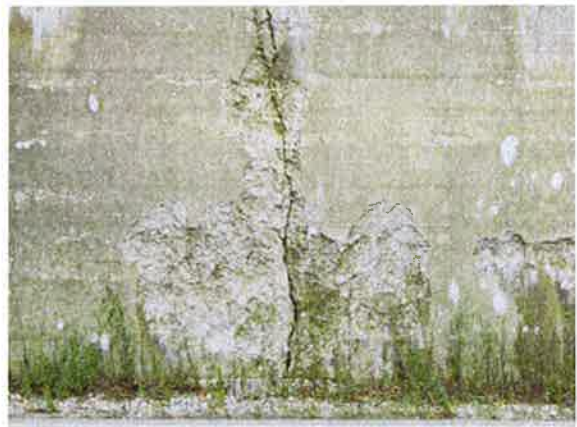
A-444 Vertical Column Cracks, Bearing Shaft & North West Wingwall

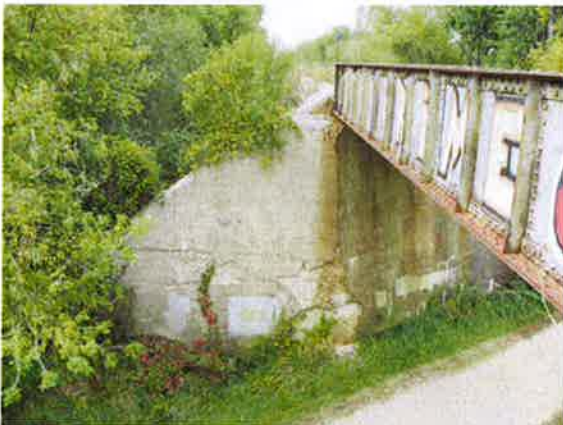
Joint WSOR/WDOT inspections of this structure since opening of this subdivision in 1989 reported on deterioration of the concrete bearing shafts and wingwalls in the east and west abutments and recommended study for repair or replacement due to its massive extent, and lack of necessity after abandonment of the former CNW rail line (under) at this location. Concrete deterioration has advanced substantially within the last year, and the structure is exhibiting large shear cracks under bearings, embedment of bearing shoes into concrete bearing seats, and heavy spalling is displacing concrete from the bearing shafts and wingwalls. In addition to the concrete deficiencies the open timber tie deck is poor, with numerous split and soft ties which are shifting due to decay around the anchor hardware and rail holding spikes.

A-446 West Abutment Shear Cracks, Under Bearings and Bearing Shaft

Contractor effected repairs would consist of removal of degraded concrete, installation of steel bearing grillages to allow structure to remain in service during repairs, and replacement of degraded areas with steel reinforced cast in place concrete. Costs to perform the A-446 concrete repairs are estimated at \$369,000.00.

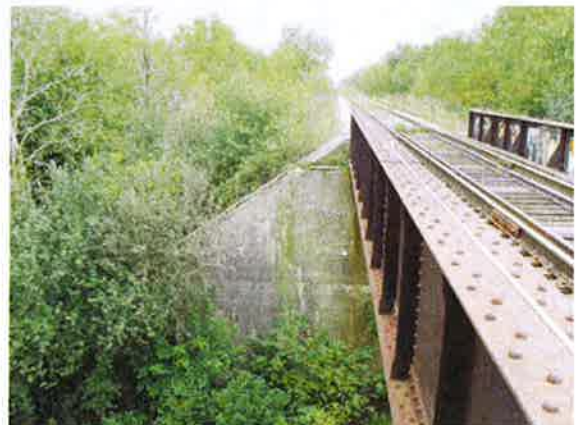
A-446 East Abutment Shear Cracks, Bearing Shaft & North East Wingwall

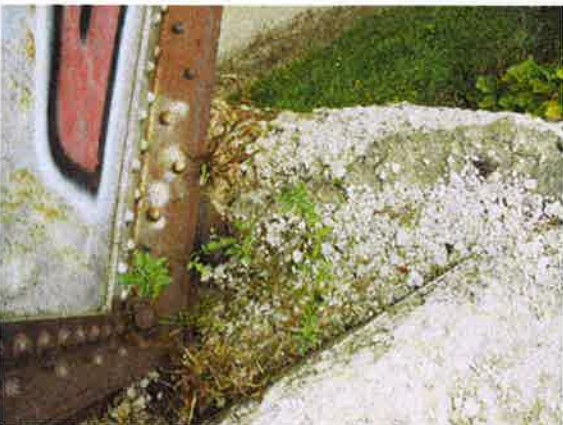
A-446 Bearing Embedment into Bearing Seat Typical at all Bearings

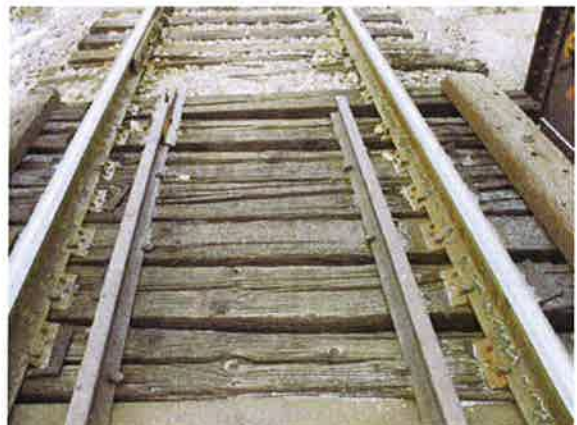
A-446 Typical Tie Deck Condition Entire Structure

Replace timber tie deck with WSOR Forces as soon as material is available for an estimated cost (labor and materials) \$10,110.25.

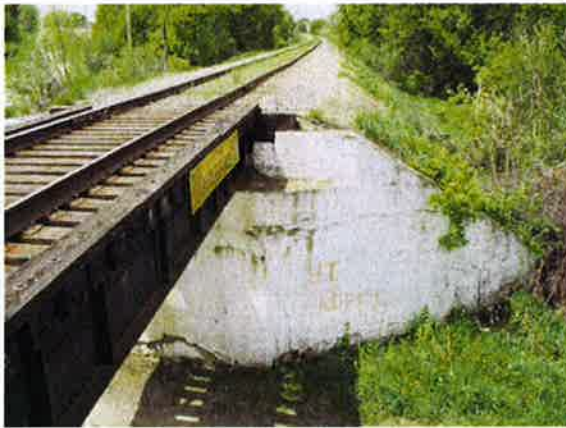
A-454 West Abutment Concrete Condition September 2007

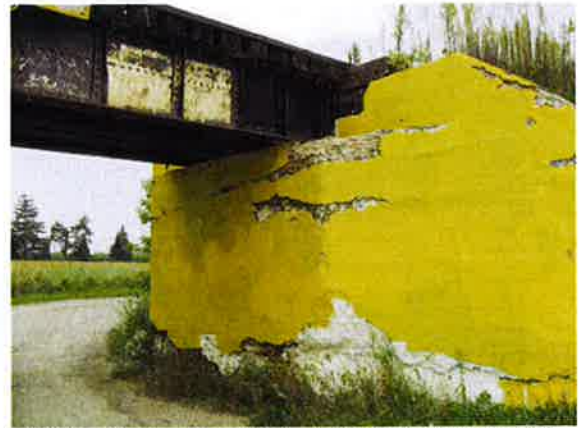
Similar to structure A-446, joint WSOR/WDOT inspections of this structure since opening of this subdivision in 1989 reported on deterioration of the concrete bearing shafts and wingwalls in the east and west abutments and recommended study for repair or replacement due to its massive extent. Concrete deterioration has advanced substantially within the last year, and the structure is exhibiting shear cracks in the bearing shafts, embedment of bearing shoes into concrete bearing seats sufficient to cause stringer beam 1 to begin to rotate out of position, and moderate spalling is displacing concrete from the bearing shafts and wingwalls into the roadway.

A-454 West Abutment Shear Cracks, Bearing Shaft November 2009

Contractor effected repairs would consist of; jacking structure to correct profile deficiencies and installation of temporary shoring towers, removal of degraded concrete bearing seats and wingwalls, installation of precast concrete bearing blocks to allow structure to remain in service during repairs, and replacement of remaining degraded concrete areas with steel reinforced cast in place concrete. E-80 Plus Constructors has tendered a repair cost for structure A-454 repairs based at a not to exceed quote of \$228,826.00.

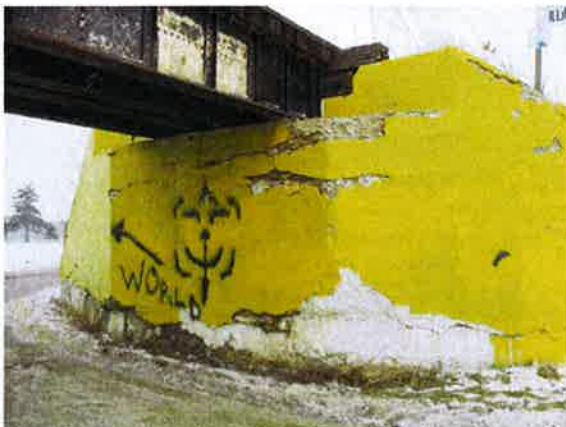
A-454 East Abutment Shear Cracks, Bearing Embedment January 2010

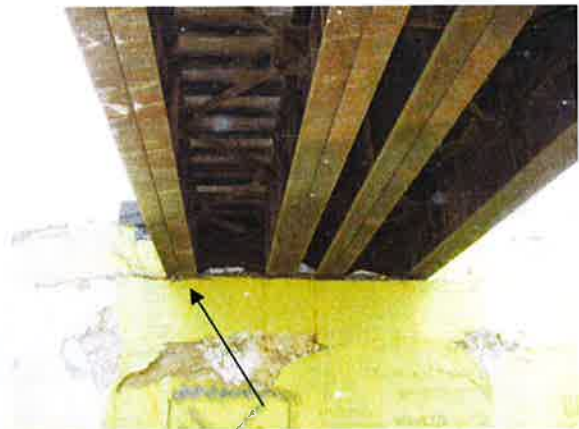
A-454 West Abutment Stringer Beam 1 Rotation/Embedment January 2010

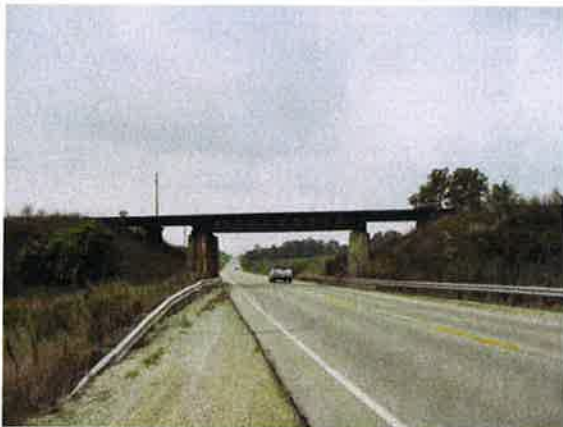
A-458 View Elevation South September 2007

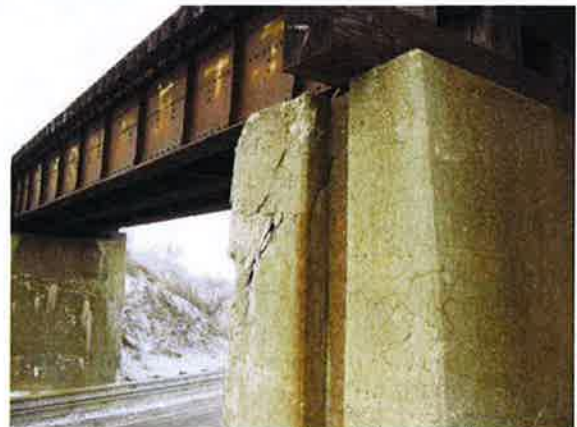
Inspection revealed severe critical shear cracked, movement displaced concrete condition at bearing 1 and sub linear shear cracking around the remaining circumference of pier 1 with similar beginning stage emanating shear cracks exhibited around and under the bearing seats of pier 2, conditions that were very advance from what was observed in previous site visits in spring of 2009. Additionally marked timber deterioration; splayed fracture and member compression was noted in timber pile trestle approach frame bent 3, pier 1 and frame bent 4, pier 2 as well as increased subsidence in track profile on east and west timber trestle approaches due to long standing out of profile conditions leading to pile settlement.

The shear cracking has compromised the integrity of pier 1 to adequately transfer and distribute the live load (train loading) requiring placement of a 10 m.p.h. slow order on the structure and twice weekly inspections for changes and or settlement as degradation could advance rapidly and cannot be predicted. The fact that the fractured pier 1 section is visibly open at the bottom indicates active rotation and further movement threatens to displace approximately 1.5 cubic yards of concrete into the roadway. Any further degradation or detectible settlement will warrant structure removal from service immediately and follow up inspection by a structural engineer to determine if train operations can resume and under what circumstances. The degraded timber condition of frame bents 3 and 4 and subsided trestle approaches are increasing the impact live load to piers 1 and 2 contributing to concrete degradation as well as timber fracture in the approach structures.

A-458 Pier 1 Shear Crack, Bearing 1 January 2010

Contractor effected repairs would consist of removal of degraded concrete, installation of precast concrete bearing blocks to allow structure to remain in service during repairs, and replacement of remaining degraded concrete areas of piers 1 and 2 with steel reinforced cast in place concrete. Repairs would also include replacement of timber frame bents 3 and 4 with precast concrete riser elements and installation of deeper section pile caps on bents 1, 2, 5, & 6 to correct profile deviations and arrest pile settlement. E-80 Plus Constructors has tendered a repair cost for structure A-458 repairs based at a not to exceed quote of \$254,968.00 however use of WDOT funds will require the project to undergo engineered bid development, and bid letting.

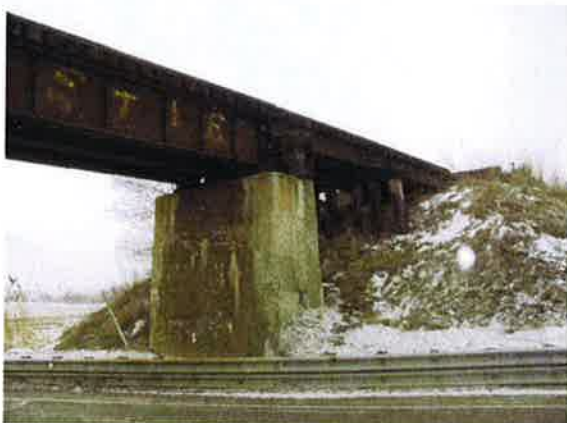
A-458 Pier 2 Shear Cracks around Pier Periphery January 2010

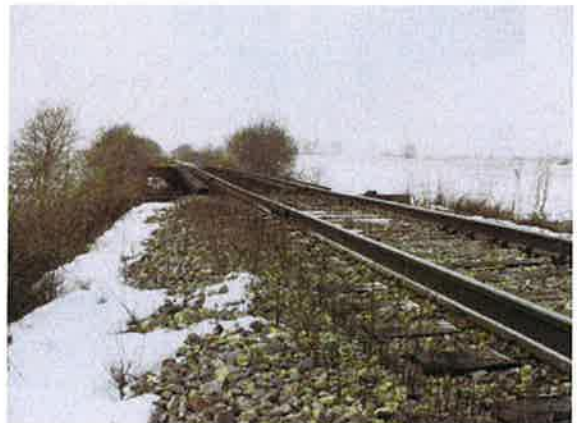
A-458 Typical Timber Trestle Approach Settlement January 2010
