Comprehensive Study

Merrimac Railroad Bridge No. 334

Wisconsin & Southern Railroad Company

January 2010

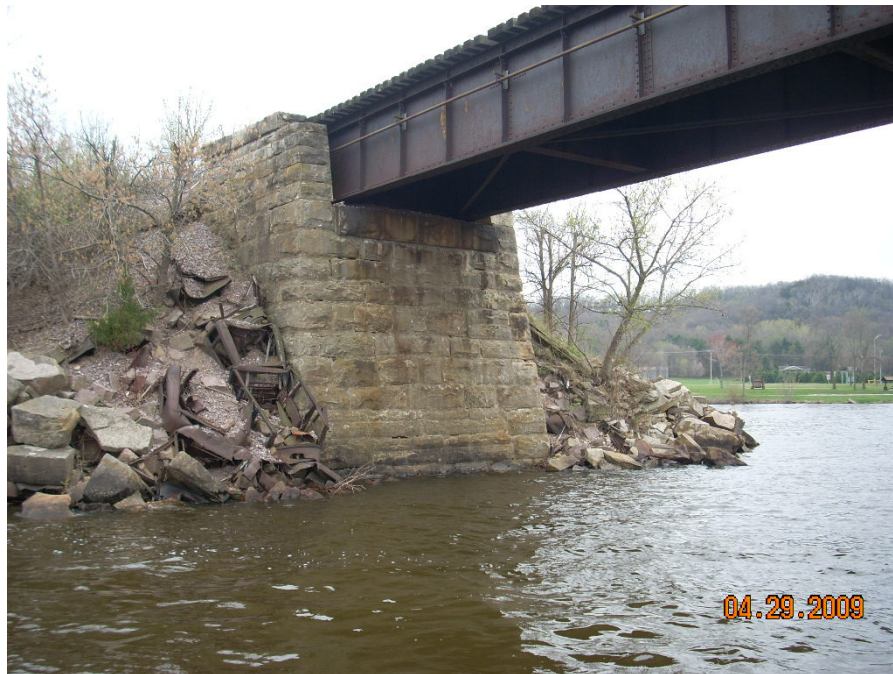
Figure 2-4 View of Abutment 1

The masonry piers and abutments are in fair to good condition with minor deficiencies. There is mortar loss up to 1 foot deep from the water surface to 6 feet below. In various locations, the upstream and downstream noses have missing stone blocks at the water surface and other blocks with section loss up to 8 inches deep at the water surface at the downstream and upstream noses. Pier 2 has a missing stone block under the south bearing at the waterline on the west face. Pier 18 has 1 row of blocks missing just below the water surface at the upstream and downstream noses. Pier 19 has 1 row of blocks missing at the water surface at the upstream nose. Pier 20 has 1 block missing at the downstream nose.

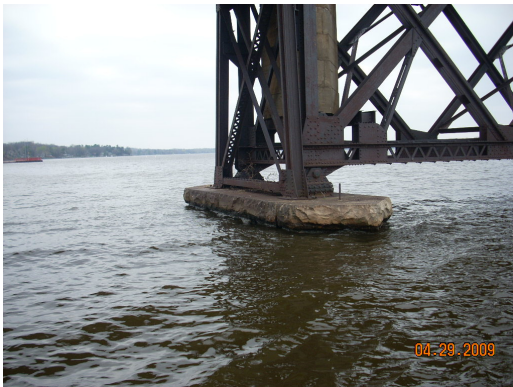
Figure 7-2 Pier 2 Bearings.

For the bearings at Piers 2, 3, 18 and 19, the inspection did not reveal any differing conditions from other bearings indicating that, from a maintenance perspective, no more significant corrosion has occurred that would require additional improvements. The bearings typically have soil and debris build-up that has caused the minor corrosion. In addition, since the adjustments have been made over 90 years ago with no adverse effects, no additional improvements to the bearings are recommended with respect to the adjusted water levels.

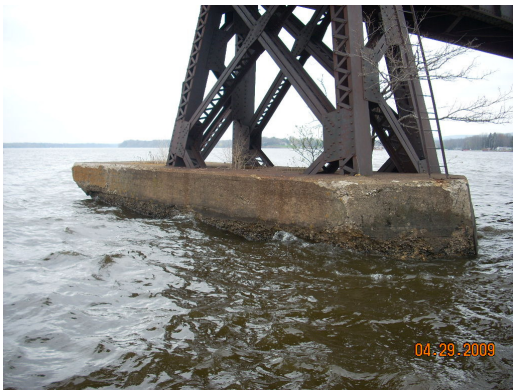
Figure 7-4 Pier 14 Columns

For the tower piers at Piers 4 to 14, no accelerated corrosion appears in the steel columns particularly at the top of the concrete cap surface. In addition, the joints between the added top concrete sections in 1915 to the first added section 1913 do not have spalling that is exposing the steel members. The spalling that is occurring on the noses of the concrete caps appears to be due to ice build-up or flow and does not affect the steel columns at this time. However, further spalling may eventually expose the columns underwater and provide the potential for increased corrosion. Damage to the concrete caps due to ice will be discussed further in Chapter 8. Although the conditions of the column members encapsulated in the concrete are unknown, an indication of corrosion problems would be apparent at the steel members exposed just at the top of the caps. Since this does not appear to be the case and, the conditions of the columns are relatively good for the length of period of exposure, no additional improvements are recommended.

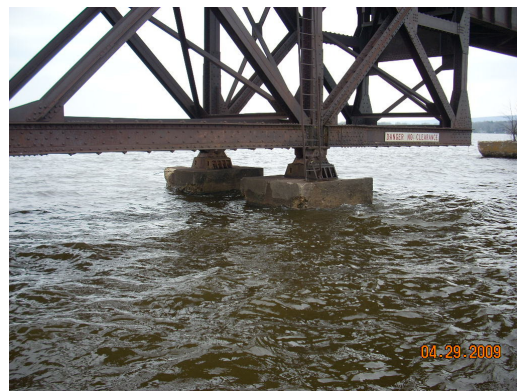
Figure 7-5 Span B Truss.

The trusses in Spans B and R have the most vulnerability in the lower chords due to the change in water elevation for the lake. In addition, all the truss spans are safety hazards to recreational boats due to the lack of clearance. Typically, the design of bridges over waterways should have 2 ft. clearance over the design high water and, for small recreational boating, a minimum of 6 ft. of clearance is recommended above the high water elevation if the channel is not designated as a navigational waterway. Span R could also be vulnerable to ice damage since the clearance is only 1 ft. above the high water line but will be discussed more in Chapter 8. However, review of the steel components in regard to possible increased corrosion for the sections closer to the water, the inspection noted that Span R had pack rust between the bottom chords and the vertical or diagonals, but was also noted similarly in Span U. Other deteriorated conditions were similar in the trusses throughout. All of the bottom chords typically had similar deficiency conditions where the inside vertical gusset plates connecting the lower chord to the diagonals and verticals have moderate pitting along the top of the bottom chord and the lower lateral transverse brace angles have developed pack rust between the angles. The pack rust between the angles and the section loss for the gusset plates will be recommended to be monitored at this time as noted in Chapter 5 whereas repairs are recommended for the pack rust between the lower chord and the diagonals and verticals.

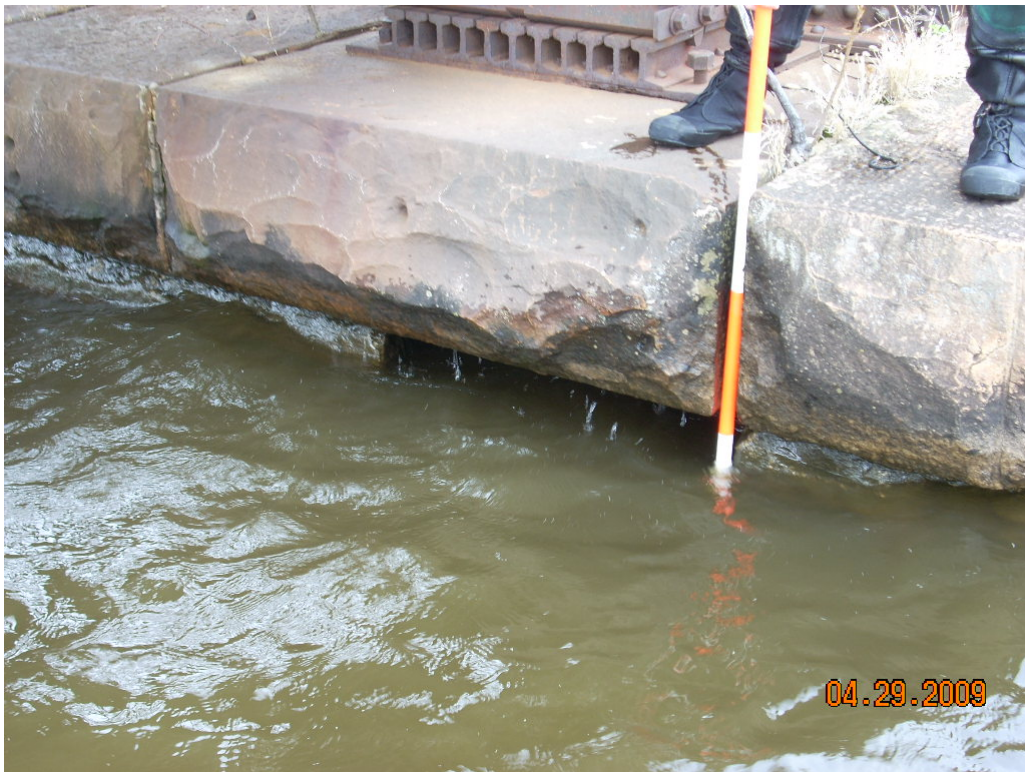
Pier 2 at south (DS) bearing has a missing block on the west face at the waterline

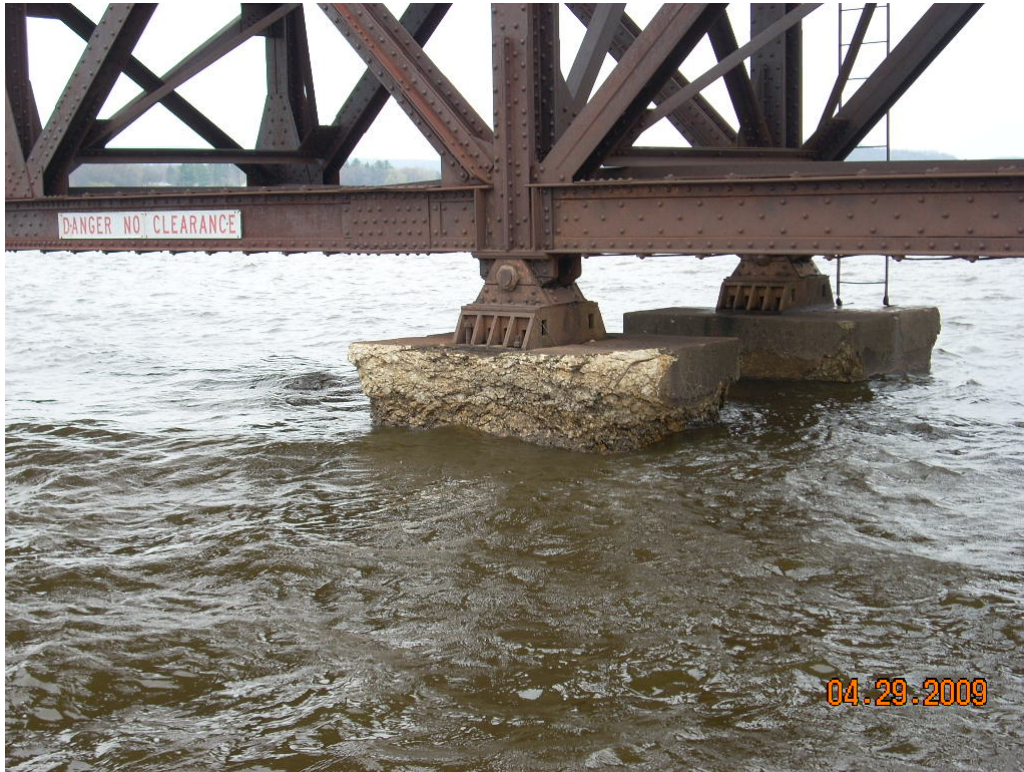
Pier 3 south (DS) bearing pedestal has spalling with exposed steel at the SE corner

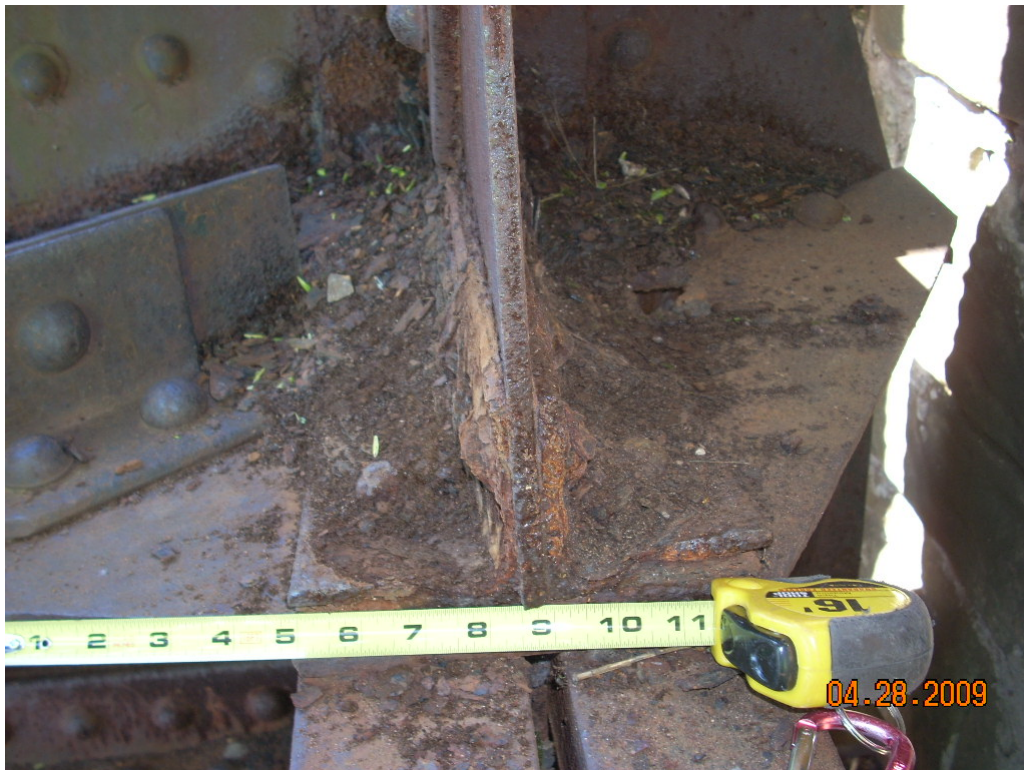
Abutment 23 has up to 50% section loss of angles on horizontal gusset plate above SW Bearing

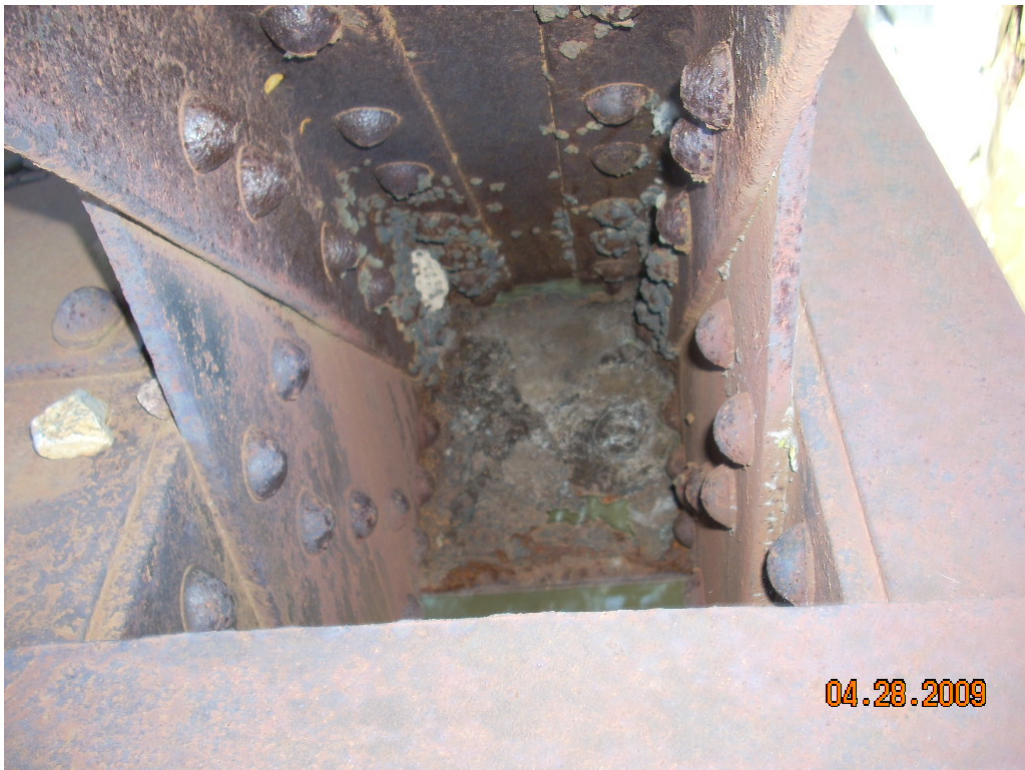
Span U batten plate at L7 on bottom of North Lower Chord has a hole

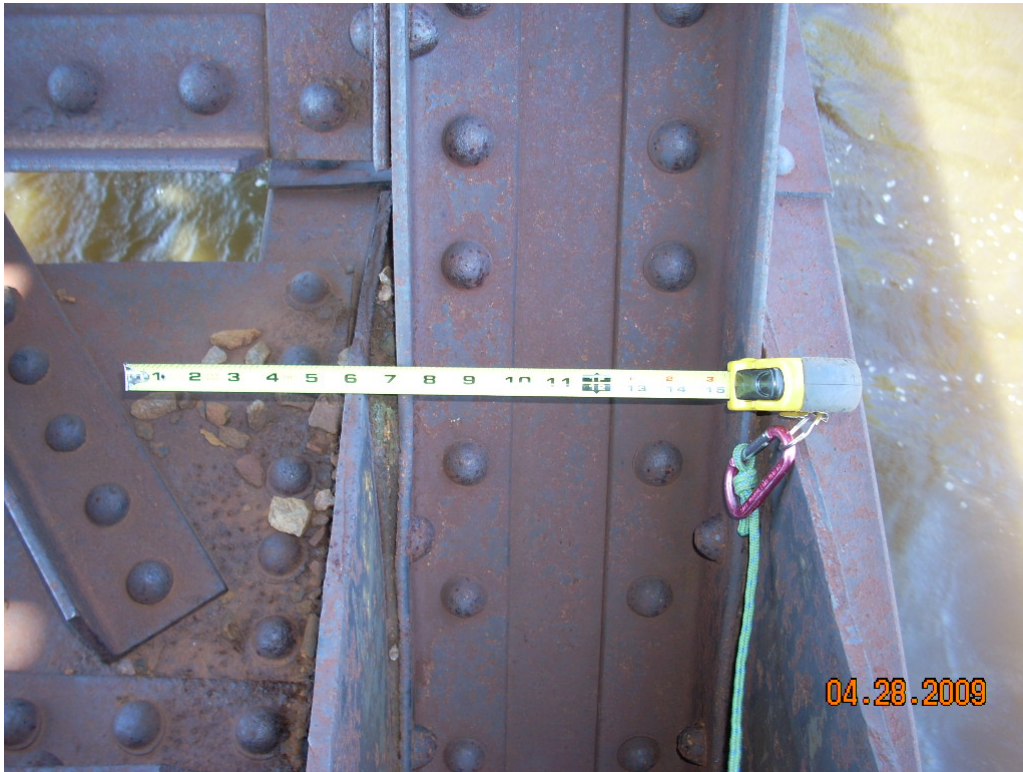
Overall, the deck truss elements are in good condition where the members typically have minor surface corrosion without section loss. A couple of conditions were noted that were typical throughout the deck truss spans. The inside vertical gusset plates on top of the bottom chords attaching the end verticals and diagonals typically have pitting that is up to 25% of the thickness of the plate. Also, the lower transverse lateral bracing angles that span between lower panel points of the bottom chords have pack rust up to 1 inch between the angles.

rust is likely caused by the accumulation of dirt and debris that can hold moisture against the steel.

Typical pack rust up to 5/8 inch between diagonal and vertical gusset plate at lower chord

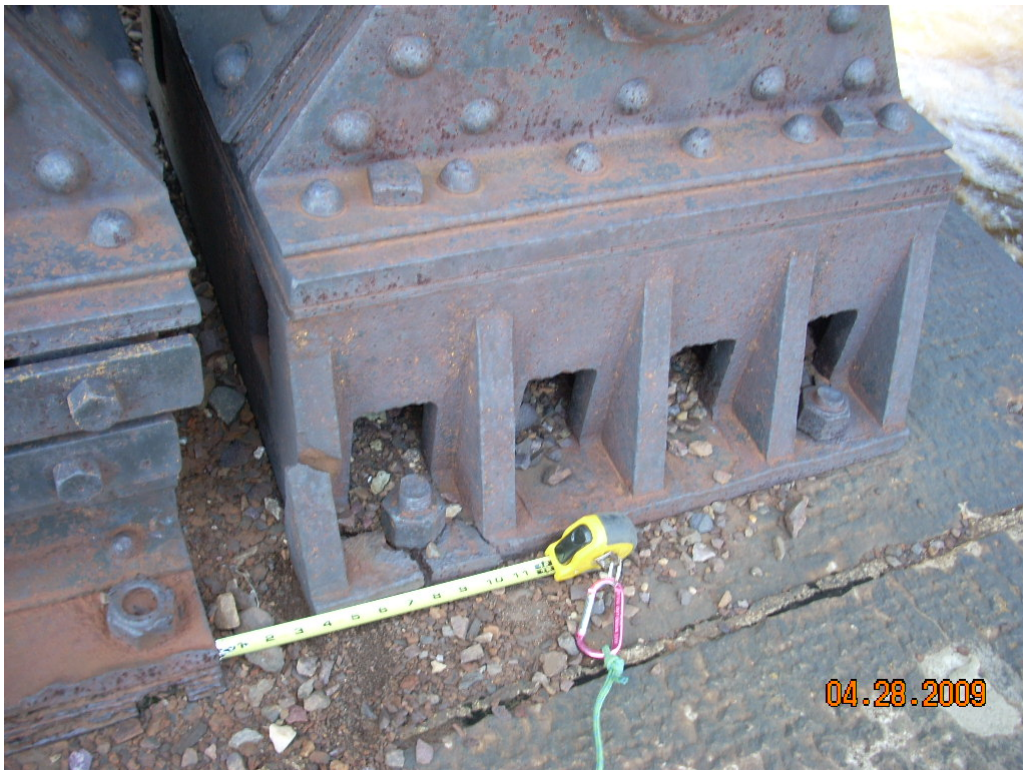
All bearings are in good condition having minor surface corrosion present except that the fixed bearing assembly for Span U on the north side at Pier 22 has a cracked bottom plate at the northeast bolt possibly due to fatigue or debris under the plate. Also, the truss span bearings typically have a minor accumulation of soil and debris.

Span U NE bearing at Pier 22 has a cracked bottom plate at NE bolt.

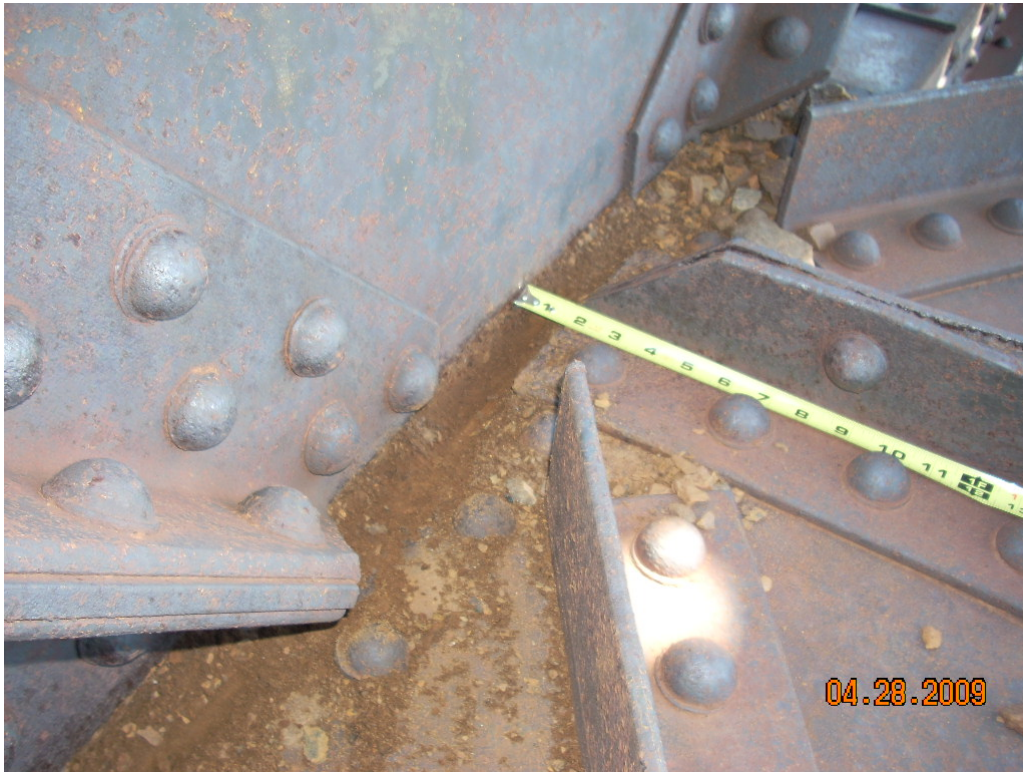
Typical pitting up to 25 percent of thickness of vertical gusset plate at lower chord connections where rock and soil are present

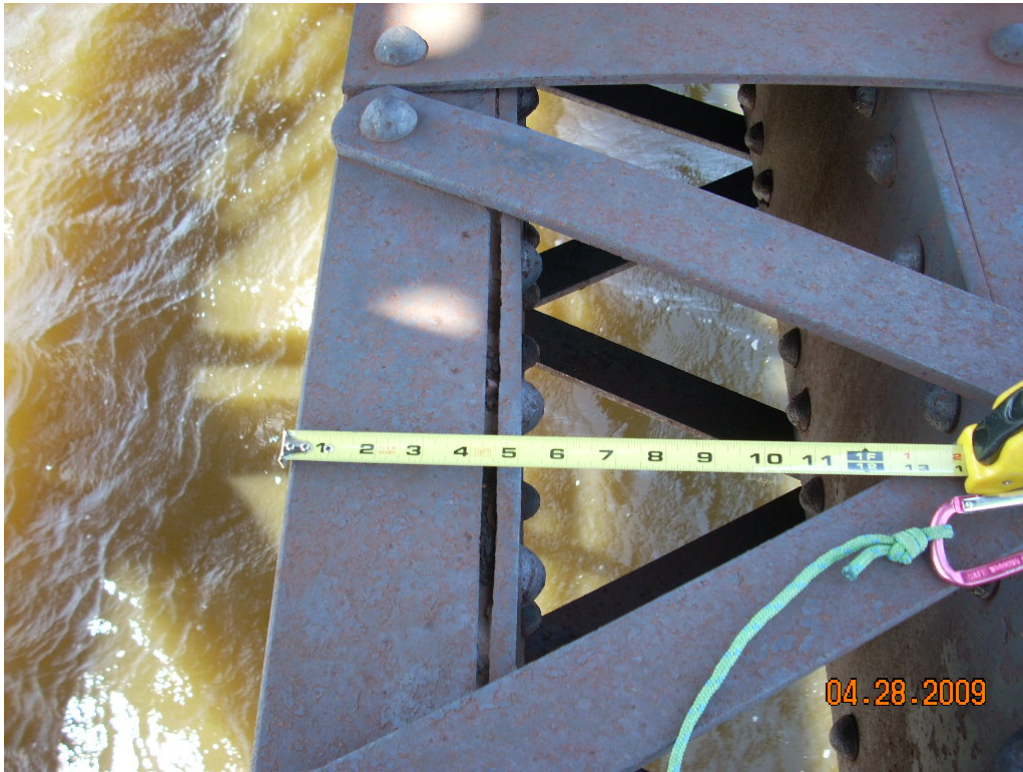
Span S North Lower Chord in 4th bay west of Pier 20 has pack rust up to ¼ inch between the south top flange and south web plate

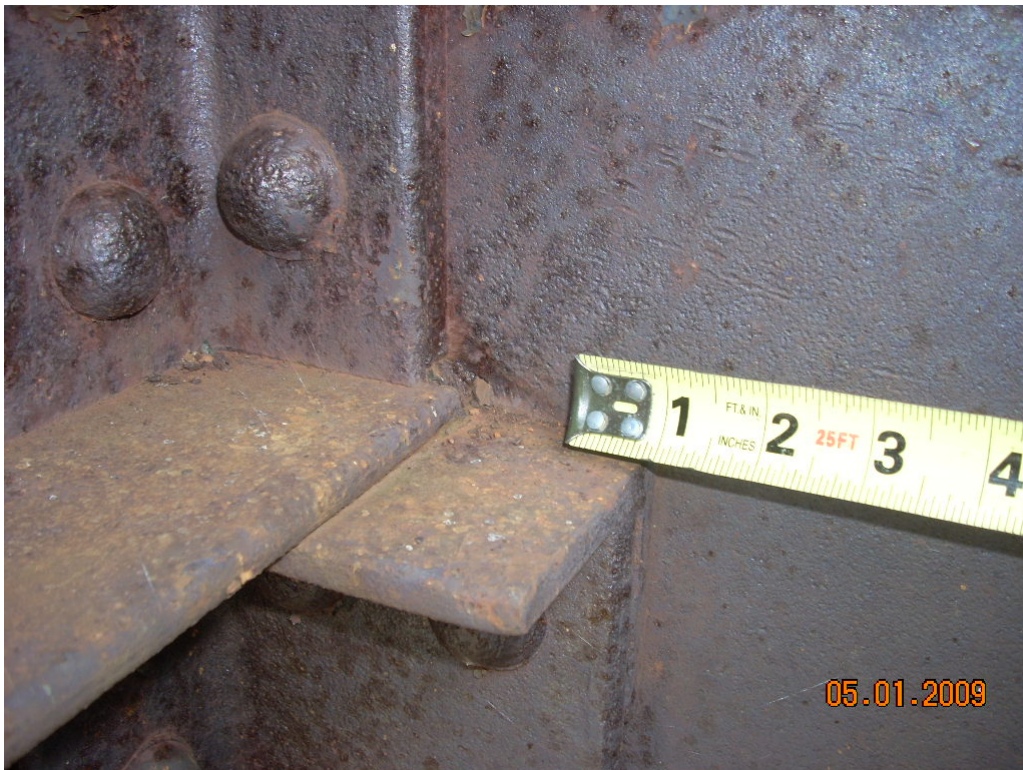
The conditions of the deck girder span elements are generally in good condition throughout where the members typically have minor surface corrosion without section loss. The main girders were noted to have a small area of pitting up to 1/8" deep in the interior of the webs adjacent to the bottom flanges of the floor beams; however, no other significant deficiencies were located in the girders. The webs of the floor beams typically have small areas of section loss up to 1/8" deep adjacent to the stringer supports. The section loss is up to 1/4" deep for the

Typical pitting up to ¼ inch deep and 1 inch tall by 3 inches wide in FB web at stringer shelf plate in Spans D through M
