# Hemlock Dam Feasibility Study

## Hemlock Dam, Sauk County, Wisconsin

**June 2019**

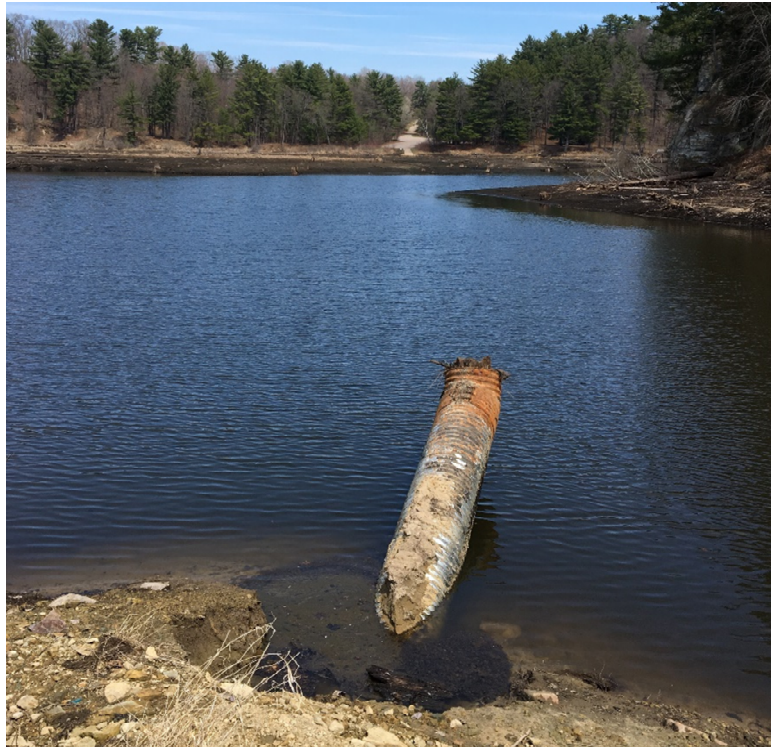
Photograph 2 upstream pipe

The Hemlock dam as shown in photos above was damaged by the 2018 flooding of the Baraboo River. The spillway pipe is an over 50 year old corrugated metal pipe. This spillway pipe was both damaged in the flood or from subsequent ice loading and corrugated metal pipe life expectancy is typically less than 50 years. The spillway for the dam either needs to be replaced or the dam removed. The following sections evaluate options for removal and repair.

Two alternatives were considered to upgrade the spillway. Alternative 1 is replacement of the existing whistle tube with a similarly designed concrete whistle tube system. Alternative 2 is replacement of the whistle tube with a drop inlet structure.

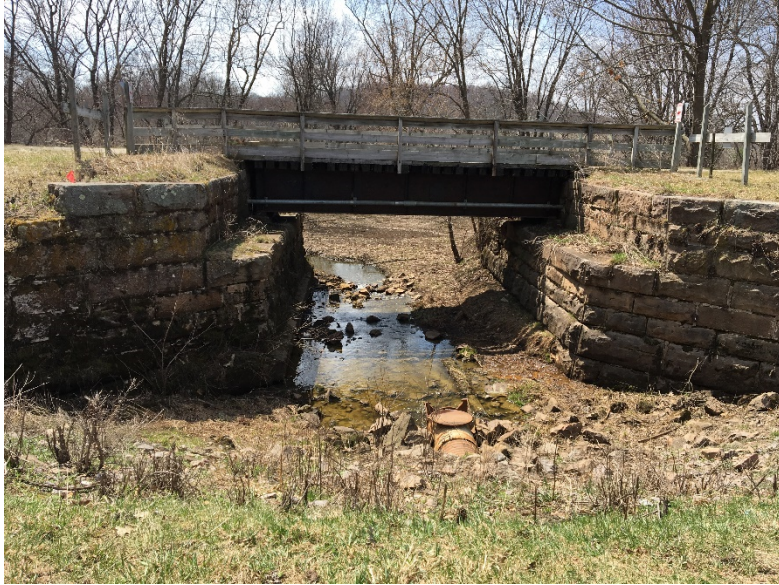
Photograph 3 downstream spillway

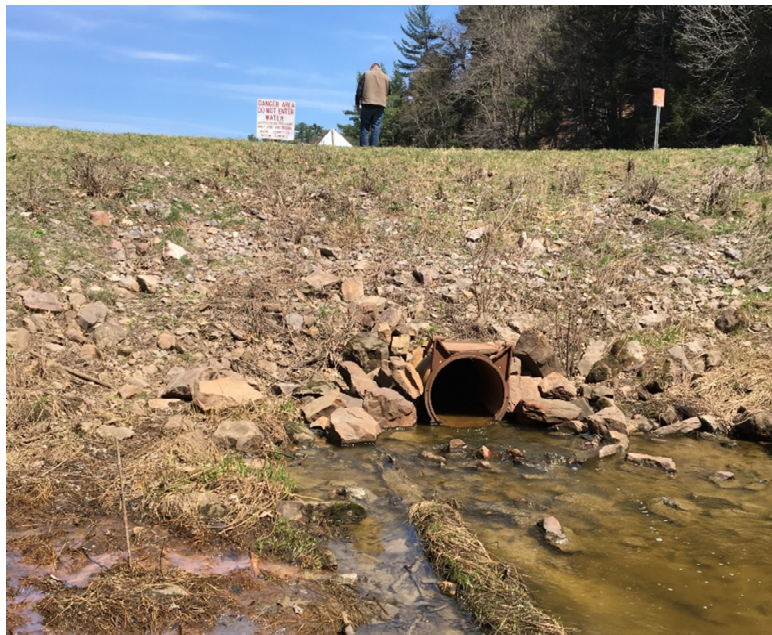
Photograph 4 downstream pipe

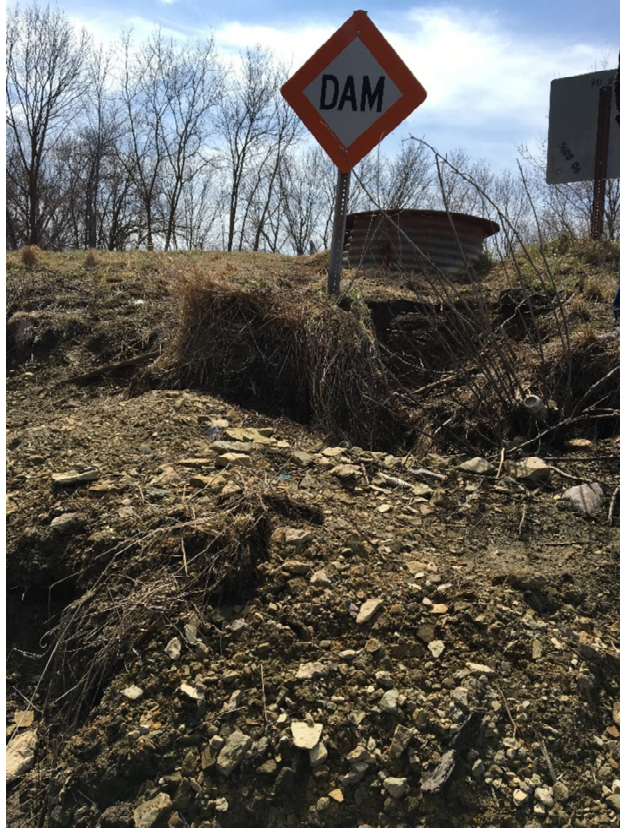
In 2018 a flood on the Baraboo River overtopped the Hemlock dam from the downstream side. This flood caused erosion and damage to the upstream embankment. As a result the County removed the stoplogs from the whistle tube spillway and the lake is currently drawdown.

Photograph 5 upstream damaged embankment

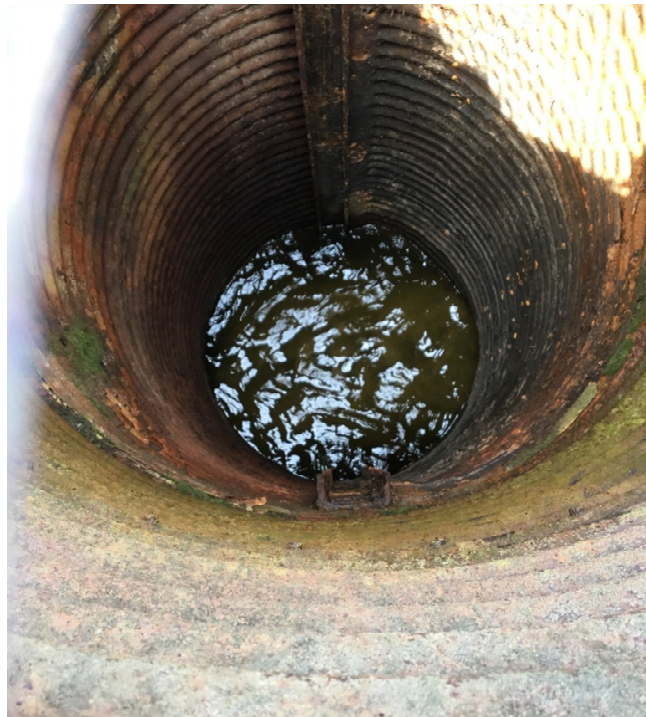
Photograph 6 Drop Inlet Structure

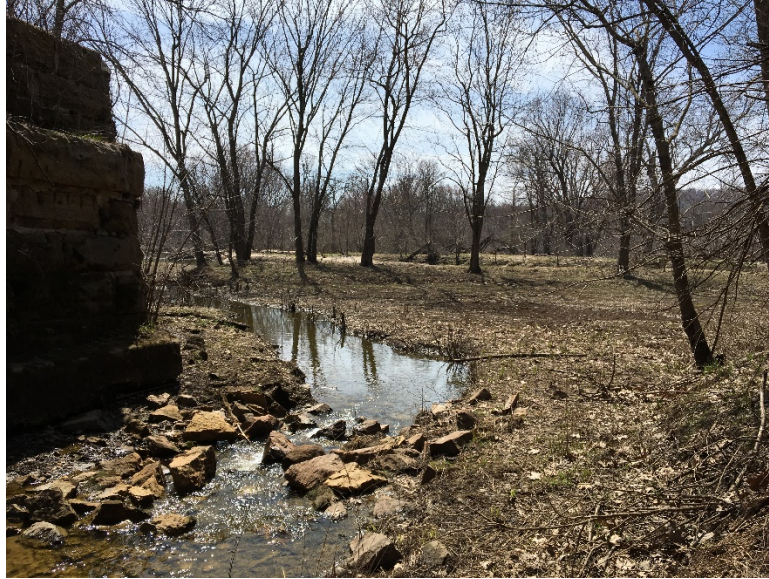
Photograph 7 Down stream looking towards the Baraboo River
