Hemlock Dam Feasibility Study

Hemlock Dam, Sauk County, Wisconsin

June 2019

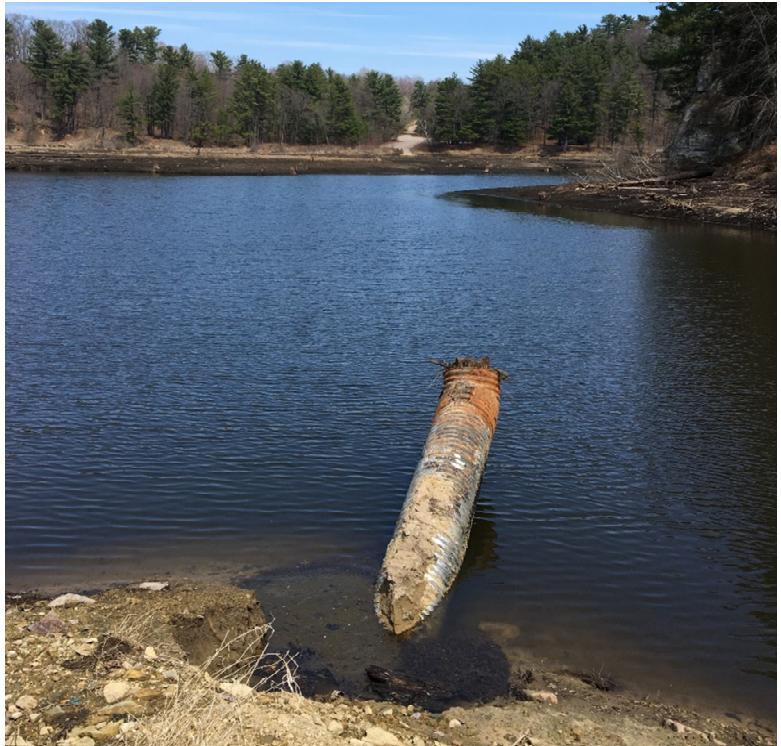
Photograph 2 upstream pipe

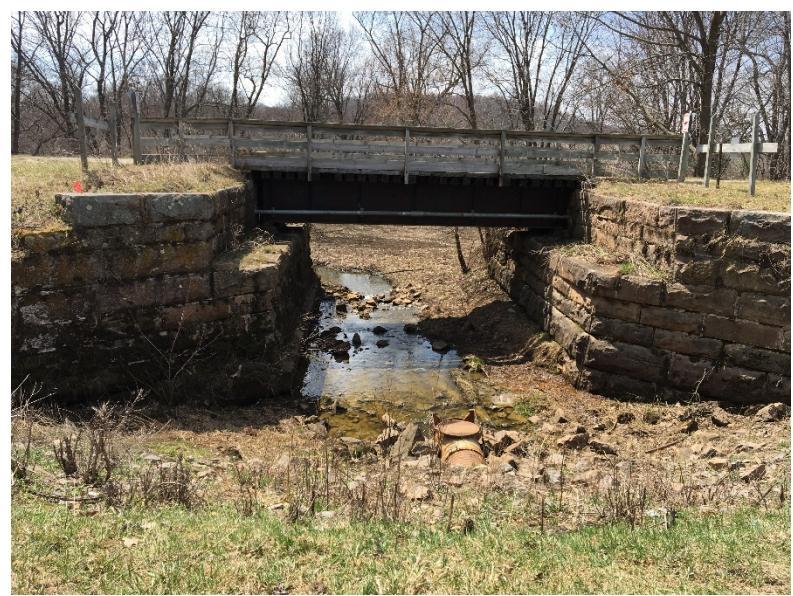
Photograph 3 downstream spillway

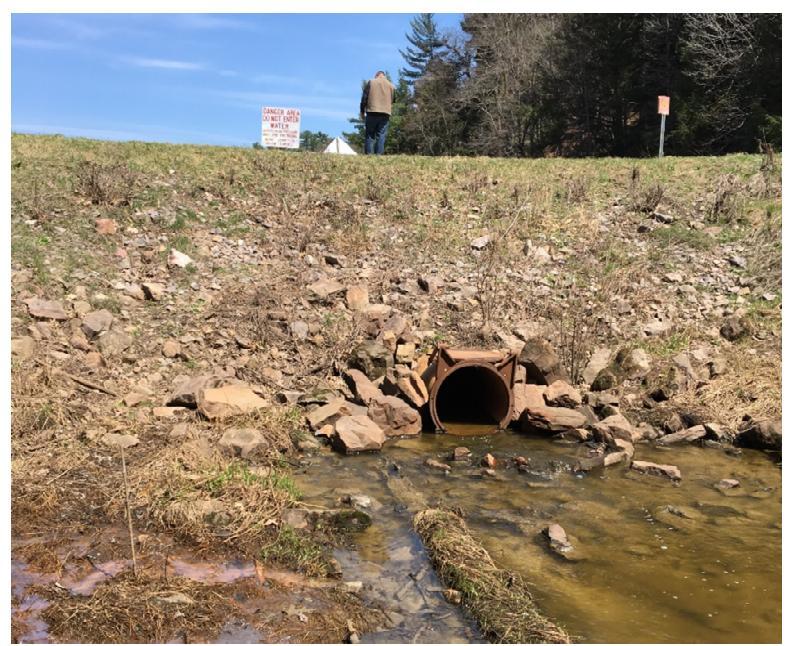
Photograph 4 downstream pipe

The Hemlock dam as shown in photos above was damaged by the 2018 flooding of the Baraboo River. The spillway pipe is an over 50 year old corrugated metal pipe. This spillway pipe was both damaged in the flood or from subsequent ice loading and corrugated metal pipe life expectancy is typically less than 50 years. The spillway for the dam either needs to be replaced or the dam removed. The following sections evaluate options for removal and repair.

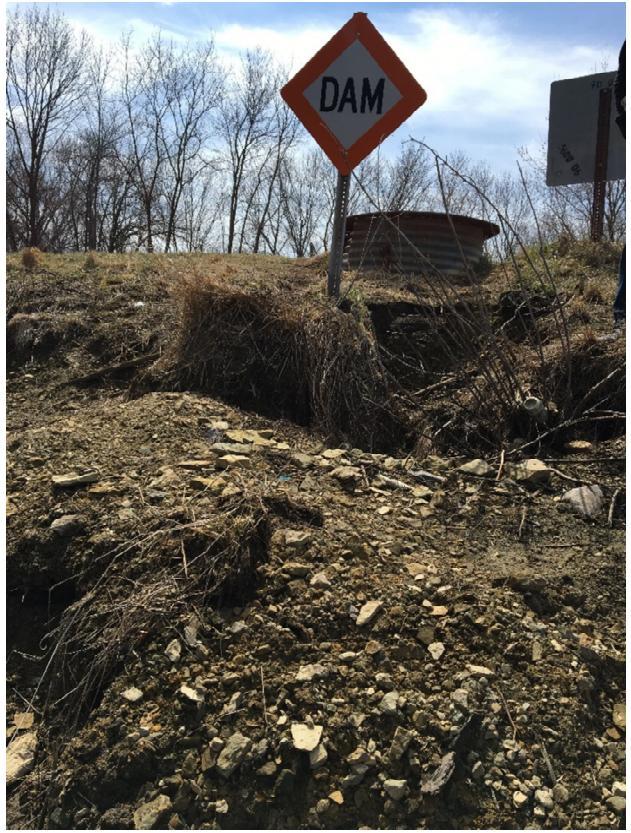
In 2018 a flood on the Baraboo River overtopped the Hemlock dam from the downstream side. This flood caused erosion and damage to the upstream embankment. As a result the County removed the stoplogs from the whistle tube spillway and the lake is currently drawdown.

Photograph 5 upstream damaged embankment

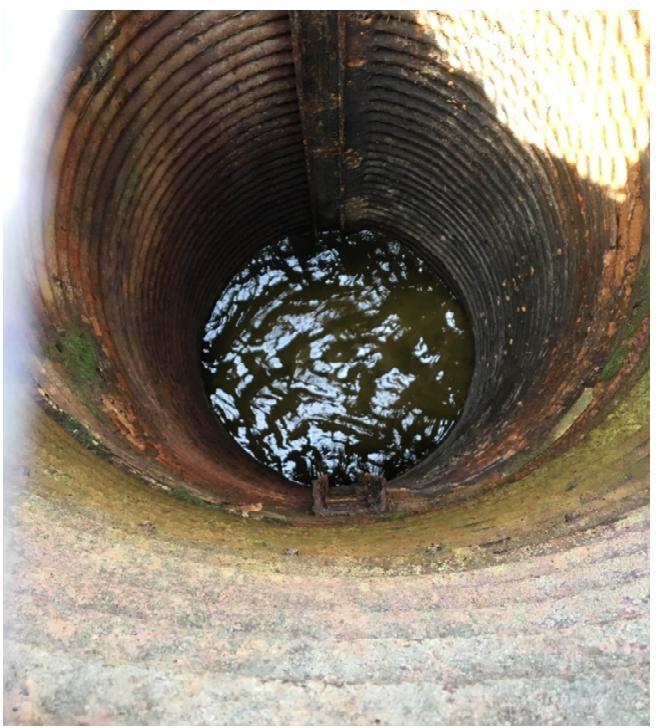
Photograph 6 Drop Inlet Structure

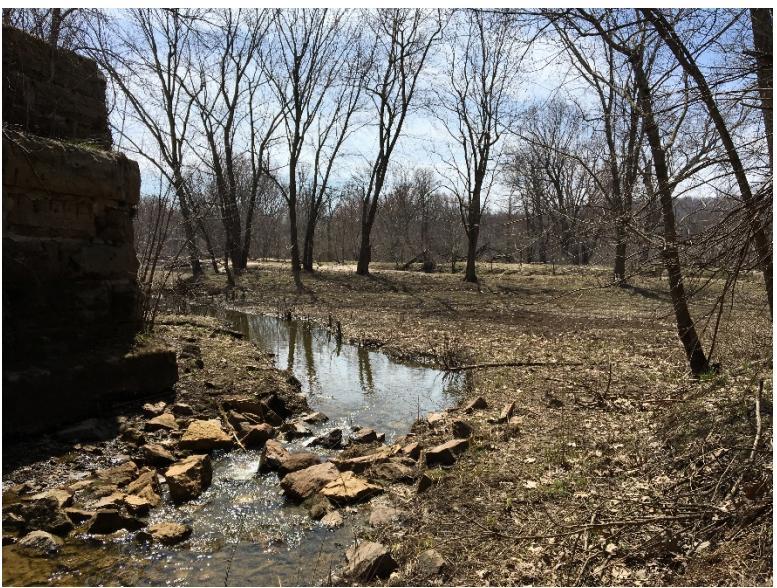
Photograph 7 Down stream looking towards the Baraboo River
