# Flooding Conditions at Clark Creek and Possible Mitigation

September 2008

# FLOODING CONDITIONS AT CLARK CREEK AND POSSIBLE MITIGATION

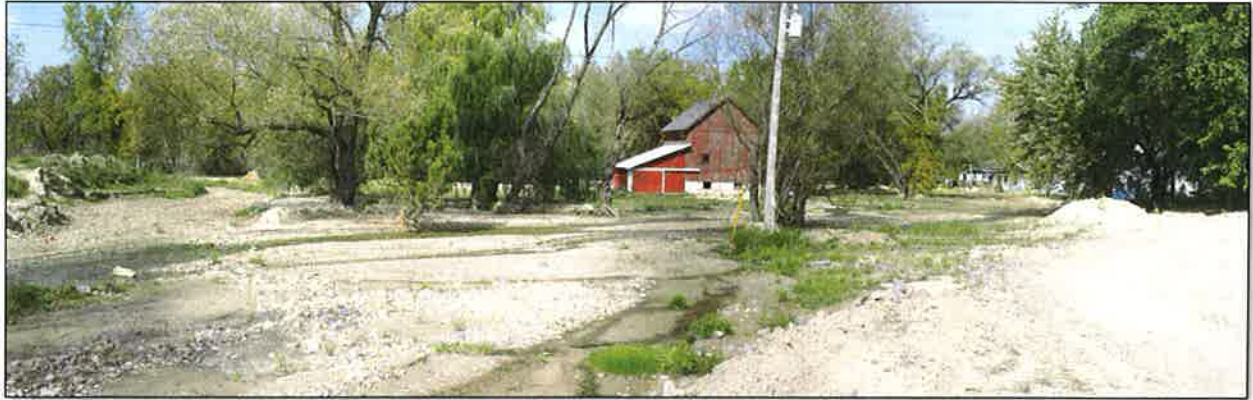
Figure 2

1. An **upper reach** of the drainage basin which is relatively flat and contains wetlands;
2. A **middle reach** which cuts through unconsolidated glacial deposits; and
3. A **lower reach**, where most stream-side development is located. The depositional landscape flattens as Clark Creek approaches the Baraboo River. Photographs taken after the most recent storm events reveal typical alluvial fan activity at the confluence (Figure 2).

Clark Creek near confluence with Baraboo River.

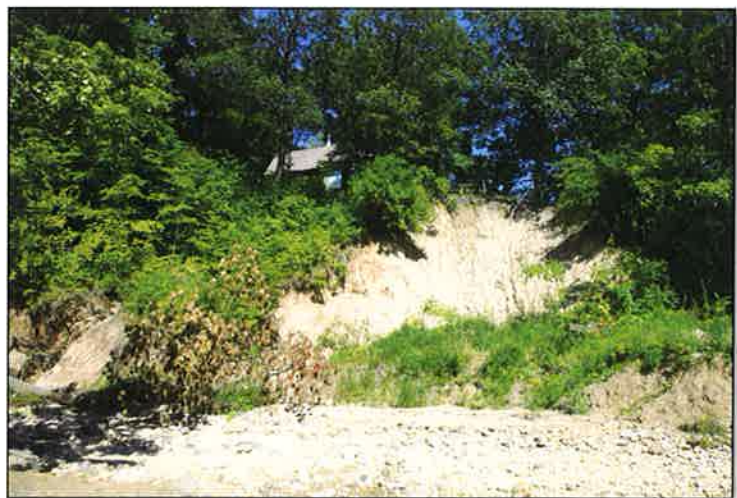
Figure 5

Approximately 60 buildings (residential / non-residential) along Clark Creek are at risk from flooding or bank collapse (PhotoAppendix). Most of the structures at risk from flooding are located within two miles of the Clark Creek – Baraboo River confluence (Figures 3 and 4). At least one residential structure is at risk from bank collapse (Figure 5).

House near sandy bluff in Clark Creek channel.

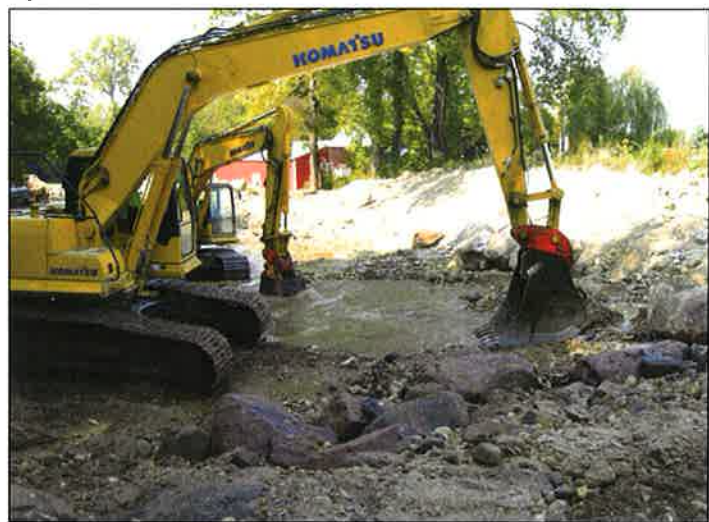
Figure 6

Construction of desiltation basin in Clark Creek Channel.

Catchment basins are designed to collect water borne sediment before it is deposited over wide areas downstream. They must, of course, be cleaned of deposited sediment on a regular basis. The Wisconsin Department of Natural Resources has begun a re-channelization project, in the lower reach by the Maxwell Farm, which includes the construction of several catchment basins (Figures 4 and 6).

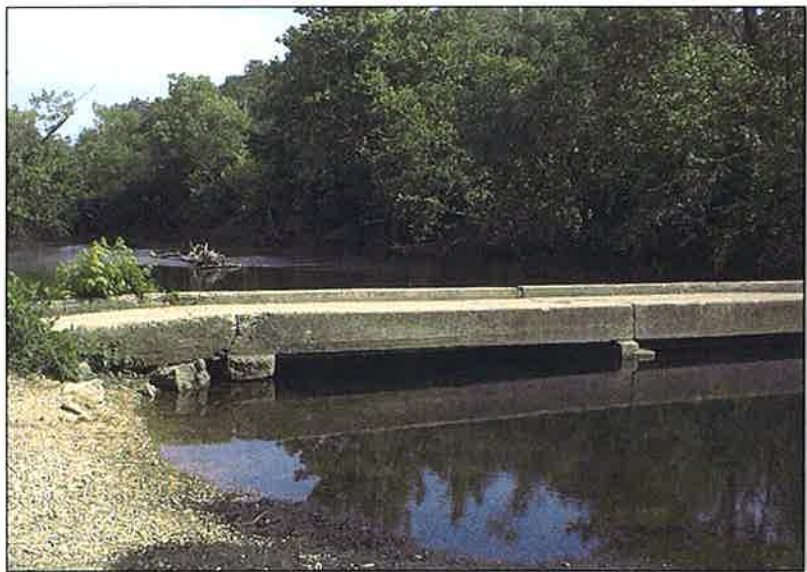
Figure 7

Low water crossing.

A "Low Water Crossing" is a depression in the roadway that will accommodate the high volume of water flooding events like those experienced during this past event (Figure 7). This proposal would require replacing the existing culverts with a culvert or bridge, properly designed to accommodate the 35-year annual storm event as determined by the Wisconsin Department of Transportation. These new crossings can handle the water flow from the lesser events. However, during the exceptional periods, the water flows over the roadway. This designed overtopping allows much of the debris carried by the flood waters to cross the roadway without blocking the flow of the water. The limitations for these crossings are the fact that during these high flow periods, the road is impassable until the flood waters subside.

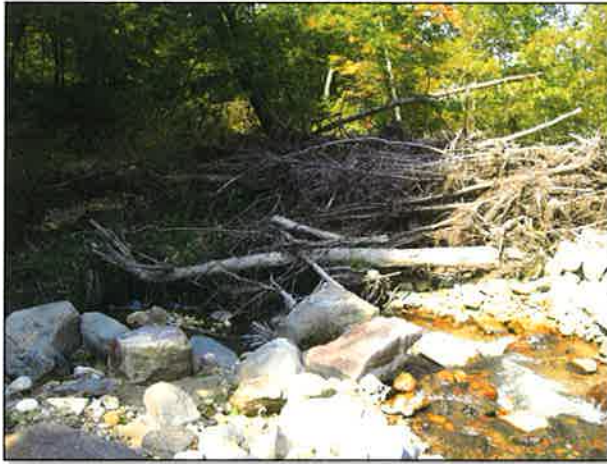
Figure 8

Debris pile in the middle reach of Clark Creek.

reaches of Clark Creek may be one of the few cost-effective options. One possibility includes the use of a skidder or similar piece of logging equipment with a chipper. In this manner, the volume of woody debris can be reduced in place and not have to be transported out of the area (Figures 8 and 9).

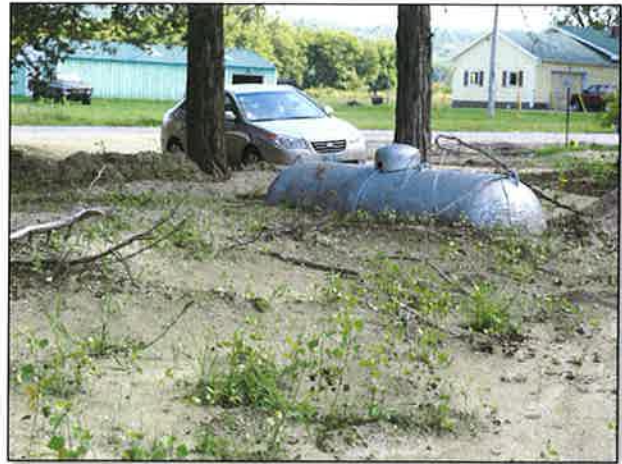
Figure 9

Sediment deposition near Baraboo River confluence.

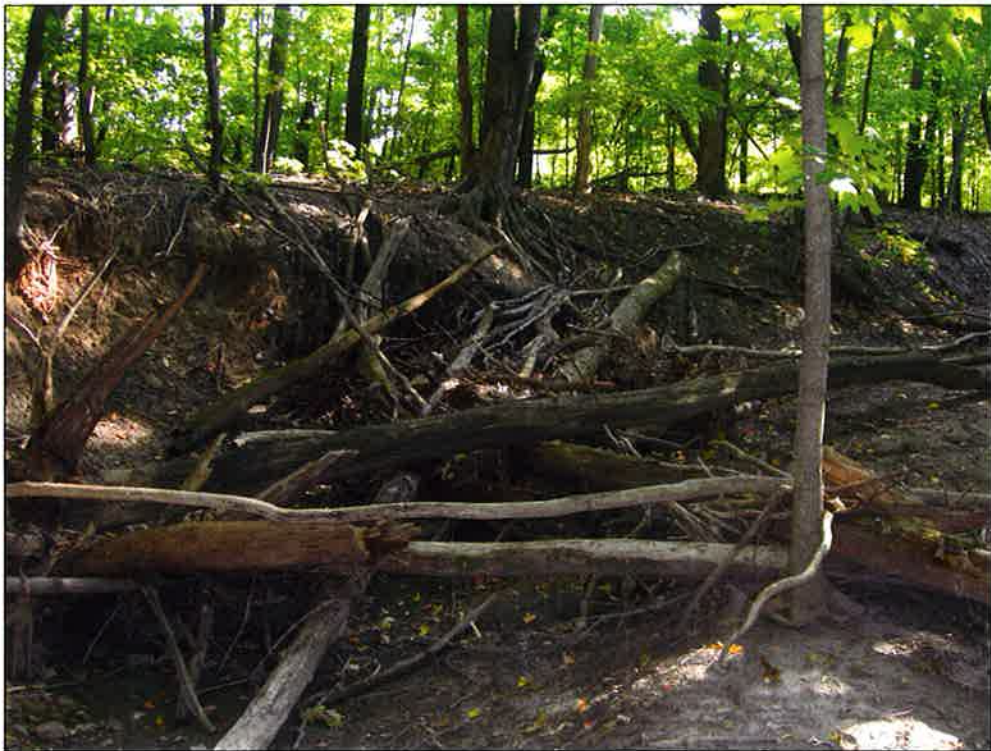
Debris pile in the channel of an intermittent reach of Clark Creek near Tower Road.

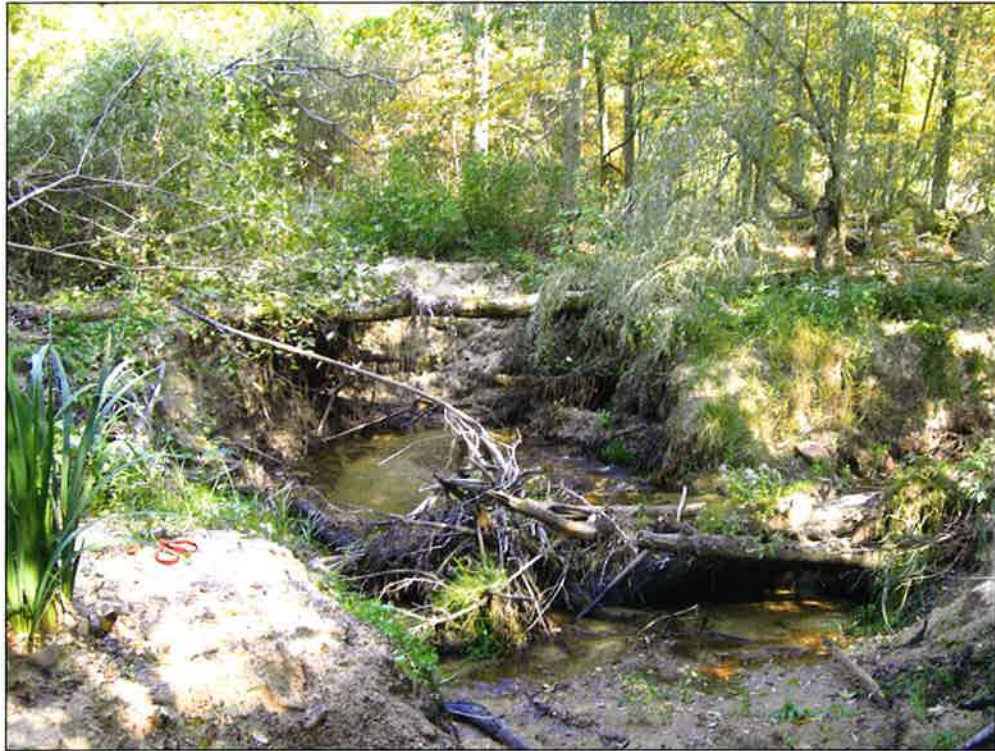
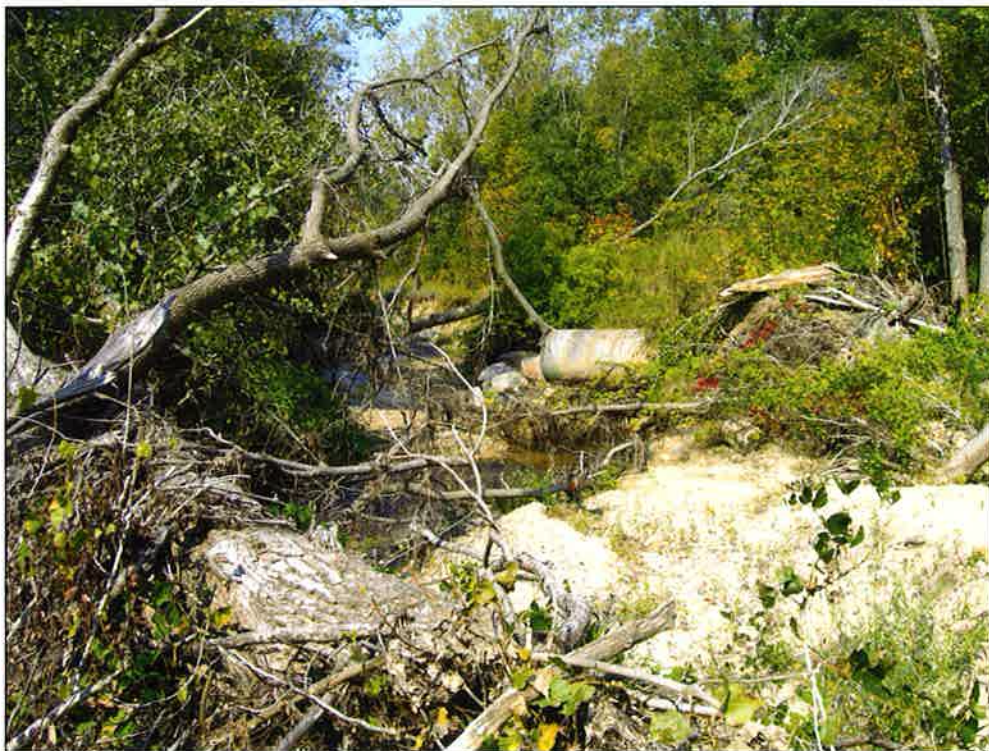
Debris pile and erosion in middle reach of Clark Creek.

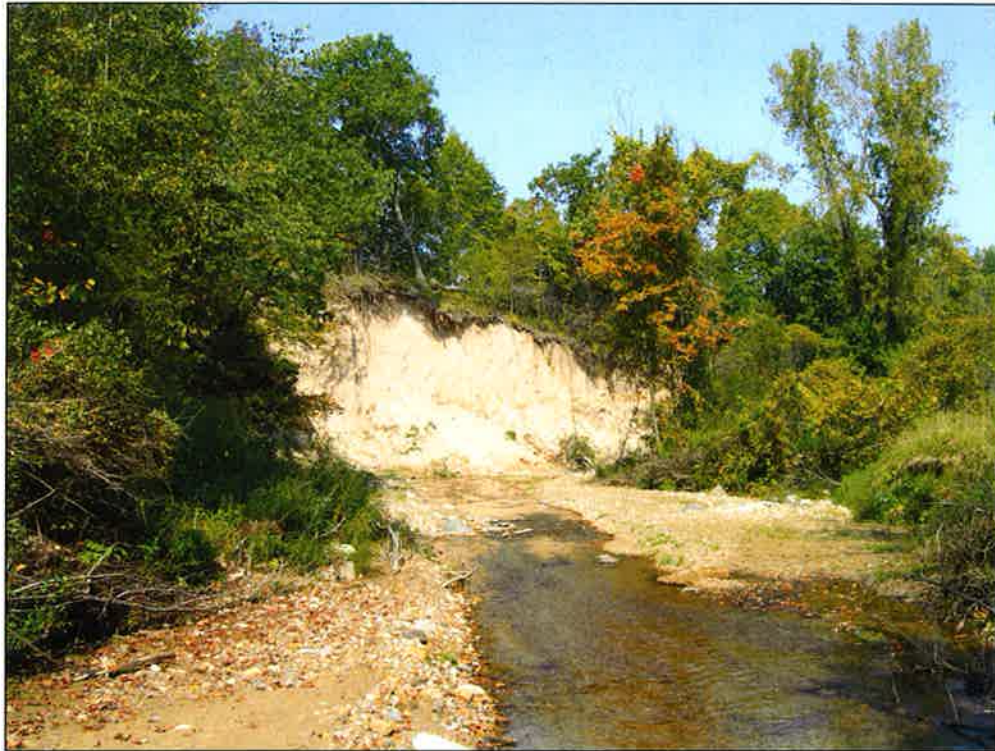
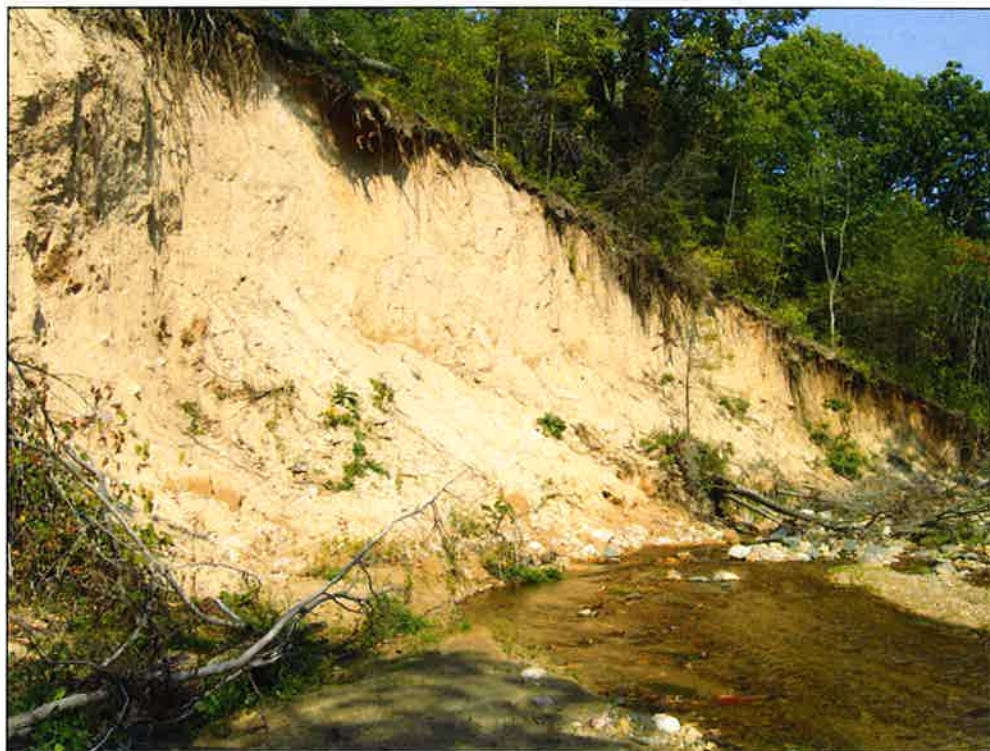
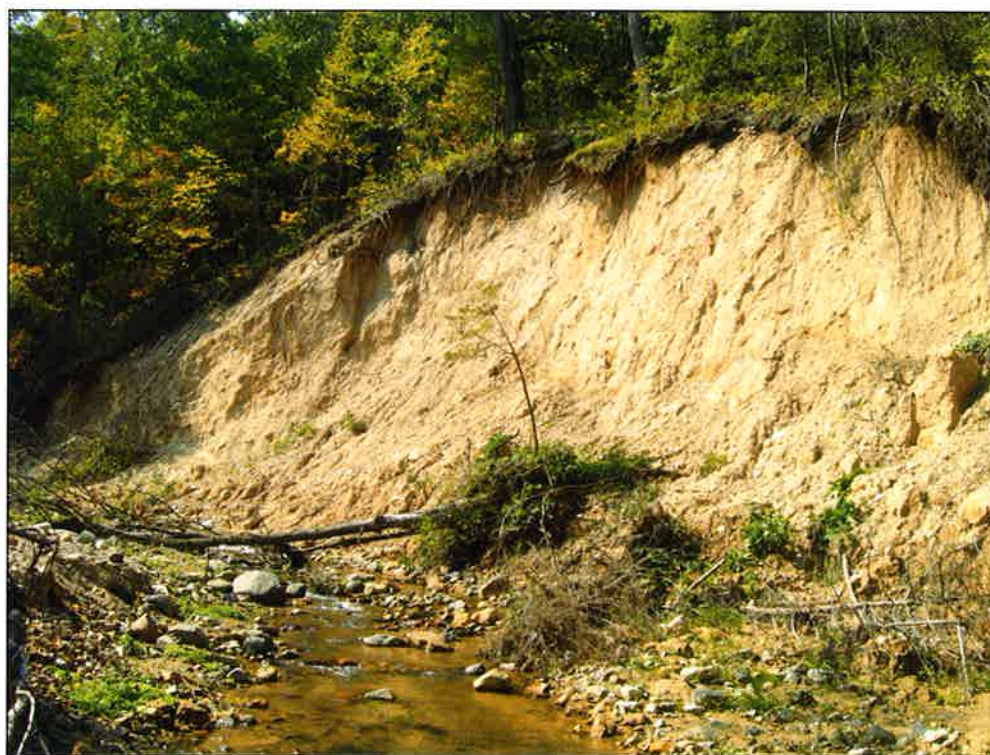
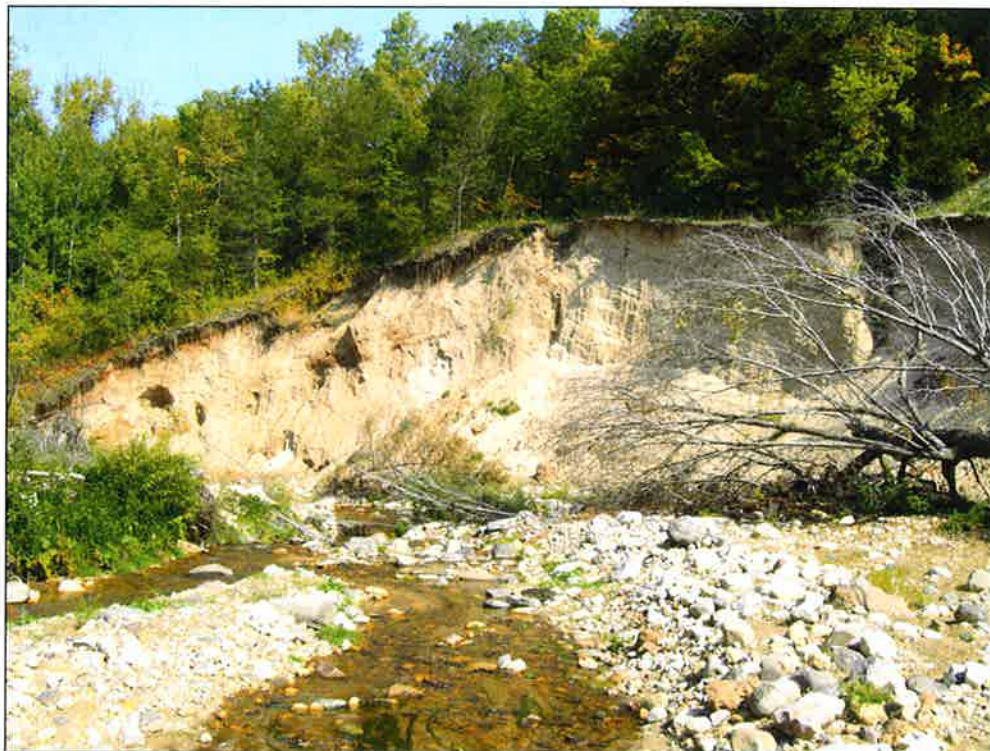
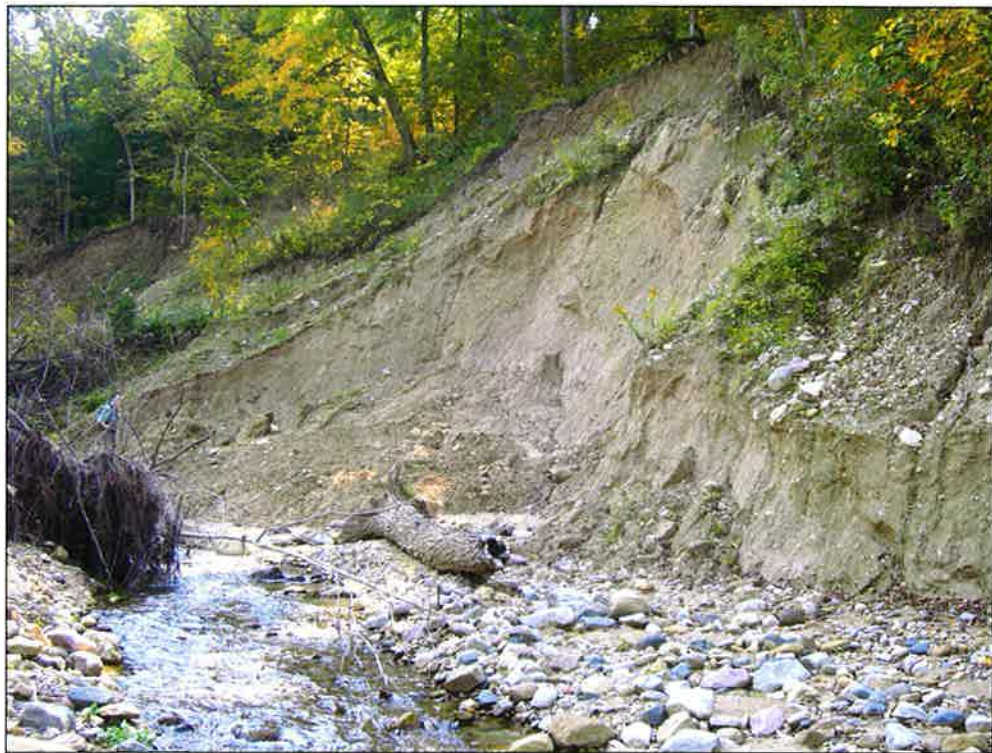
Sandy bluff in middle reach of Clark Creek.

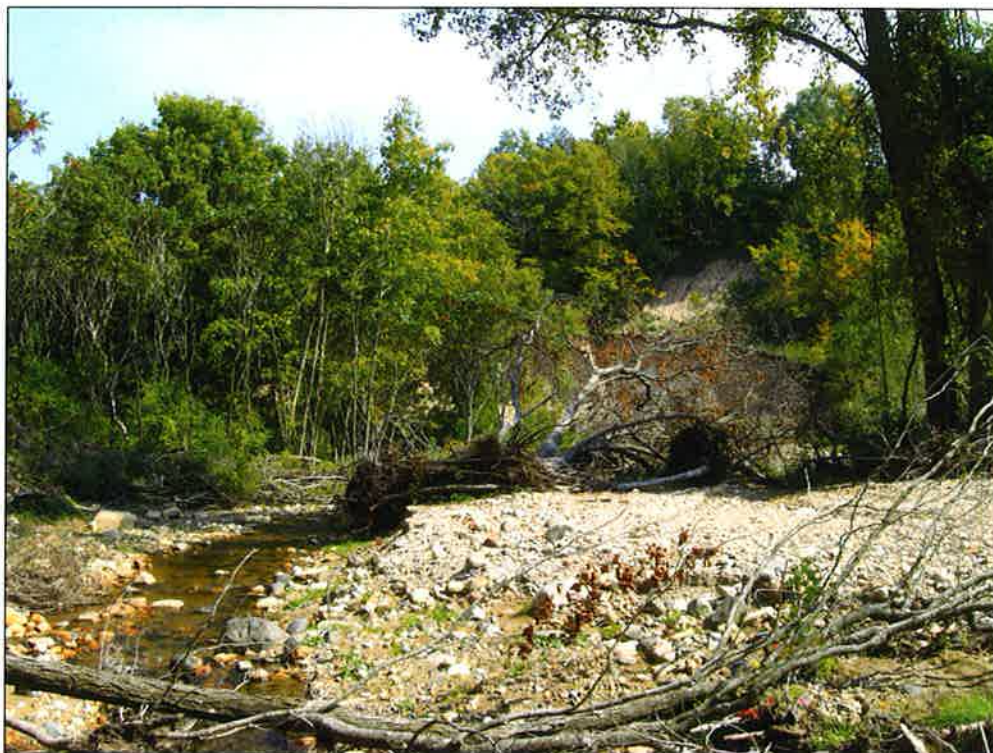
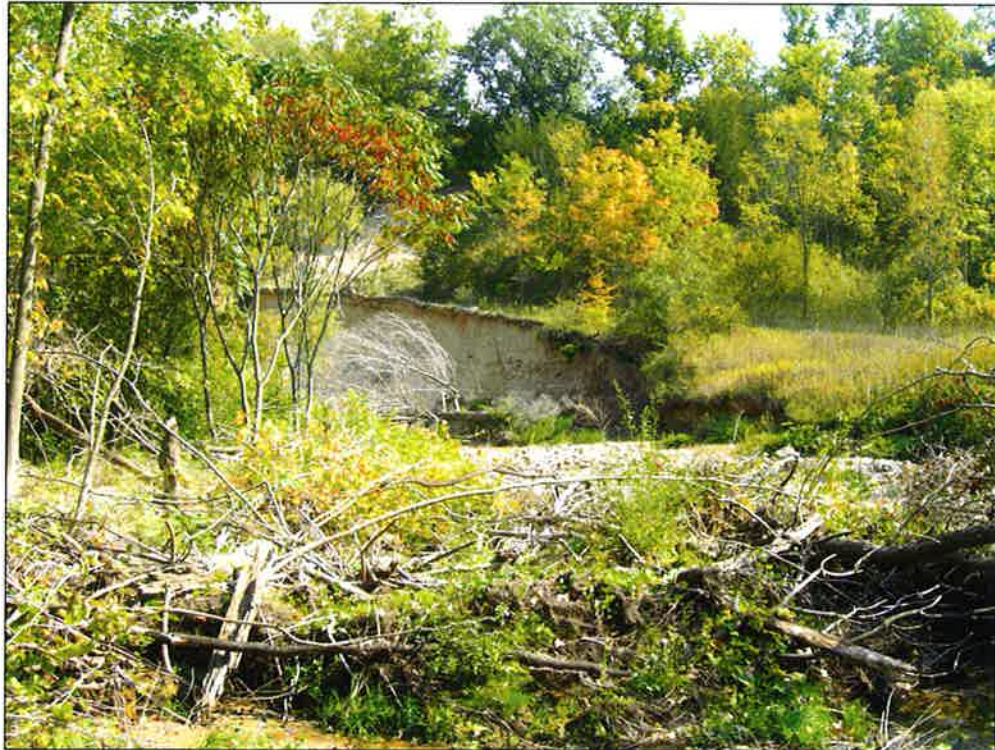
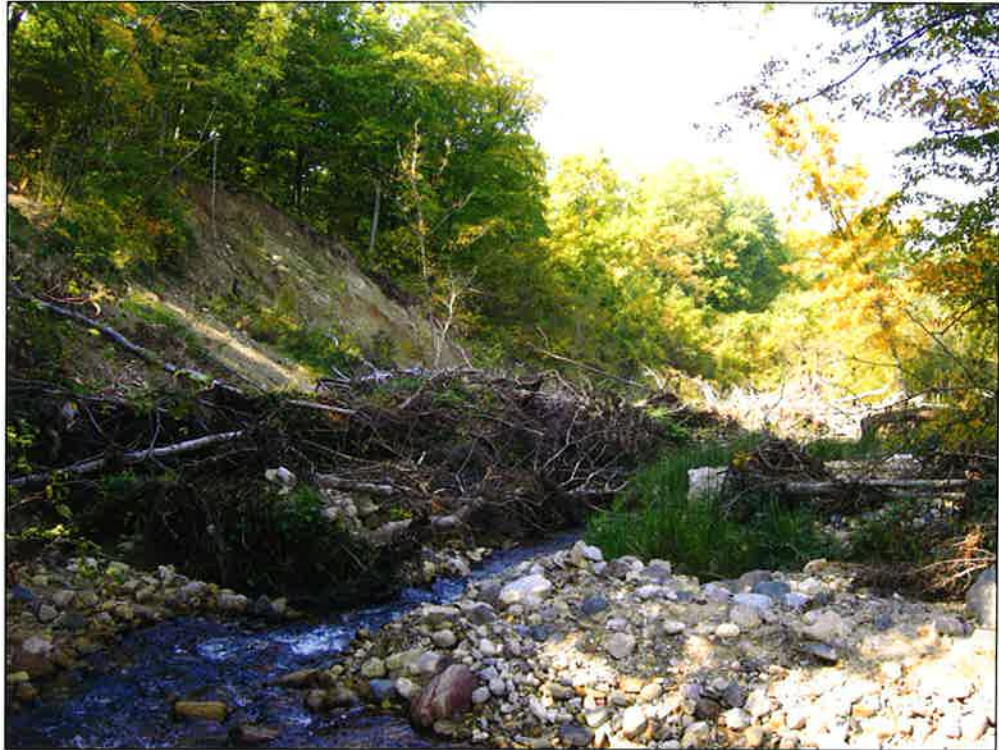
Sandy bluff and debris pile in middle reach of Clark Creek.

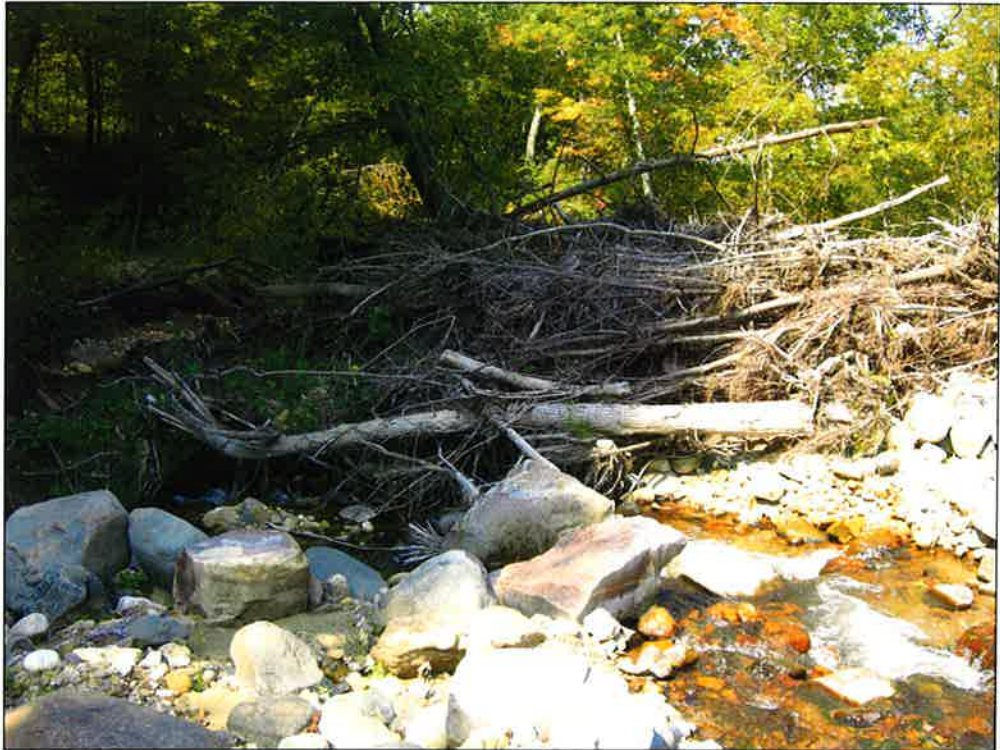
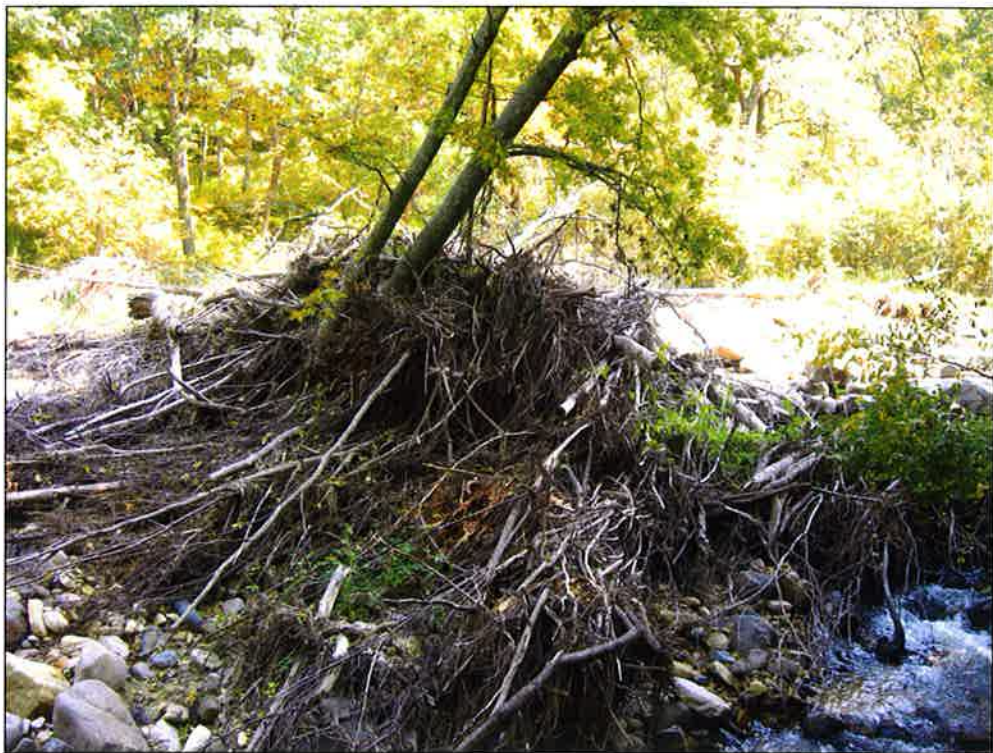
Debris pile in middle reach of Clark Creek.

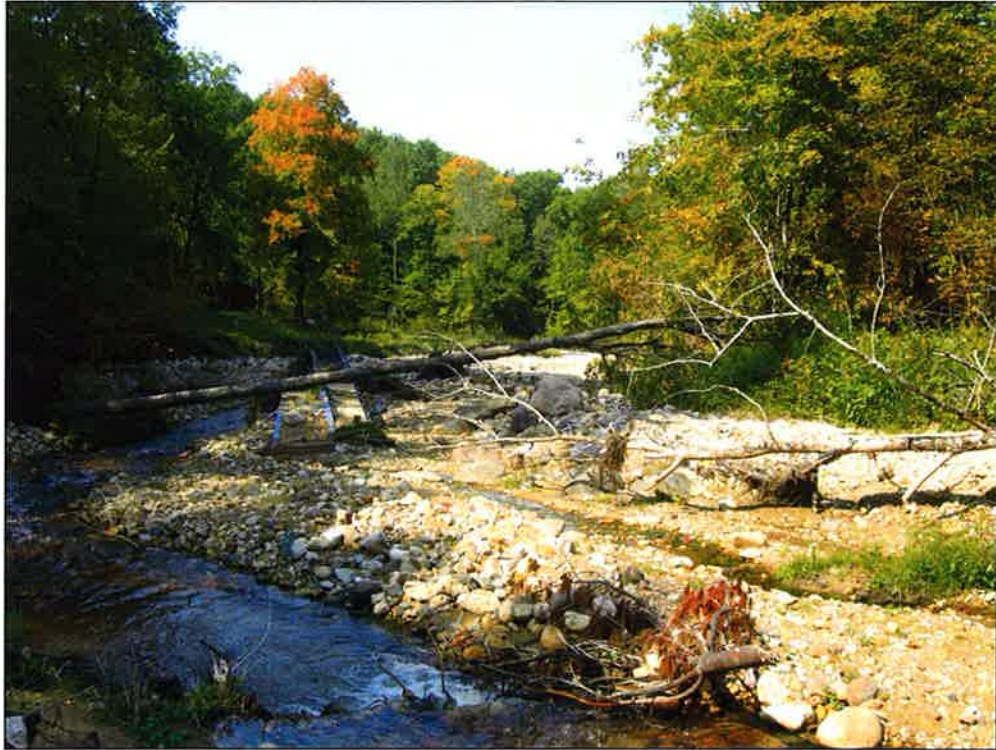
Flatbed trailer in middle reach of Clark Creek.

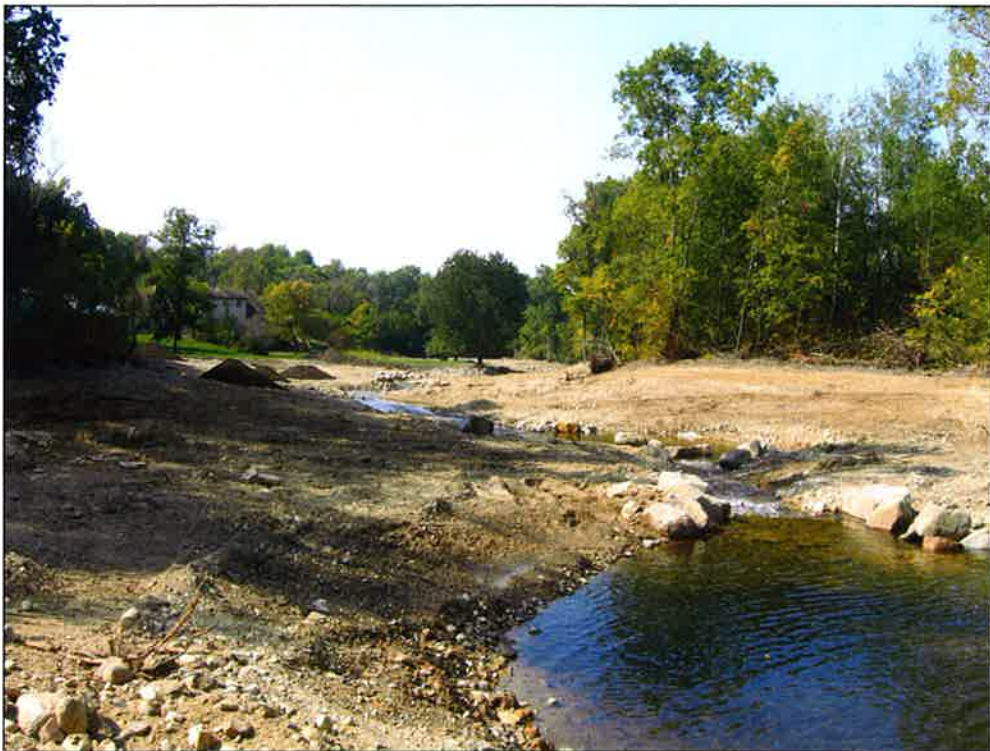
Desiltation basin at upstream extent of rechannelization of Clark Creek.

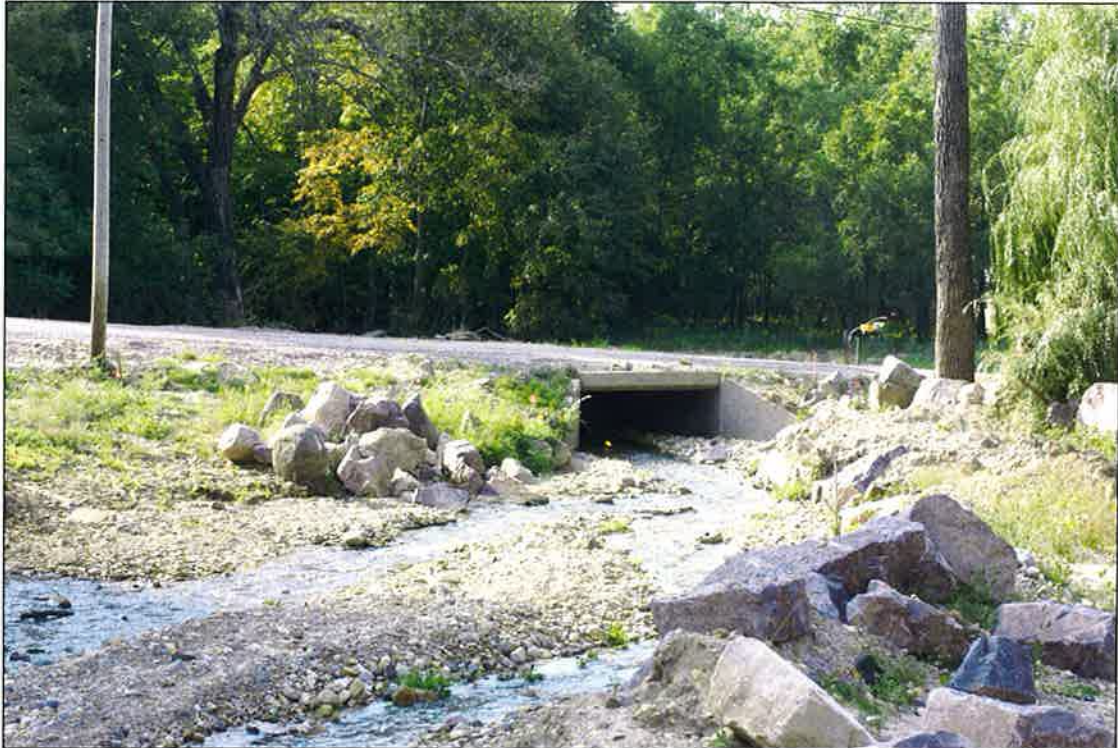
Misaligned Highway 113 box culvert near Maxwell Farm at downstream extent of rechannelization of Clark Creek.

Several culverts along Clark Creek should be realigned to conform to the present stream flow.

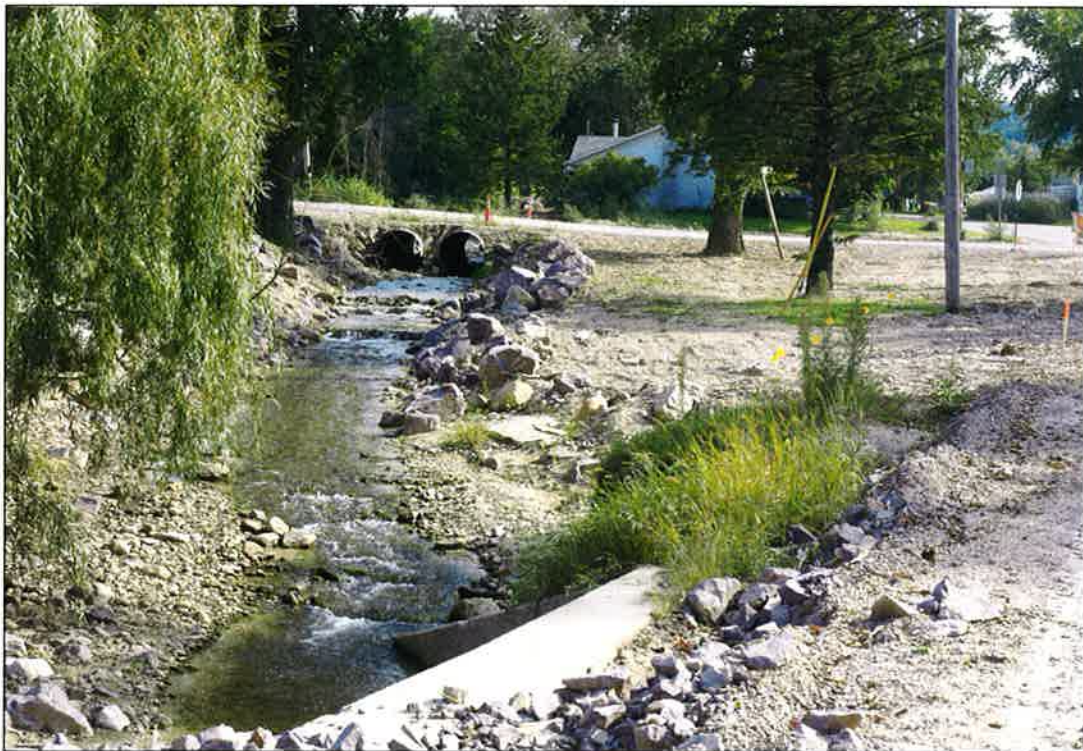
Misaligned Highway 113 box culvert in foreground and County Road W dual corrugated metal pipe culverts in background in lower reach of Clark Creek.
