Comprehensive Study

Merrimac Railroad Bridge No. 334

Wisconsin & Southern Railroad Company

January 2010

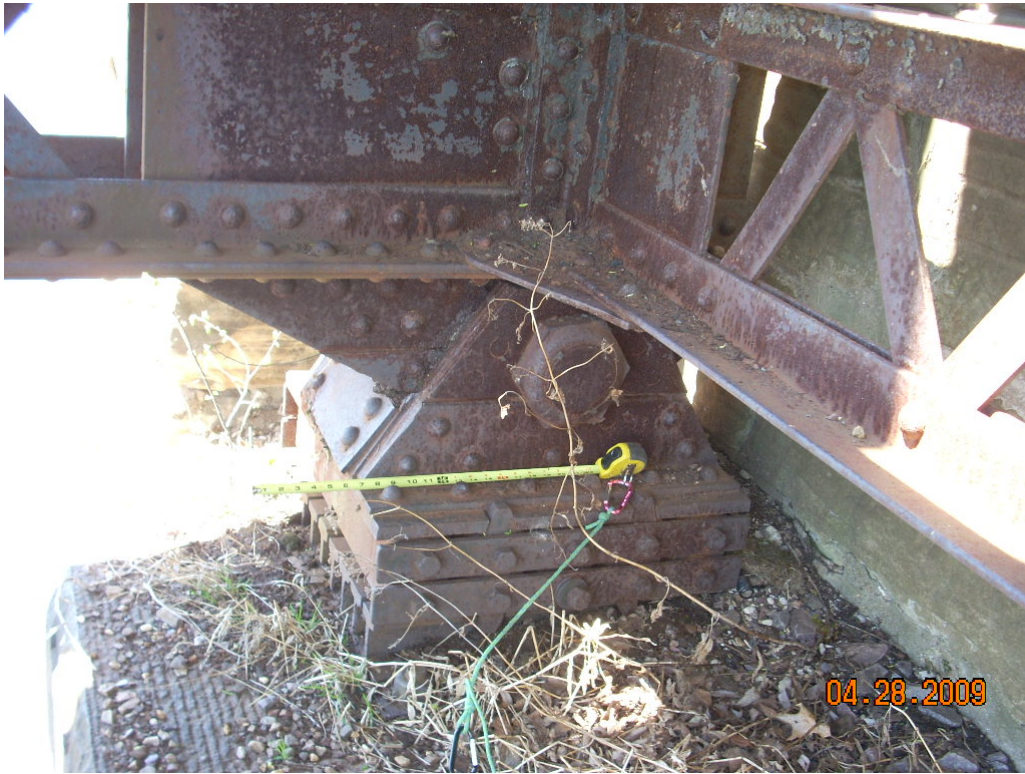
Typical bearing at Abutment 23 (West)

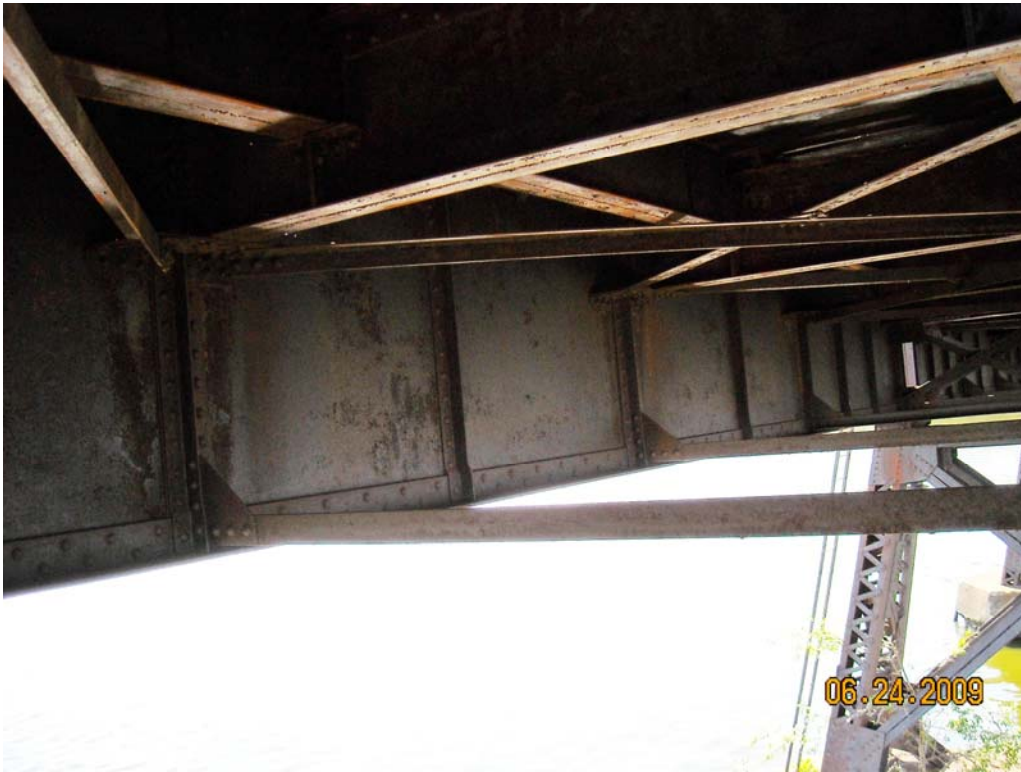
Typical Interior of Deck Girder

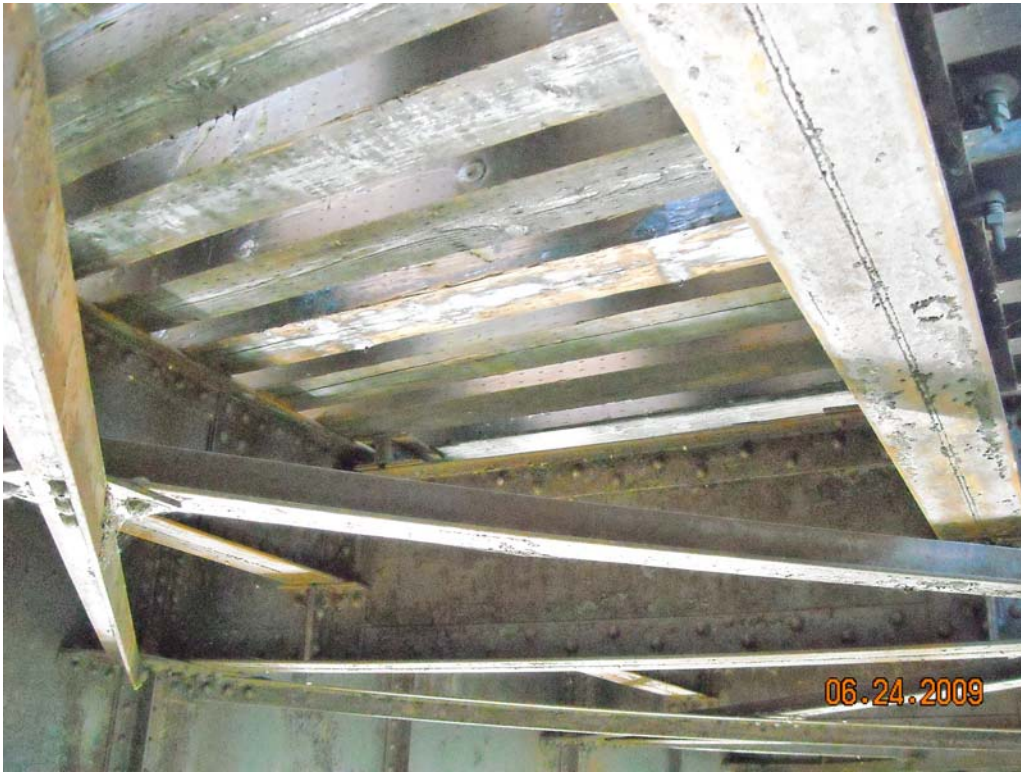
Typical Deck Underside

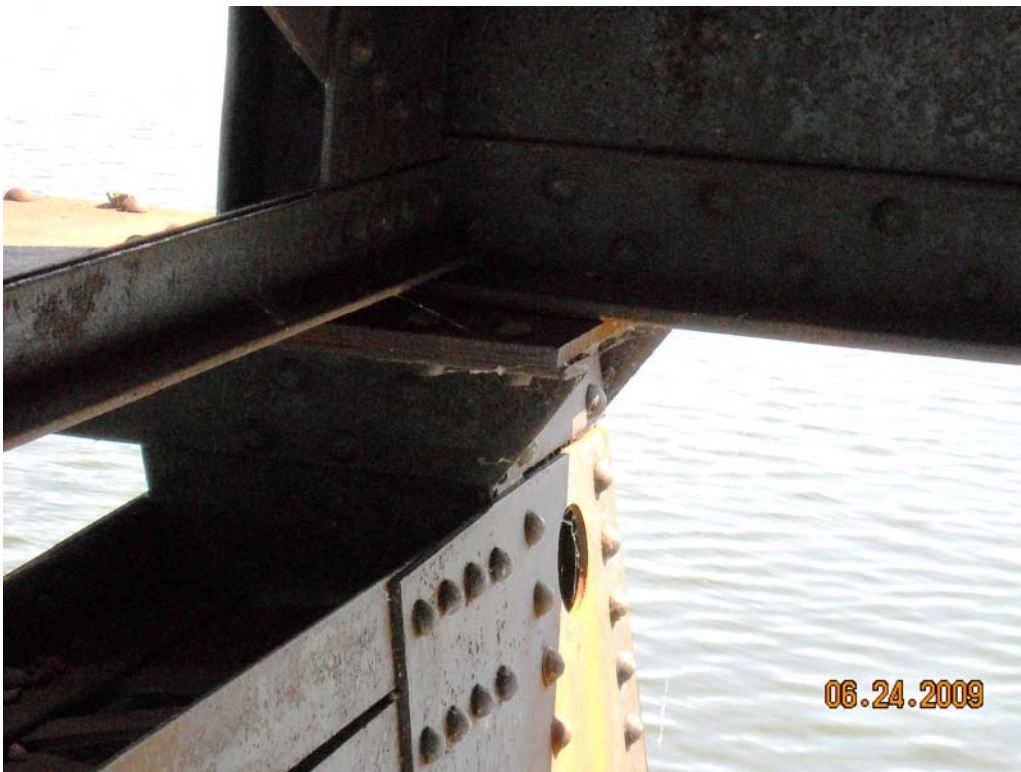
Typical Interior of Bearing

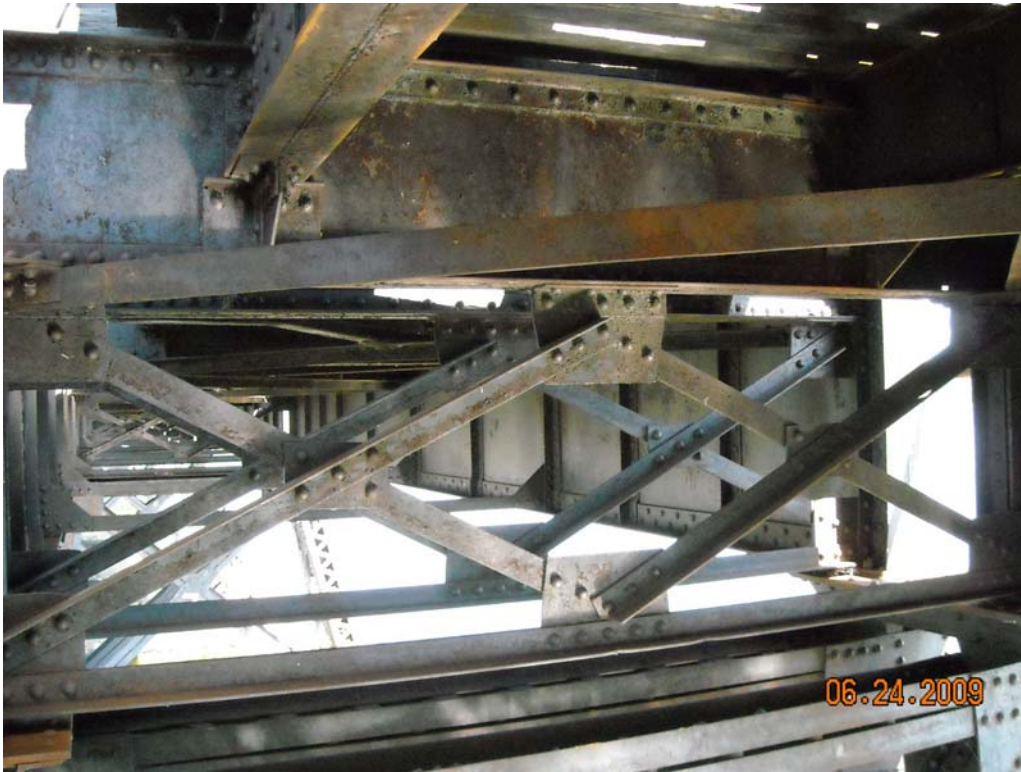
Typical Floor Beam and Cross Frame at Pier

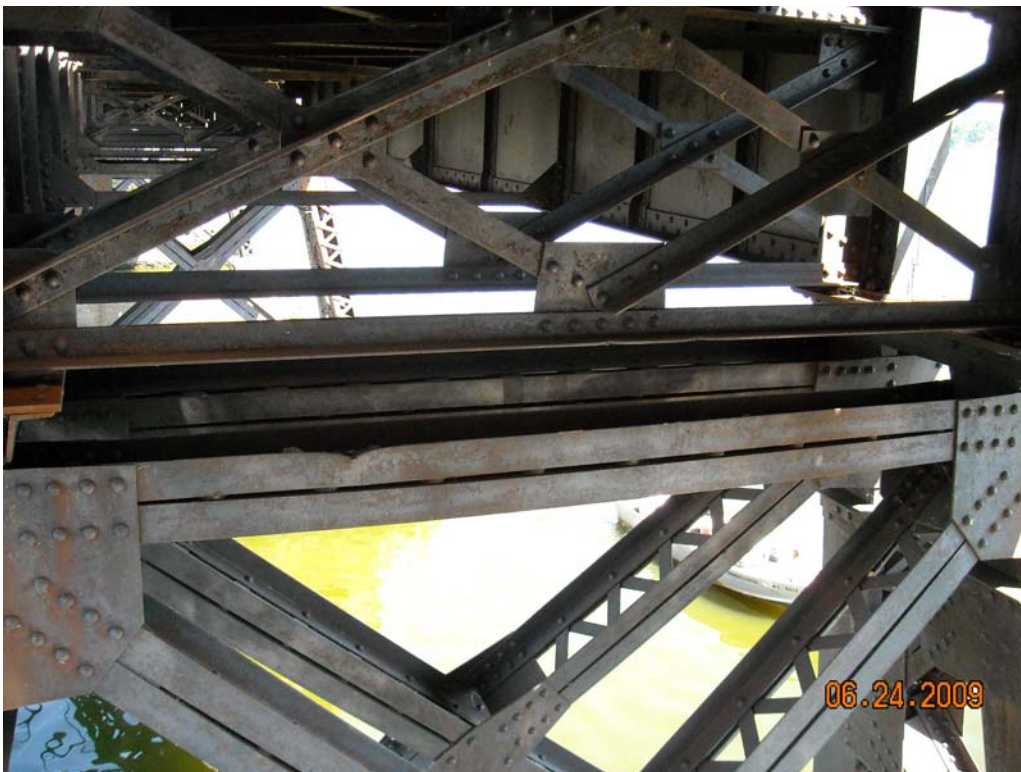
Typical Cross Frame and Top of Steel Tower at Pier

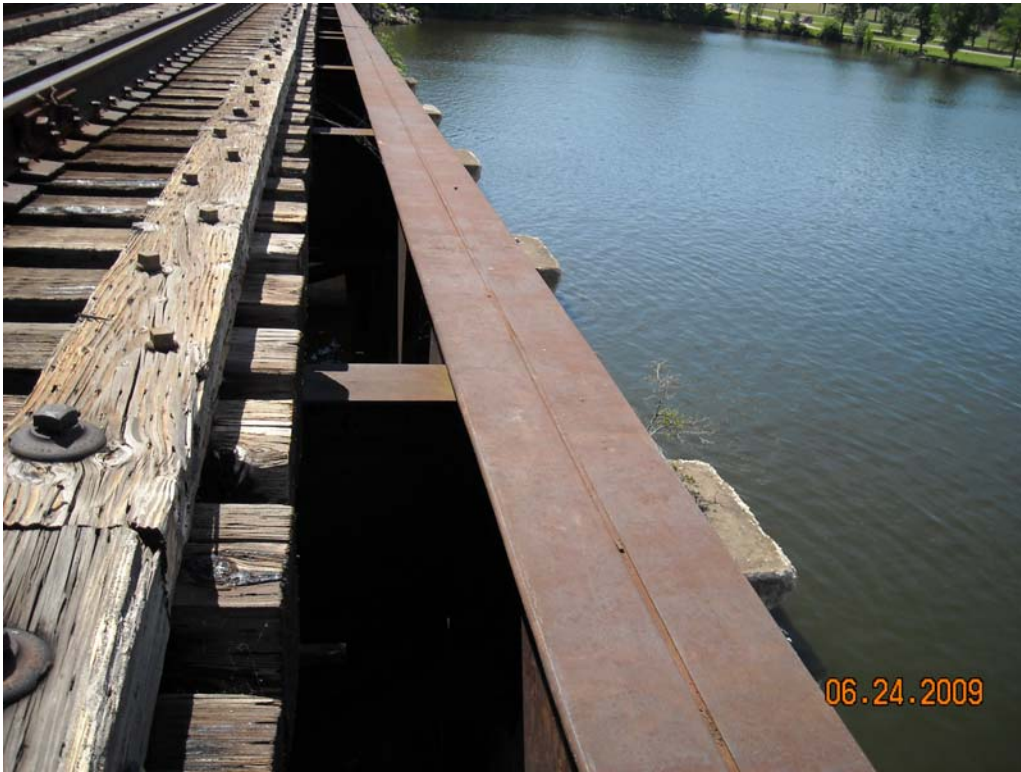
Typical Top Flange of Deck Girder

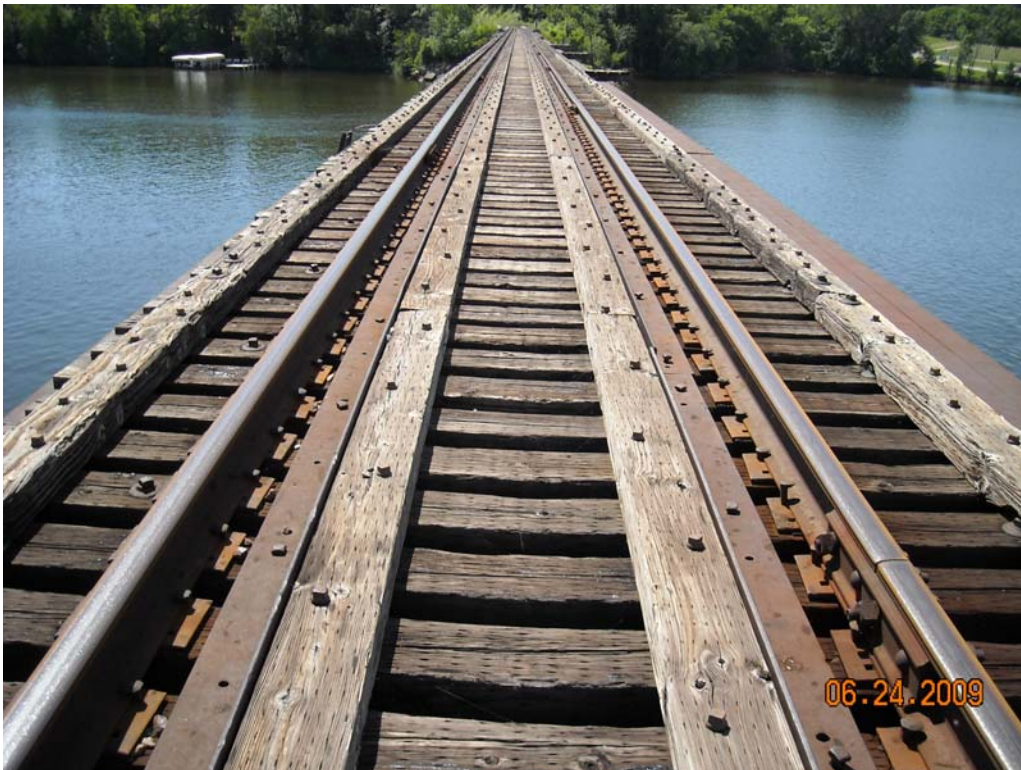
Typical Top of Deck

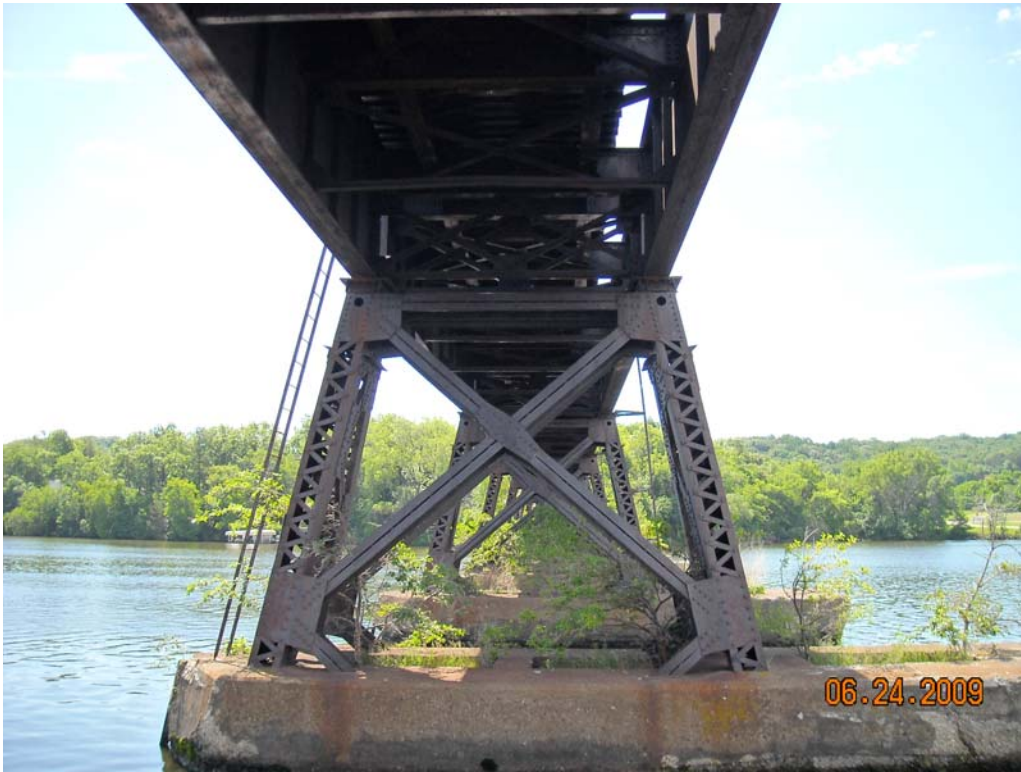
Typical Concrete Encased Steel Tower Pier

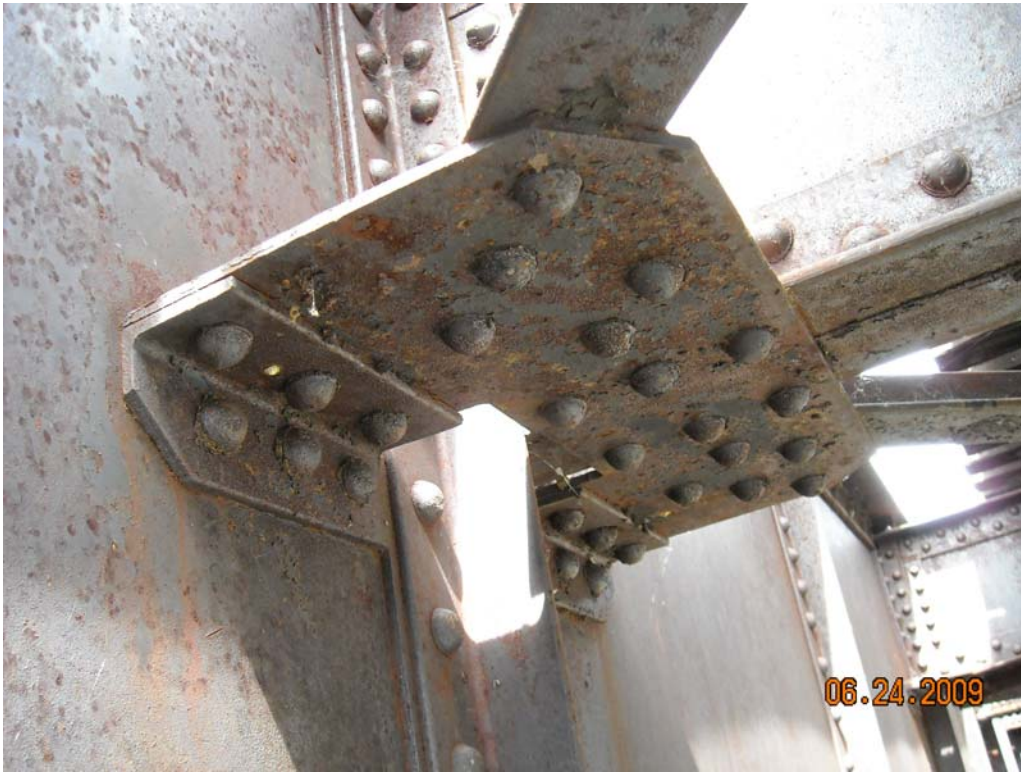
Typical Bottom Side of Floor Beam to Deck Girder Connection

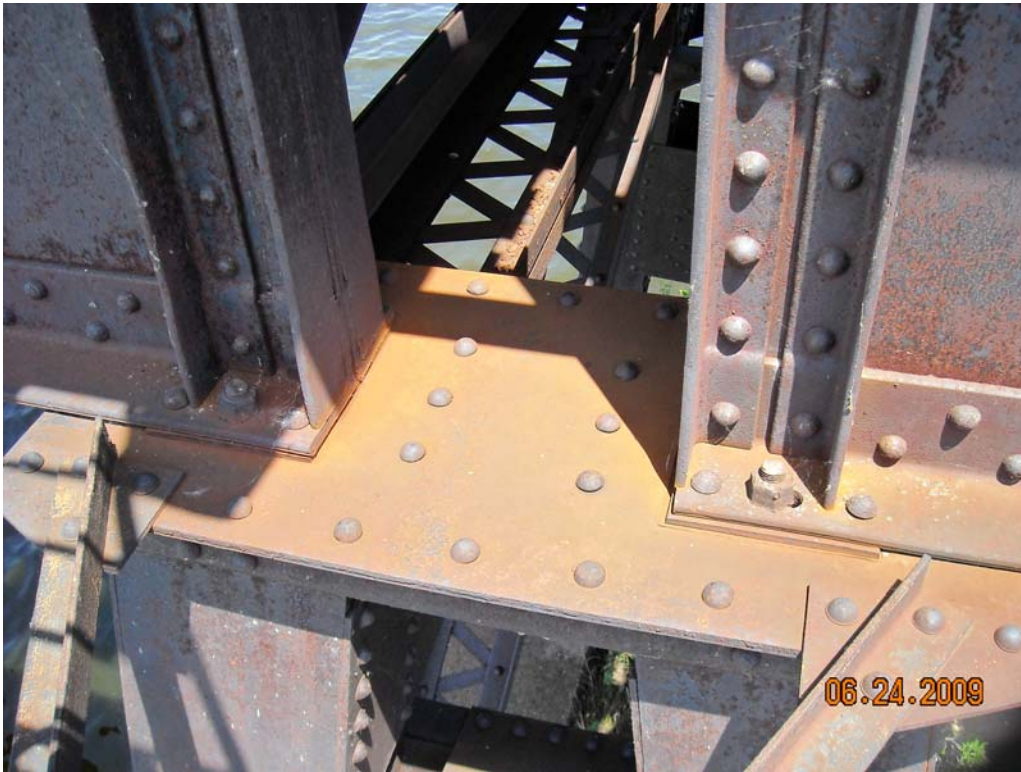
Typical Exterior of Bearings

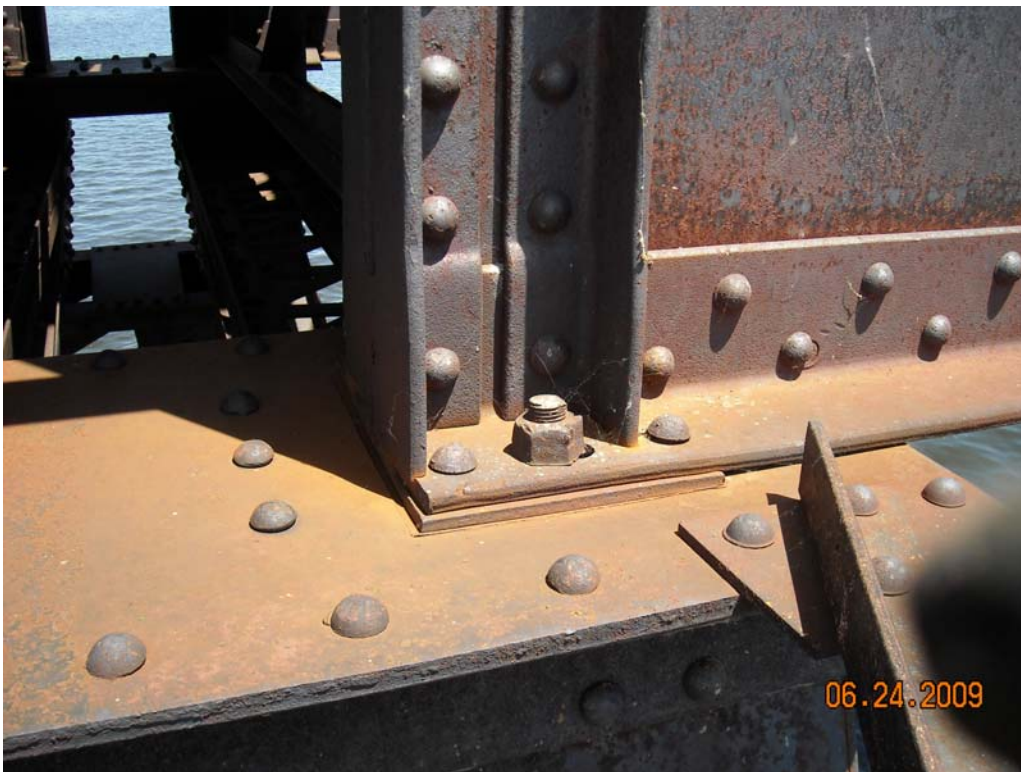
Typical Exterior of Bearing

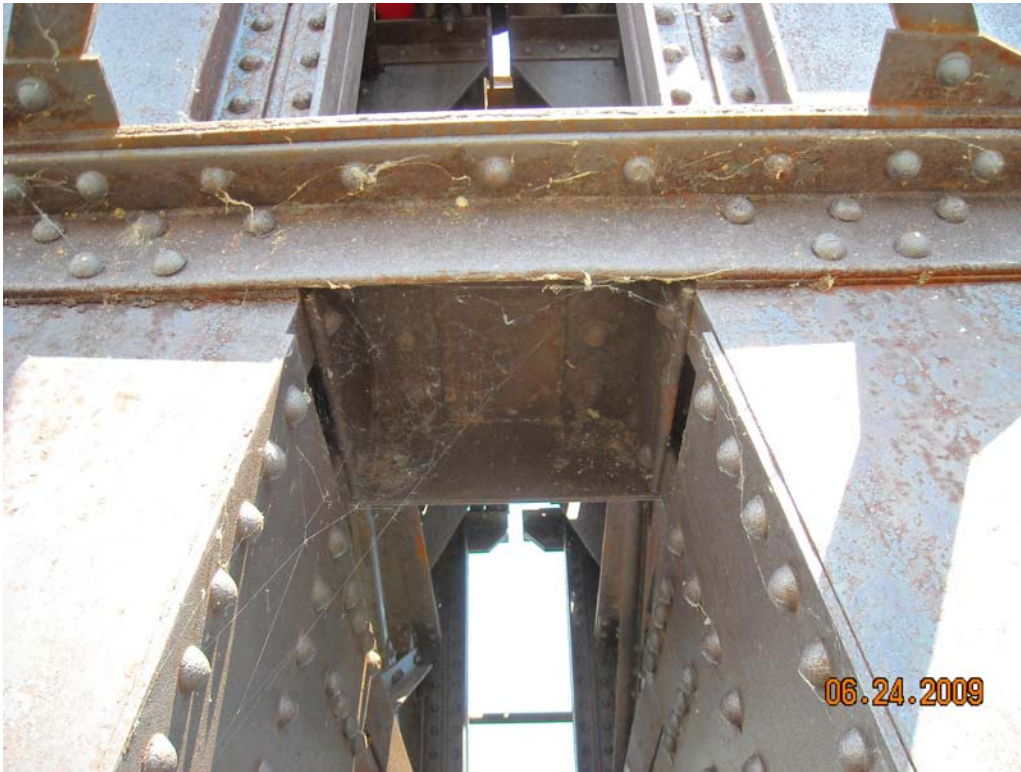
Typical Underside of Bearing Pedestal at Top of Steel Tower

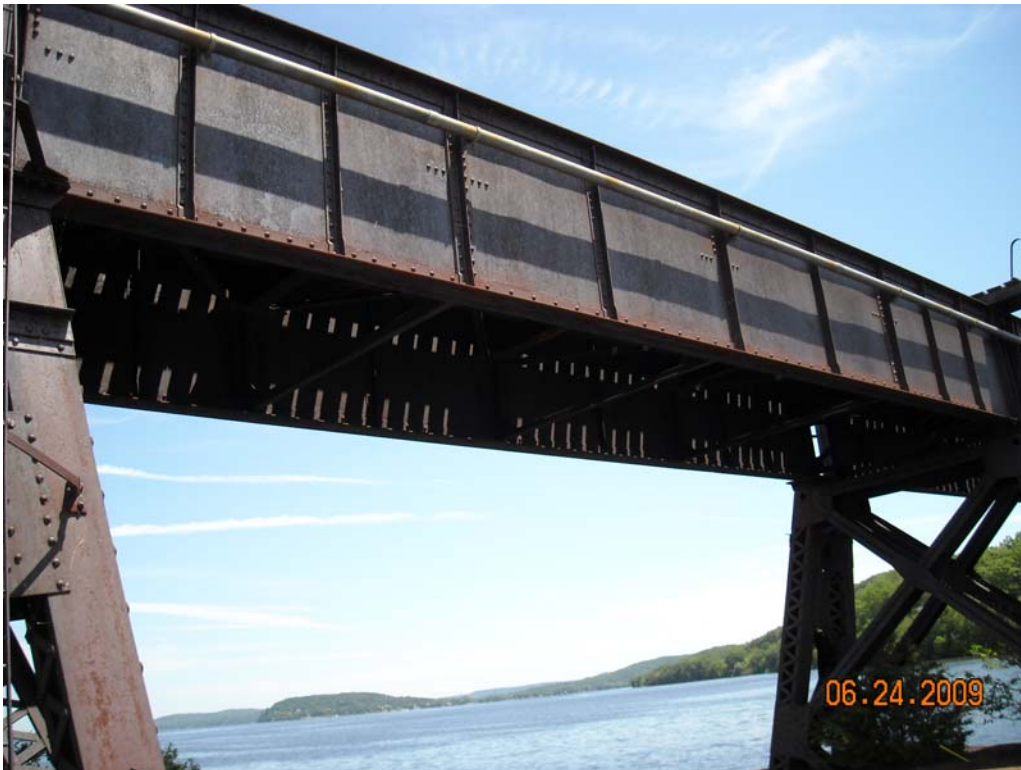
Typical Downstream (South) Profile of Deck Girder Span
