Hemlock Dam Feasibility Study

Hemlock Dam, Sauk County, Wisconsin

June 2019

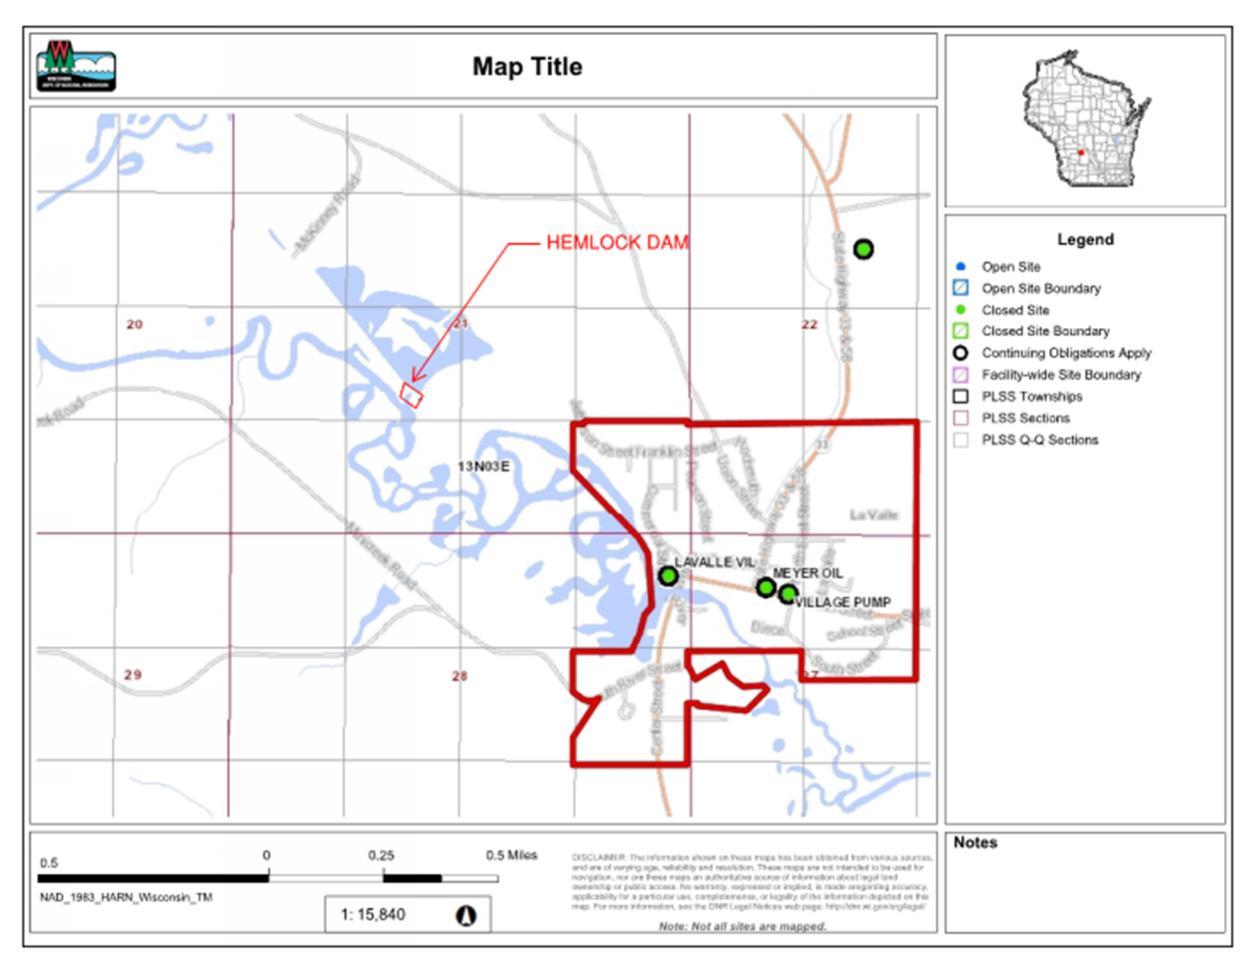
Figure 1. BRTTS sites around the Hemlock Dam

For the Hemlock Dam watershed, the BRTTS database listed no sites (Figure 1) that could contribute pollution to the tributary to the Hemlock Slough tributary upstream the Hemlock Dam.

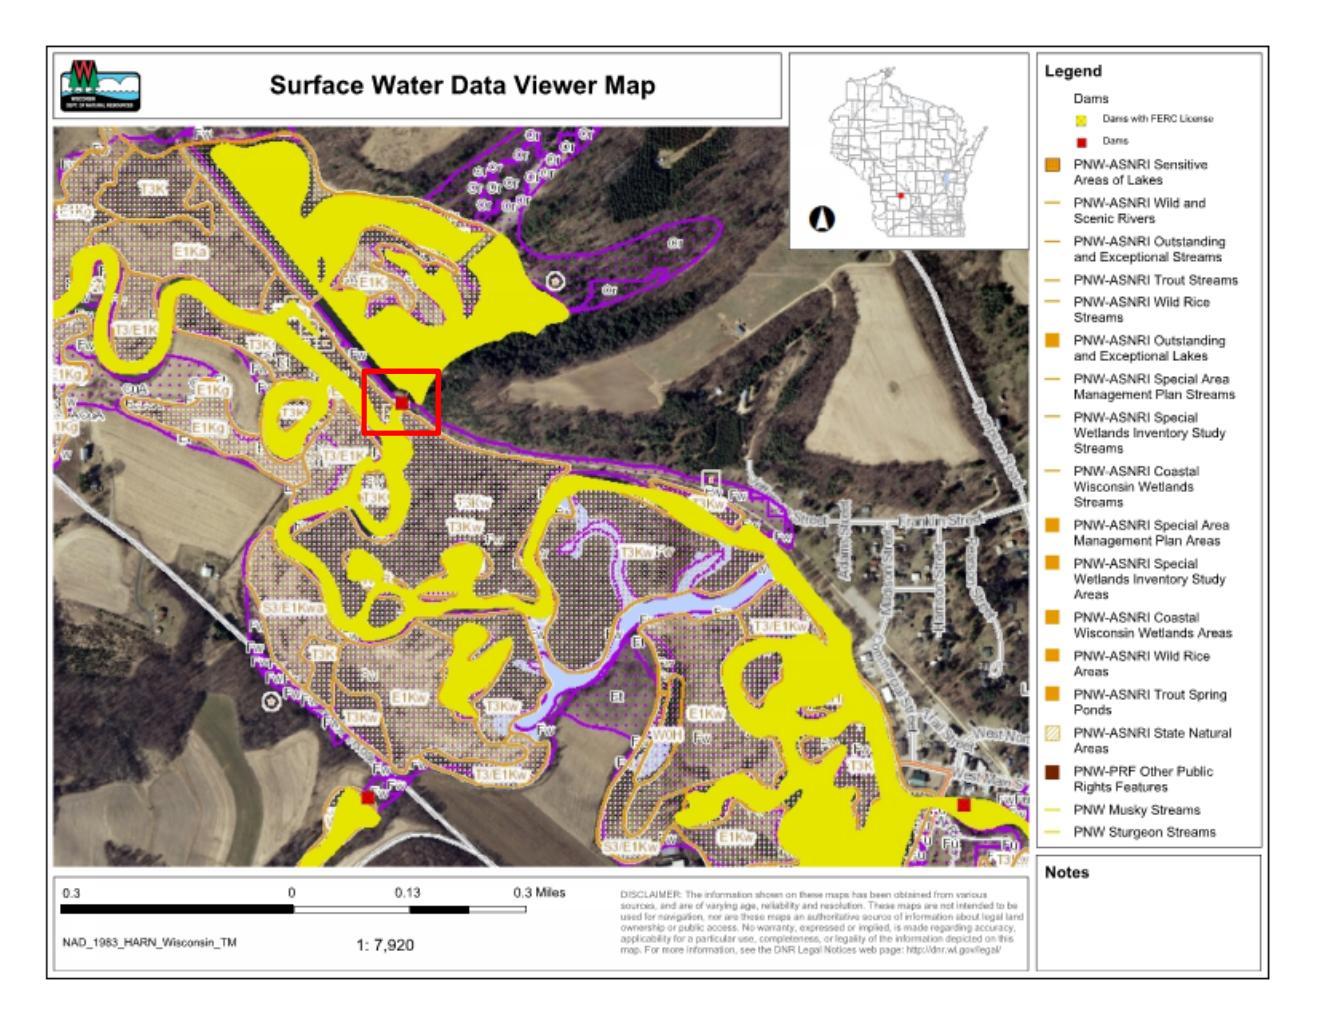
Figure 2. Surface Water Data Viewer Map

The WDNR requires dam removal applicants to identify wetland areas, disposal locations (fill only), and construction scheduling to minimize impacts to endangered resources. A WDNR map of wetland indicators is shown in Figure 2.
