# Hemlock Dam Feasibility Study

## Hemlock Dam, Sauk County, Wisconsin

**June 2019**

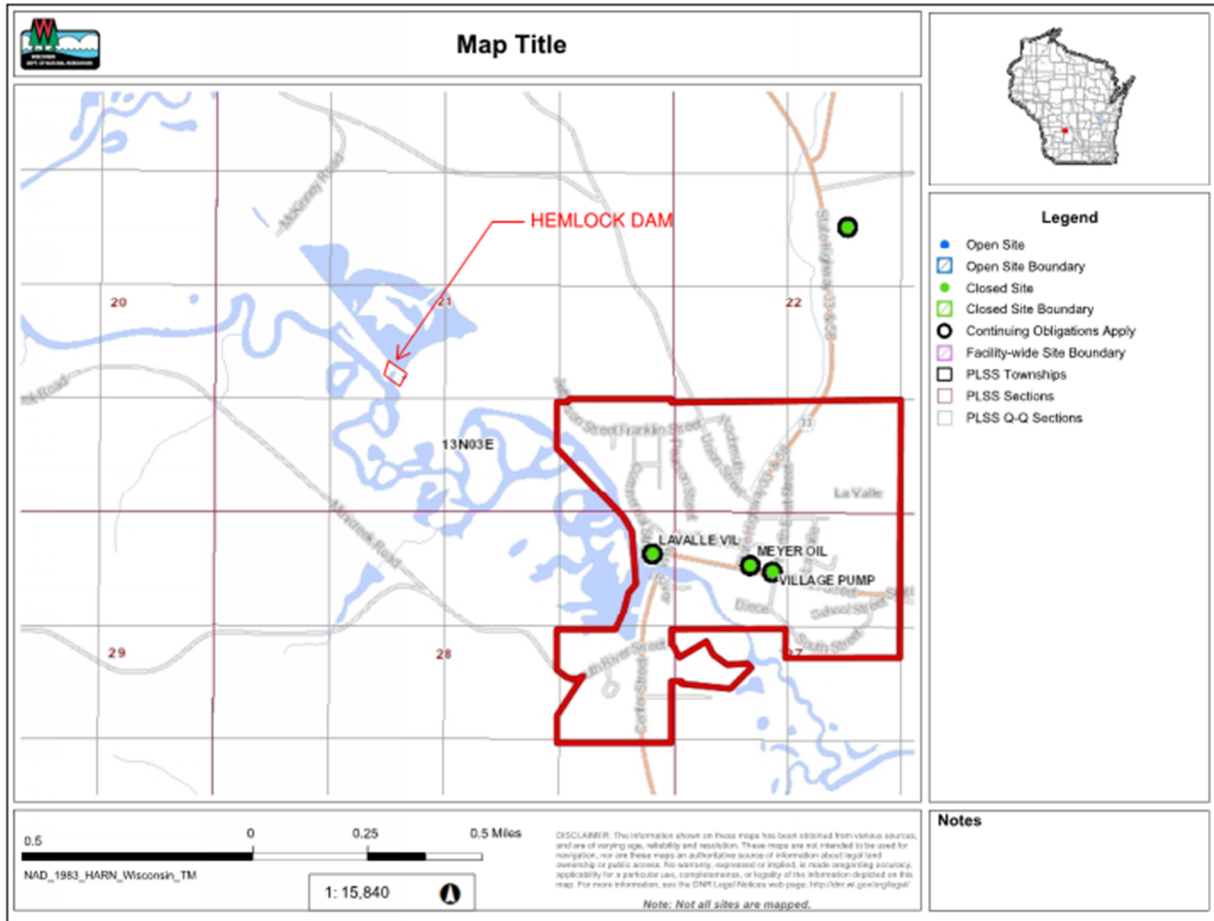
Figure 1. BRTTS sites around the Hemlock Dam

For the Hemlock Dam watershed, the BRTS database listed no sites (Figure 1) that could contribute pollution to the tributary to the Hemlock Slough tributary upstream the Hemlock Dam.
