Comprehensive Study

Merrimac Railroad Bridge No. 334

Wisconsin & Southern Railroad Company

January 2010

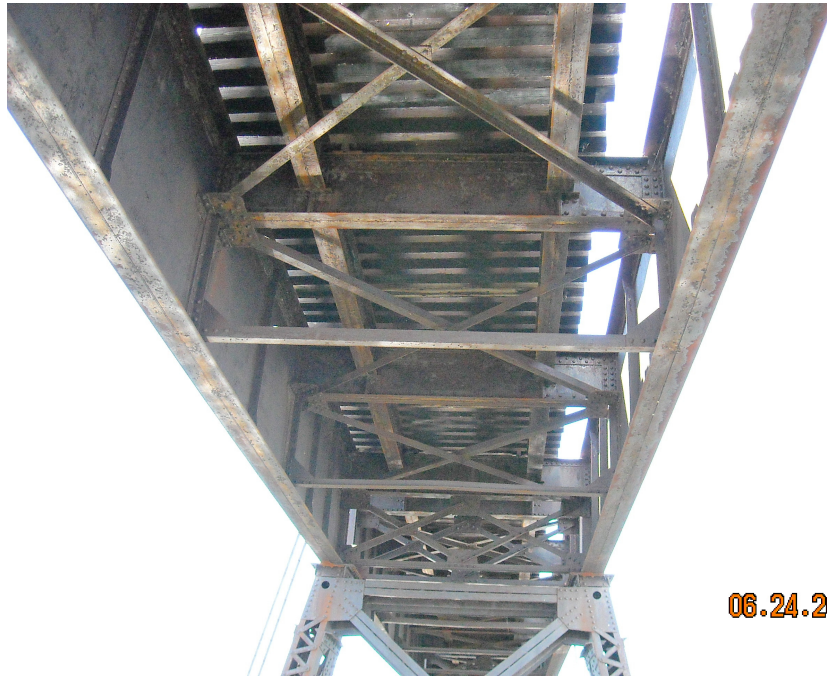
Figure 2-2 Typical View of Deck Girder System

floor beams in Span J. Floor Beam F-2 has a 2" x 3" area with up to 50% section loss with a 1/8" diameter hole. Also, the lower strut at Floor Beam 4 is bent 6 inches out of plane 4 feet from the south girder. No other significant deficiencies were noted in the stringers or lateral bracing, and the rivets were also in good condition with no loose or deteriorated rivets encountered. Refer to Appendix B for photos of typical deficiencies.

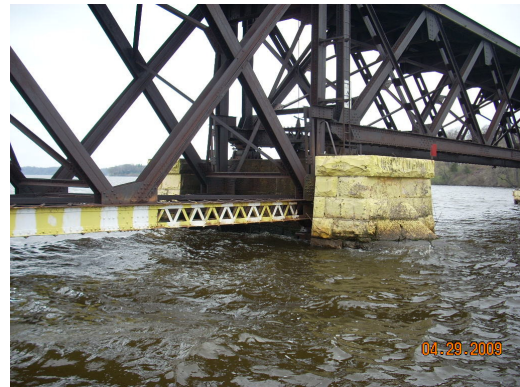
Figure 7-3 Pier 19 Bearings.

With the change in water elevations, the steel bearings and some of the steel truss members are closer to the water surface and thus more prone to corrosion and accelerated deterioration. In addition, the potential for increased damage from ice buildup is another condition that could result. Chapter 8 will discuss in more detail the vulnerability to ice damage from flow or buildup.

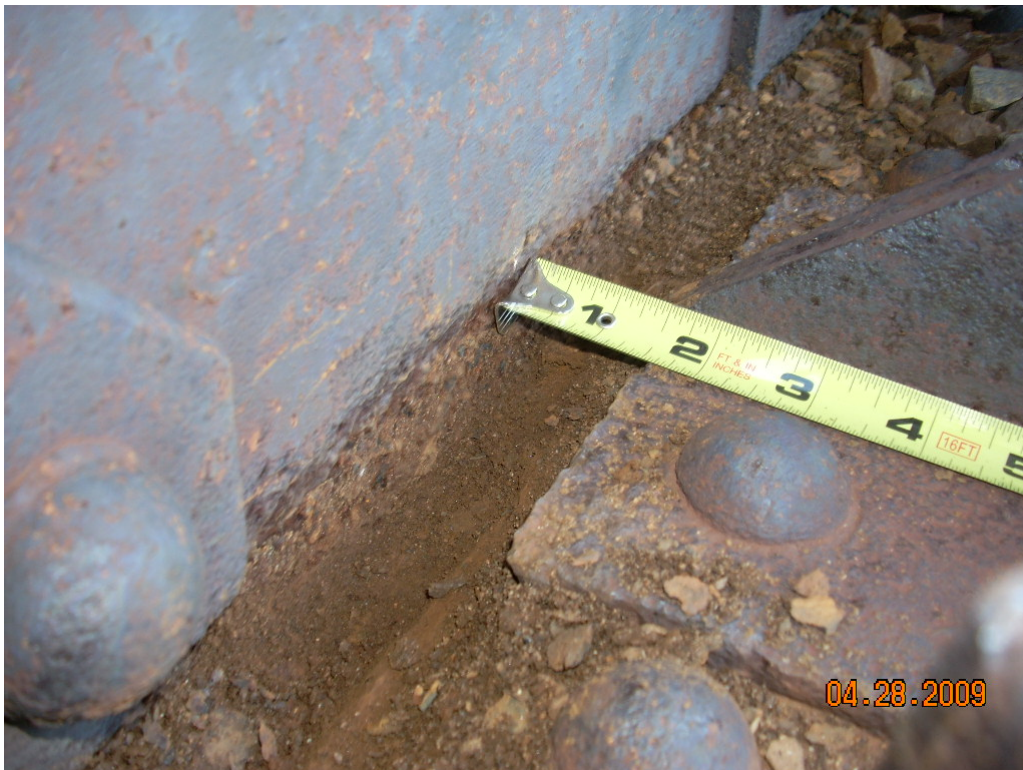
Typical pitting up to 25 percent of thickness of vertical gusset plate at lower chord connections where rock and soil are present

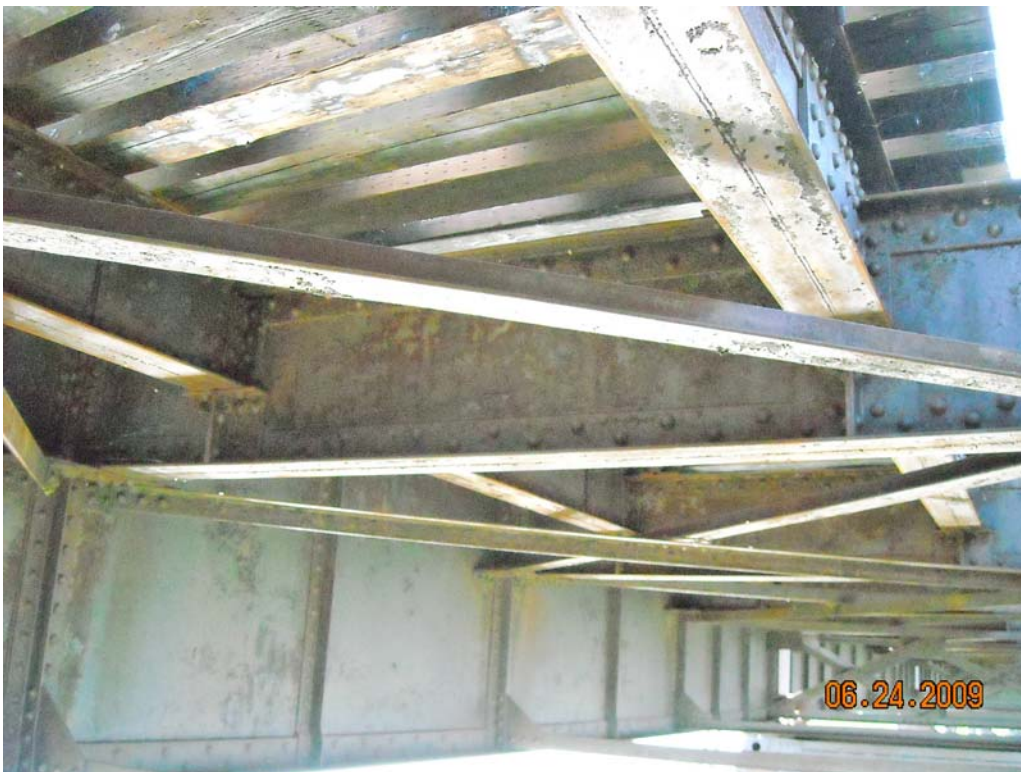
Typical Diagonal Lateral Bracing

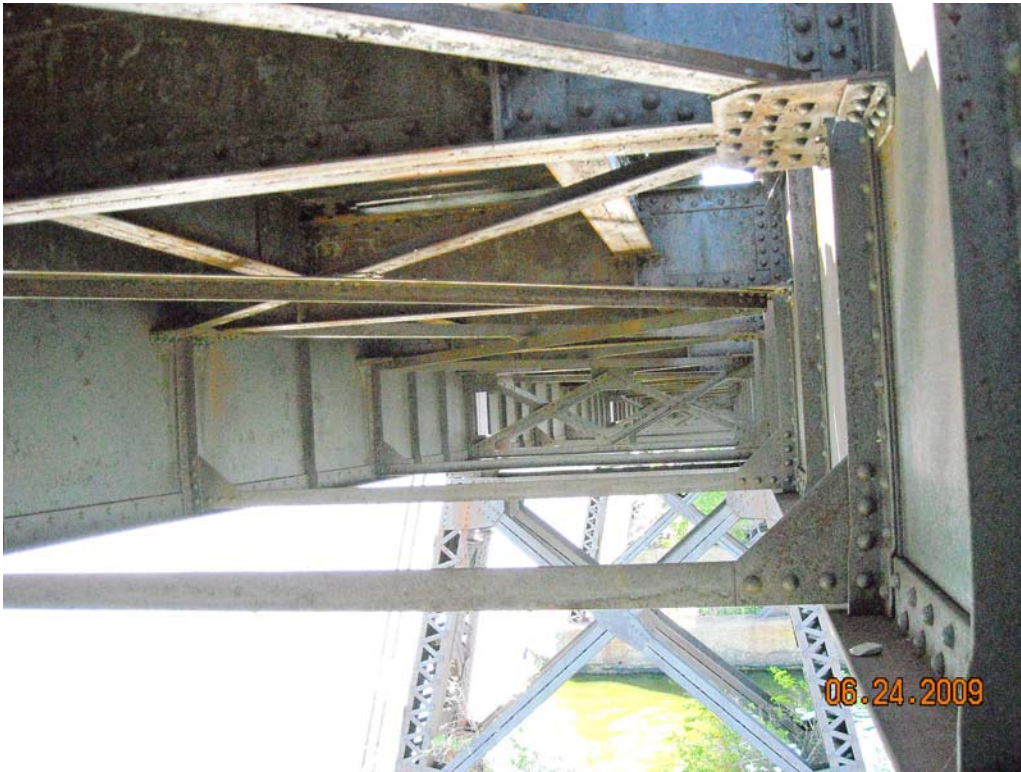
Typical Transverse and Diagonal Lateral Bracing

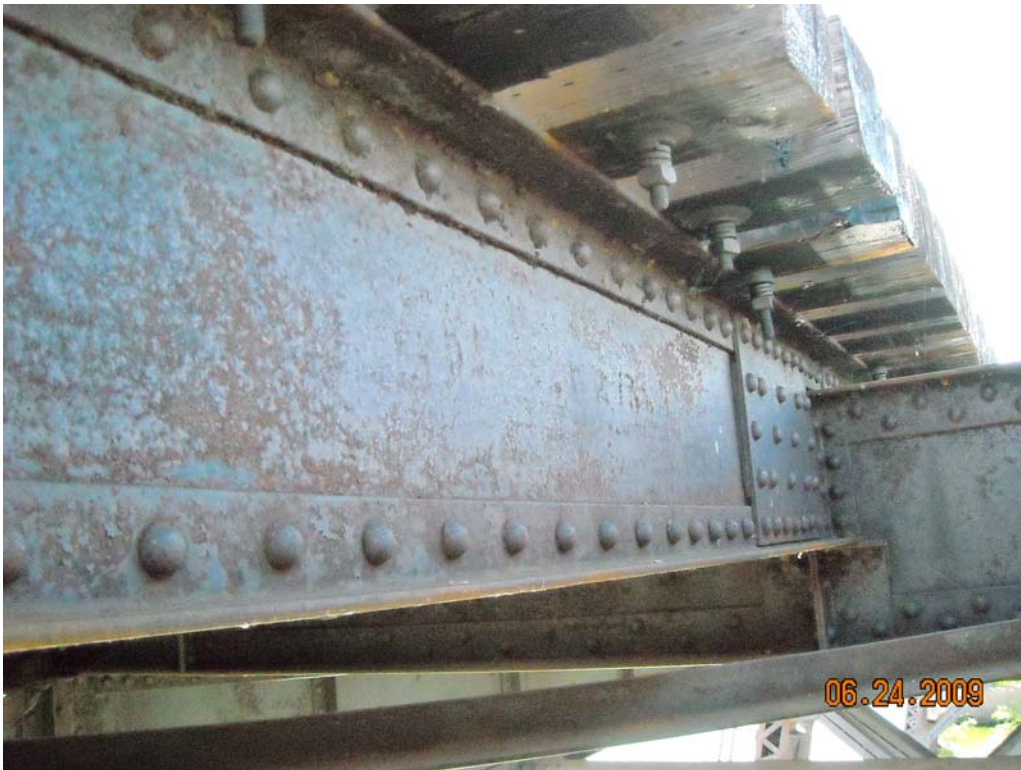
Typical Exterior of Stringer

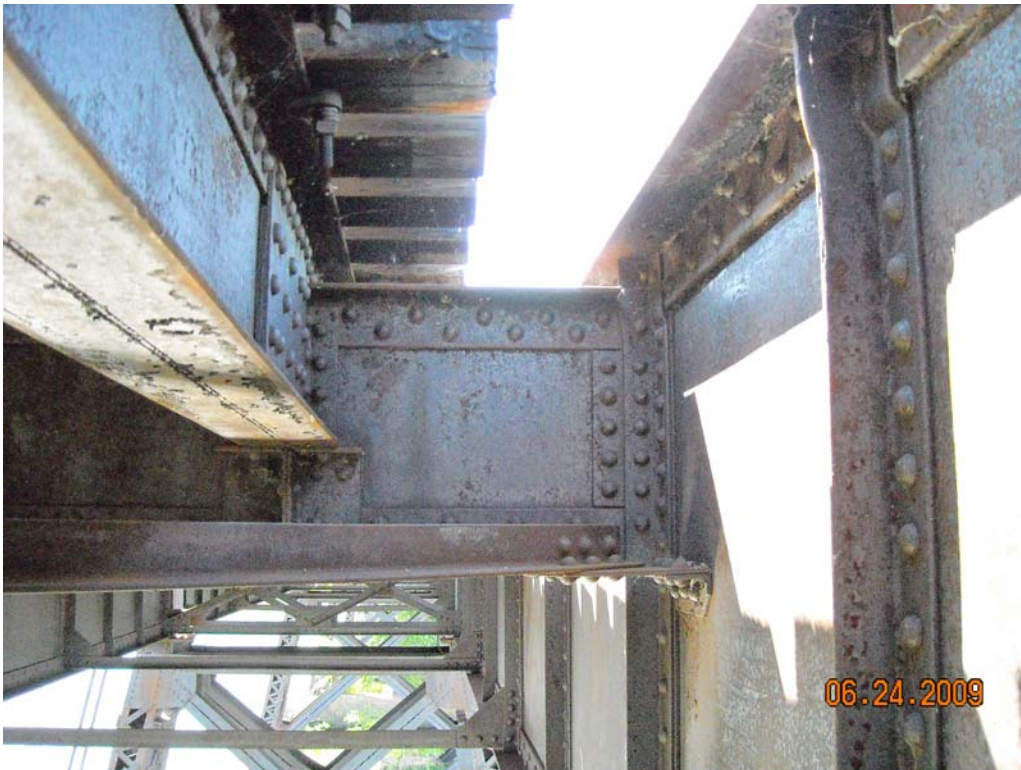
Typical Stringer to Floor Beam and Floor Beam to Deck Girder Connections

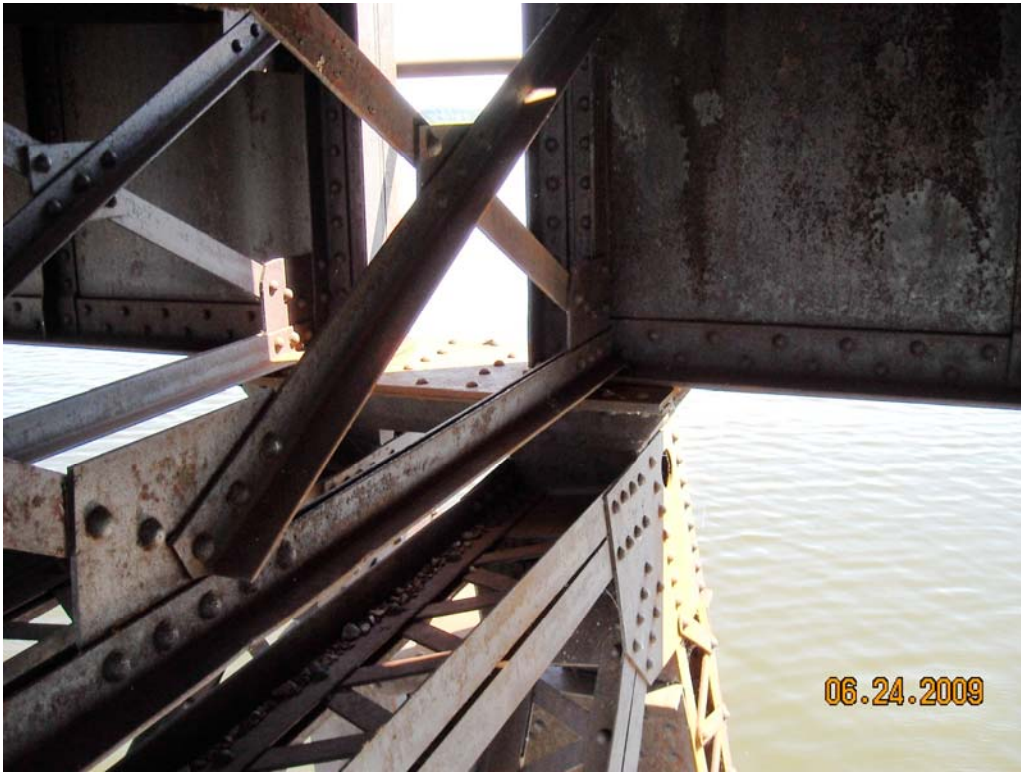
Typical Interior of Bearings

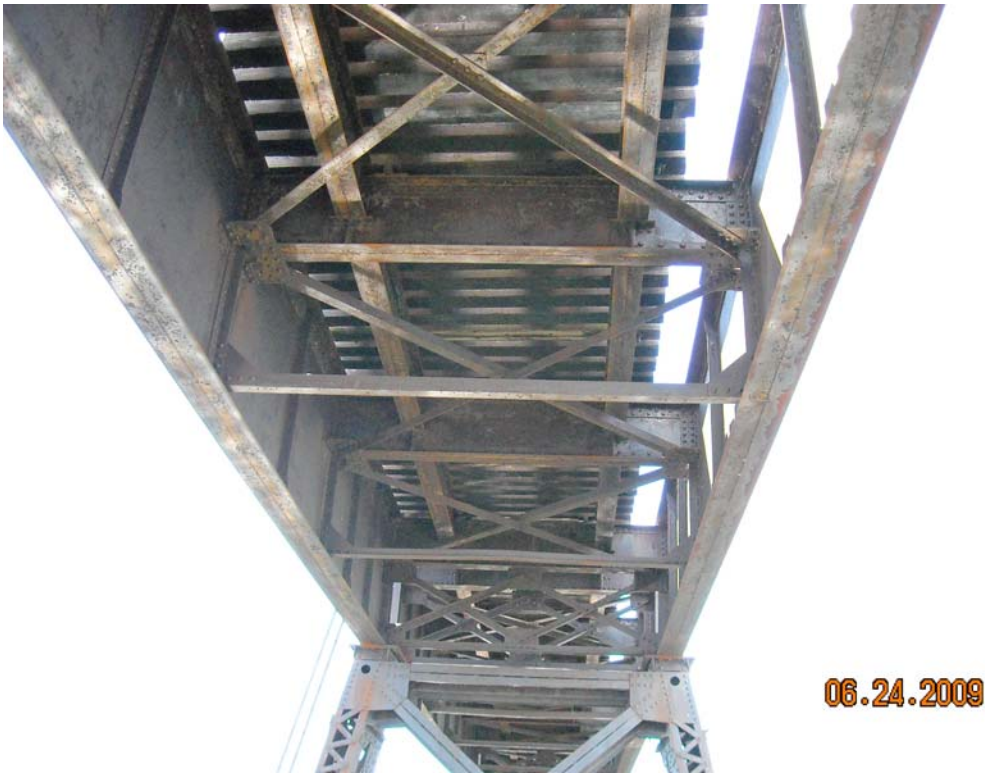
Typical Deck Girder Span

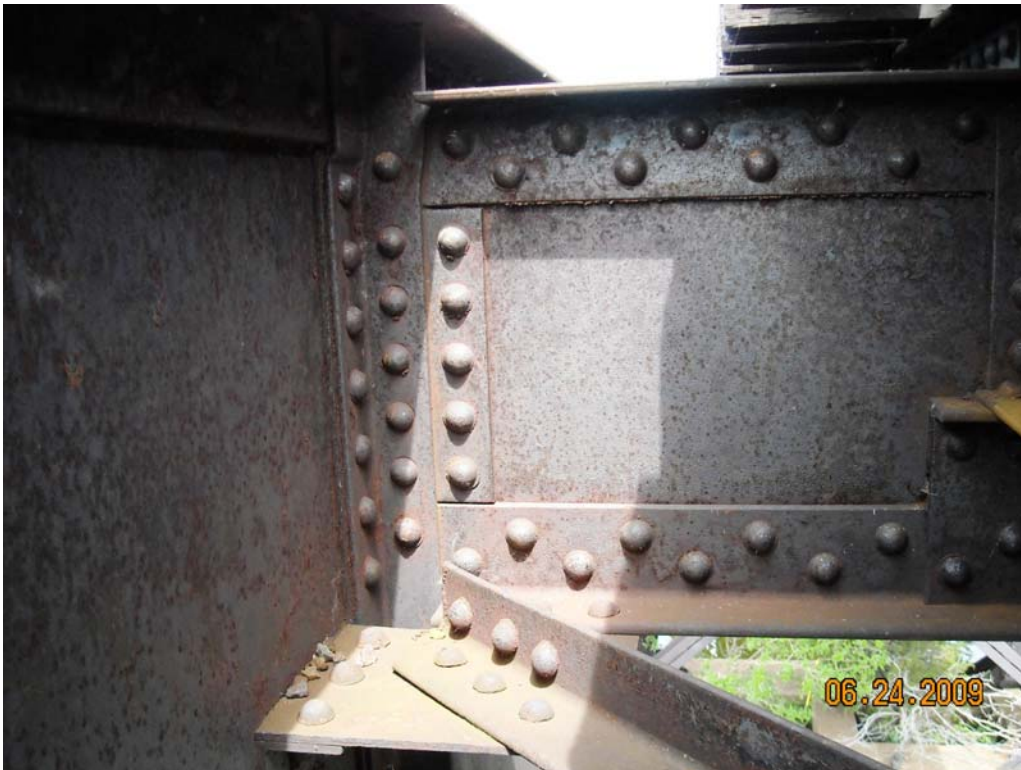
Typical Top Side of Floor Beam to Deck Girder Connection

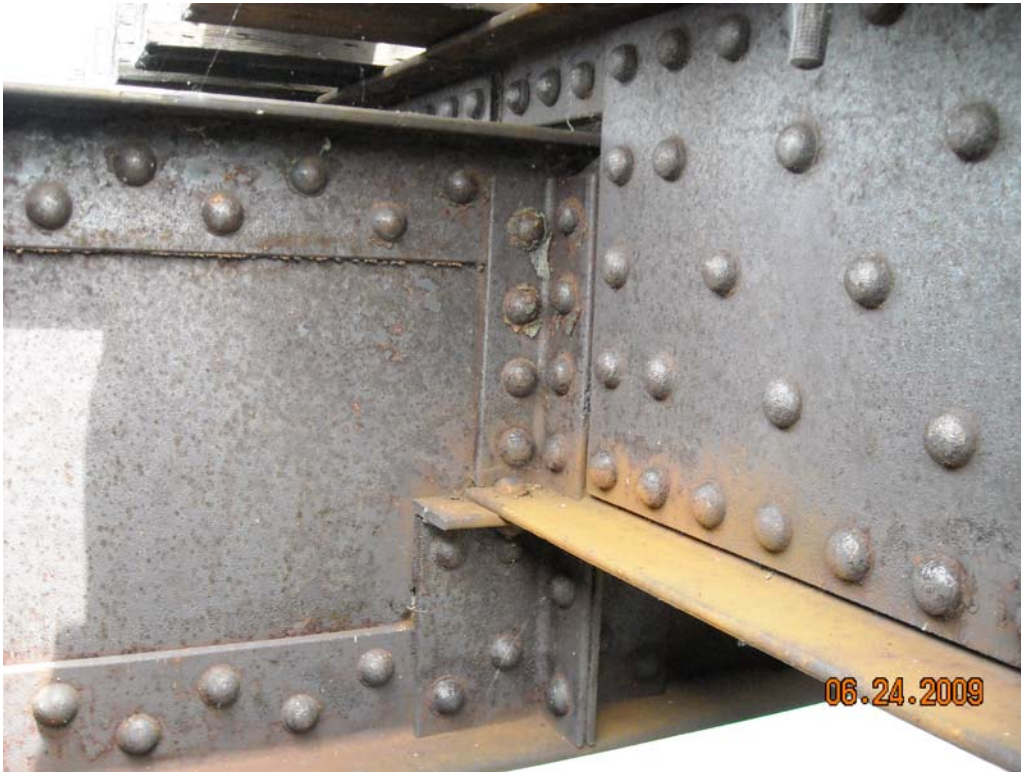
Typical Stringer to Floor Beam Connection

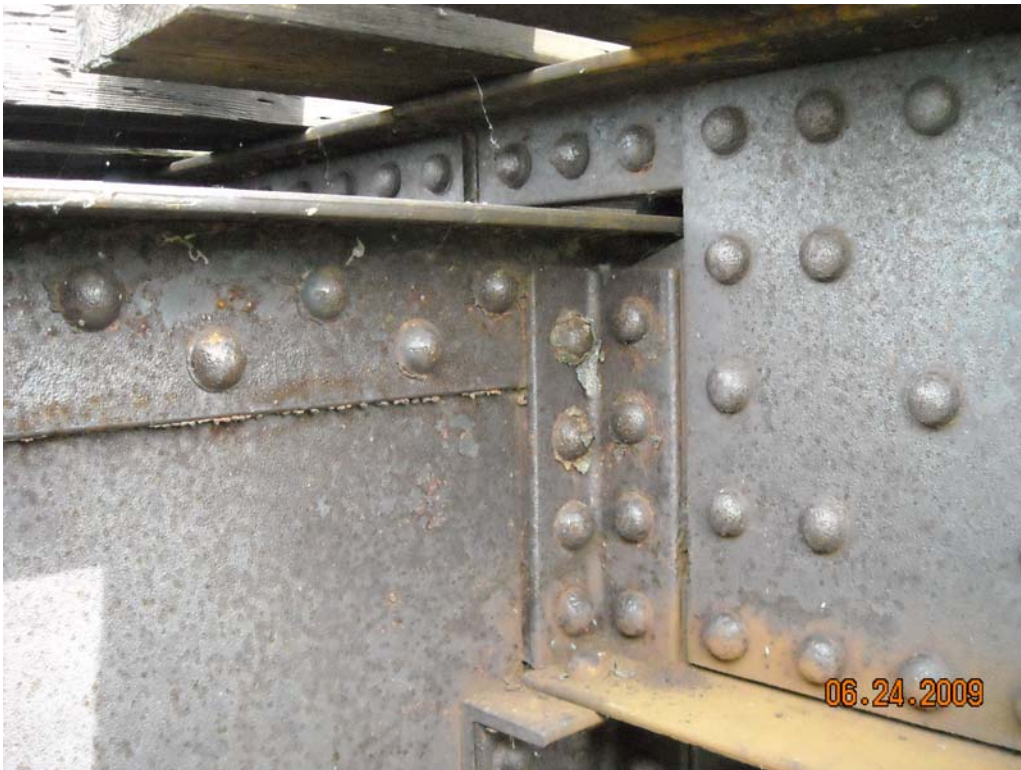
Typical Stringer to Floor Beam Connection
